NOTICE TO BUYER: SELLER-PROCURED INSPECTION REPORT

The following notice is given with respect to the Purchase and Sale Agreement dated _____ between _____ ("Buyer") and John C Hopkins Stephanie R Hopkins ("Seller") concerning 17509 NE 137th St Redmond WA 98052 ("the Property").

At your request, a visual inspection of the above referenced property was conducted on 07/01/2022. We have inspected the major structural components, plumbing, heating and electrical systems for signs of significant non-performance, excessive or unusual wear and general state of repair.

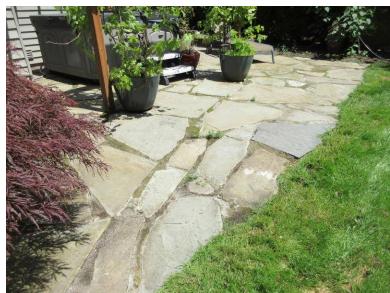
2.5 PATIO

The walking surface was not even and trip hazards were present. We recommend all walking surfaces be maintained free of trip hazards.

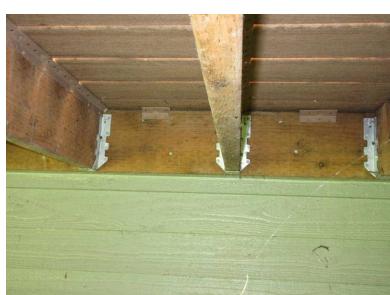
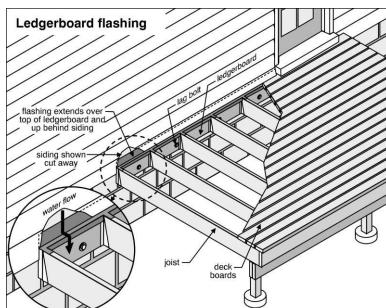
3.6 DECK

The deck is not adequately secured to the building. The installation of lag bolts through the ledger board into the wall is recommended.

There is no flashing at the intersection between the deck and house. This will allow water to enter behind the siding. The installation of flashing in this area is recommended.

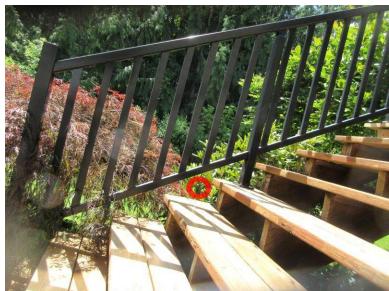
3.8 STAIRS

The spacing under stair railing is too wide. This is a hazard for small children. The spacing should be reduced as a safety upgrade. Current standards require that a 4" sphere not pass under the railing.

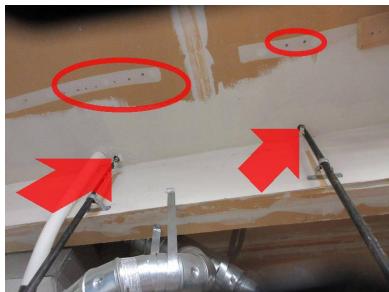
There are voids in the fire resistive barrier between the living space and garage that will allow flames to penetrate. The gypsum barrier slows the spread of a fire from the garage to the structure and/or living space. Patching the voids with a fire retardant caulk is recommended.

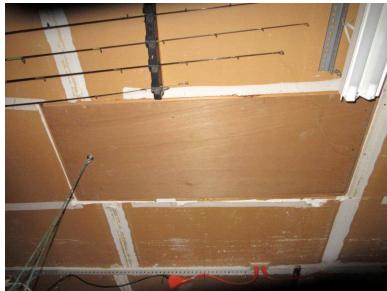
The pull down ladder is a breech in the fire resistive barrier in the garage. This is a safety concern. The gypsum barrier on the ceiling slows the spread of a fire from the garage to the attic. The installation of a layer of 5/8" gypsum type X board over the 1/4" plywood is recommended.

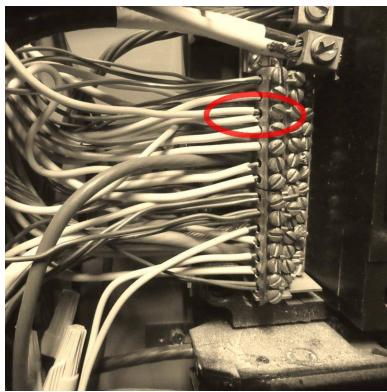
One of the neutral wires is double tapped on the buss bar. Double tapping means that two conductors share a single terminal. Double tapped terminals can loosen and overheat and therefore are not permitted unless the terminal is specifically listed for multiple wires. This defect is easily repaired by connecting the two wires to a "pig tail", securing them with a wire cap, and then inserting the pig tail conductor under the terminal.

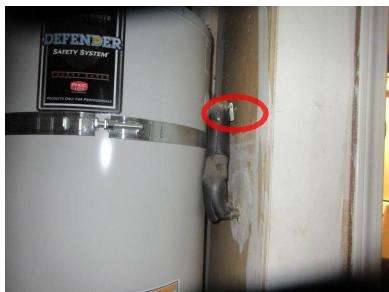
The pressure relief valve is obstructed. This can result in failure of the pressure relief valve. The water tank should be repositioned so that it allows for the relief valves proper operation.

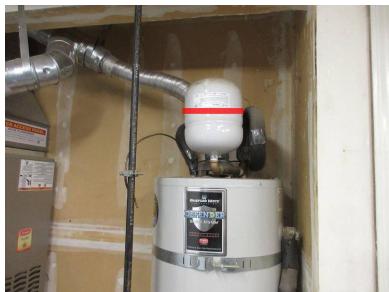
10.6 EXPANSION TANK

The expansion tank is not adequately secured to the wall. As code requirements start to call for engineered expansion tank supports we recommend the installation of seismic restraints to secure the expansion tank instead of allowing it to simply depend on piping connections that could result in damage to the water pipe and leakage during an earthquake.

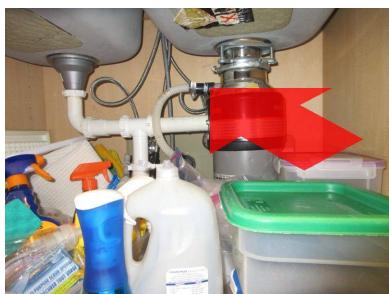
The dishwasher drain lacks an air gap. The dishwasher will function without one, but there is a risk of contamination of the inside of the dishwasher by waste water. The installation of an air gap is recommended.

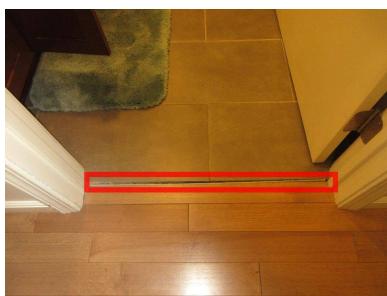
The hard surface flooring lacks a transition strip. The exposed edge of the flooring is a hazard. We recommend the installation of a floor edge transition strip.

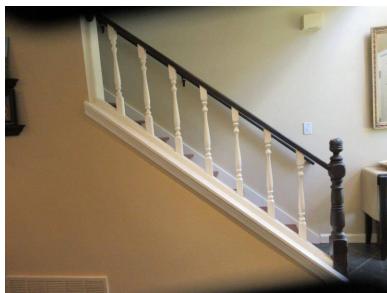
15.3 STAIRS

The stair railing baluster spacing is too wide. This is a hazard for small children. The baluster spacing should be reduced as a safety upgrade. Current standards require that a 4" sphere not pass through the railing.

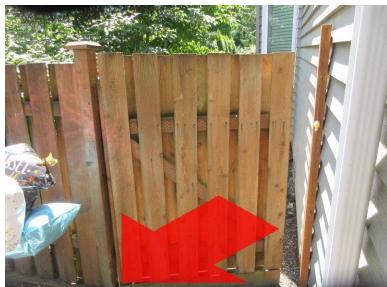
The gate post needs repair, posts should be replaced as necessary to restore full function.

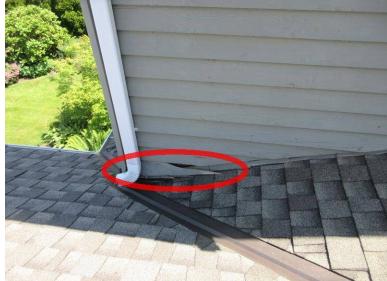
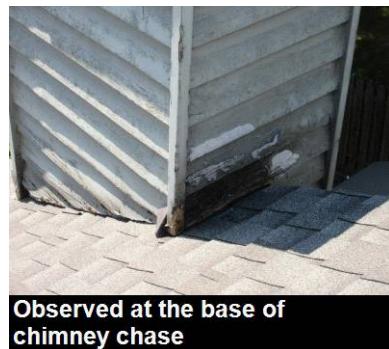
3.1 PRIMARY EXTERIOR WALL CLADDING

The siding is damaged where it has been in contact with the roofing material. The split, rot damaged and/or loose siding should be repaired and a minimum of a 2" clearance should be maintained between the top of the roofing and bottom of the siding.

Observed at the base of
chimney chase

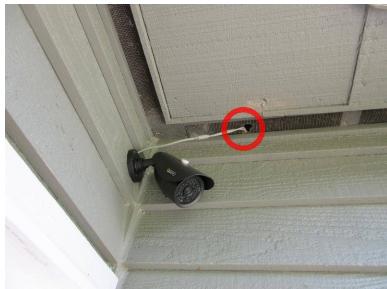
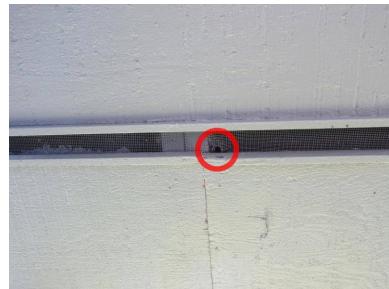
3.3 SOFFITS AND OVERHANGS

There is a damaged vent screen on the front of the house. The vent screen should be repaired to prevent insect, bird and rodent entry.

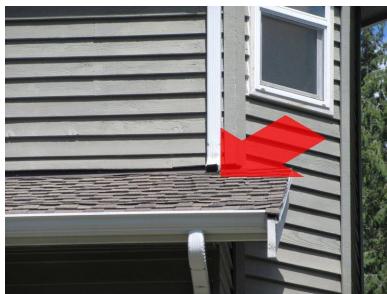
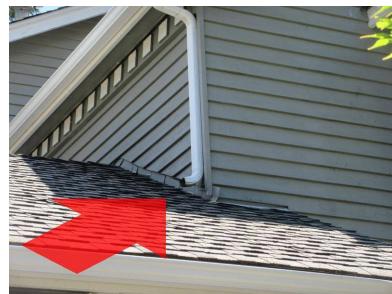
3.4 GUTTERS AND DOWNSPOUTS

Downspouts draining directly onto the asphalt shingle surface causes excessive wear of the roofing material. Downspout extensions to the lower gutters should be installed to prevent excessive wear and tear of the roofing.

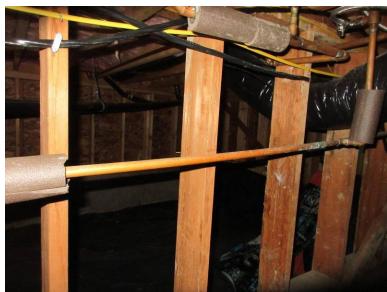
There are water pipes in the crawlspace that are not adequately insulated and could freeze. The installation of foam pipe insulation on all exposed water pipes is recommended.

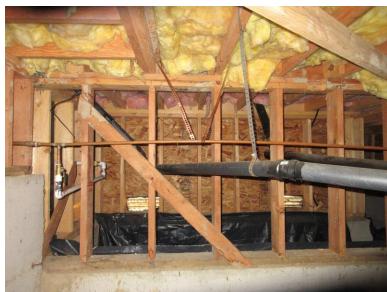
19.6 SHEAR PANELS

Shear panels are plywood or OSB panels that are mechanically fastened to both vertical and horizontal framing members in critical structural areas of the building. They prevent lateral movement of the structure during an earthquake. Shear panels are often visible in the crawlspace on cripple walls between the first floor and foundation. They may also be installed on interior walls that are covered with drywall. An examination of the crawlspace revealed the absence of shear panels on the cripple walls. The installation of shear panels on the cripple walls is recommended as an upgrade.

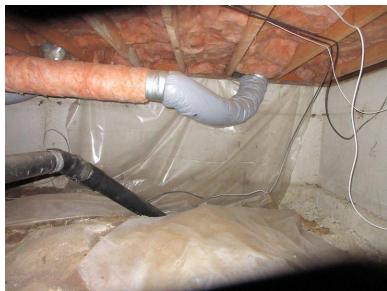
Portions of the foundation walls are covered with the plastic vapor retarder. This allows the transmission of water vapor from the soil up and into the exterior wall framing. The plastic vapor retarder should be removed from the foundation so that it covers at least 85% of the entire surface of the soil only.

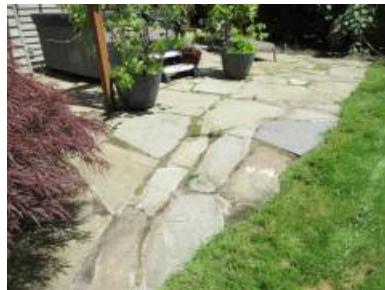
The walking surface was not even and trip hazards were present. We recommend all walking surfaces be maintained free of trip hazards.

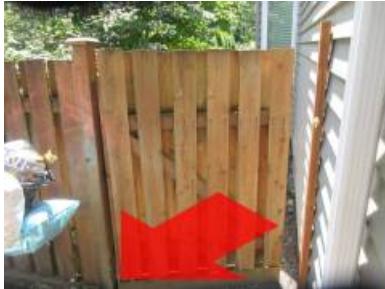
The gate post needs repair, posts should be replaced as necessary to restore full function.

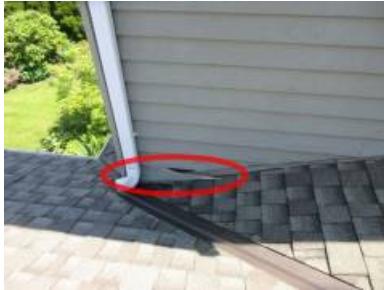
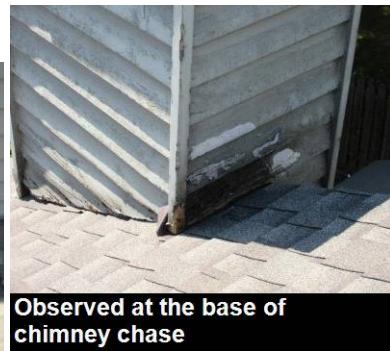
The siding is damaged where it has been in contact with the roofing material. The split, rot damaged and/or loose siding should be repaired and a minimum of a 2" clearance should be maintained between the top of the roofing and bottom of the siding.

Observed at the base of
chimney chase

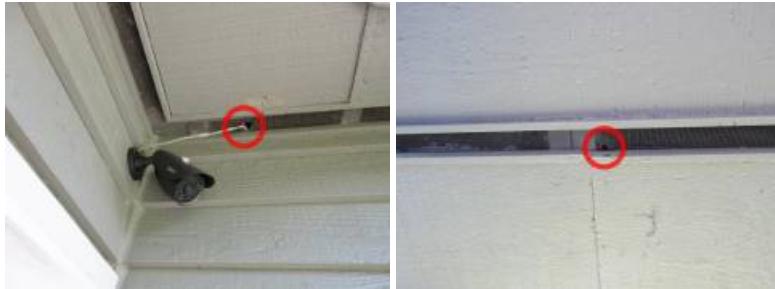
There is a damaged vent screen on the front of the house. The vent screen should be repaired to prevent insect, bird and rodent entry.

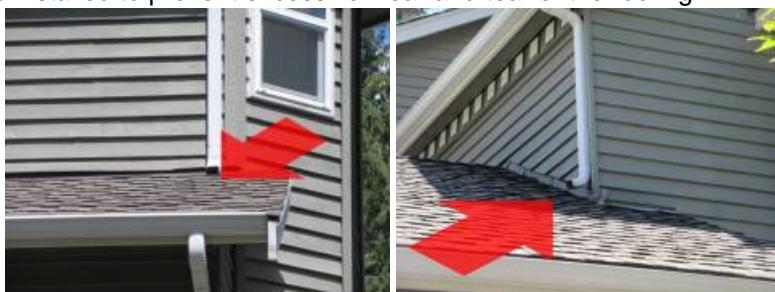
3.4 GUTTERS AND DOWNSPOUTS

Downspouts draining directly onto the asphalt shingle surface causes excessive wear of the roofing material. Downspout extensions to the lower gutters should be installed to prevent excessive wear and tear of the roofing.

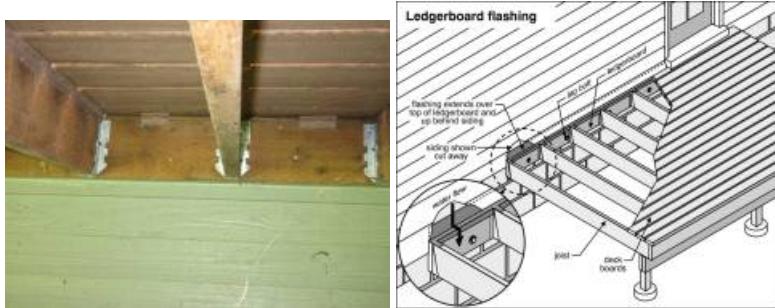
There is no flashing at the intersection between the deck and house. This will allow water to enter behind the siding. The installation of flashing in this area is recommended.

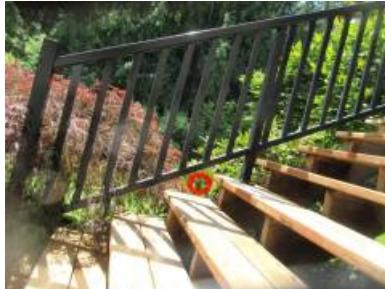
The spacing under stair railing is too wide. This is a hazard for small children. The spacing should be reduced as a safety upgrade. Current standards require that a 4" sphere not pass under the railing.

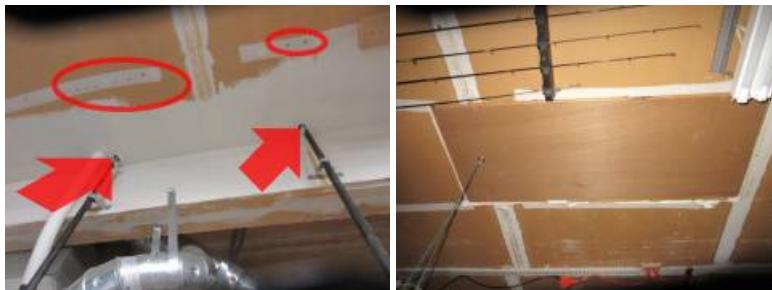
The pull down ladder is a breech in the fire resistive barrier in the garage. This is a safety concern. The gypsum barrier on the ceiling slows the spread of a fire from the garage to the attic. The installation of a layer of 5/8" gypsum type X board over the 1/4" plywood is recommended.

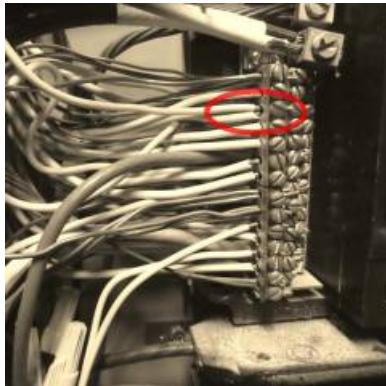
One of the neutral wires is double tapped on the buss bar. Double tapping means that two conductors share a single terminal. Double tapped terminals can loosen and overheat and therefore are not permitted unless the terminal is specifically listed for multiple wires. This defect is easily repaired by connecting the two wires to a "pig tail", securing them with a wire cap, and then inserting the pig tail conductor under the terminal.

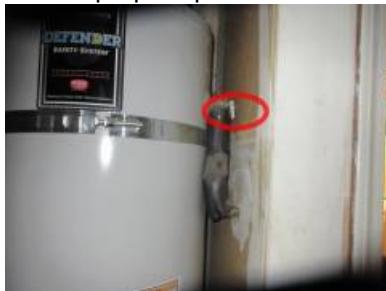
The pressure relief valve is obstructed. This can result in failure of the pressure relief valve. The water tank should be repositioned so that it allows for the relief valves proper operation.

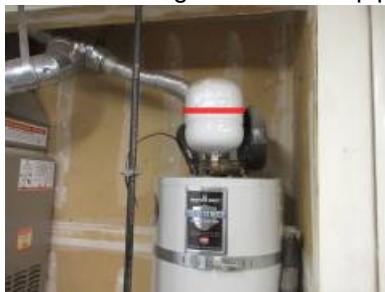
The expansion tank is not adequately secured to the wall. As code requirements start to call for engineered expansion tank supports we recommend the installation of seismic restraints to secure the expansion tank instead of allowing it to simply depend on piping connections that could result in damage to the water pipe and leakage during an earthquake.

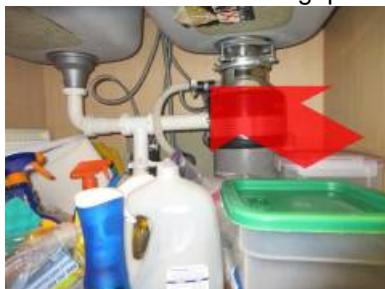
The dishwasher drain lacks an air gap. The dishwasher will function without one, but there is a risk of contamination of the inside of the dishwasher by waste water. The installation of an air gap is recommended.

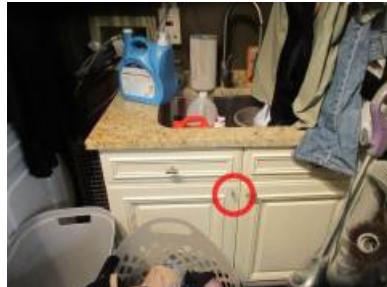
The door hardware is missing and in need of replacement.

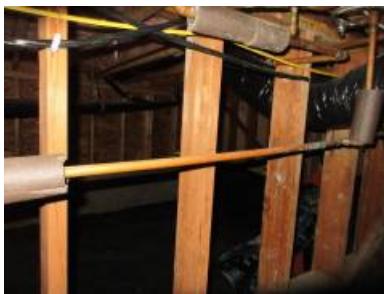
There are water pipes in the crawlspace that are not adequately insulated and could freeze. The installation of foam pipe insulation on all exposed water pipes is recommended.

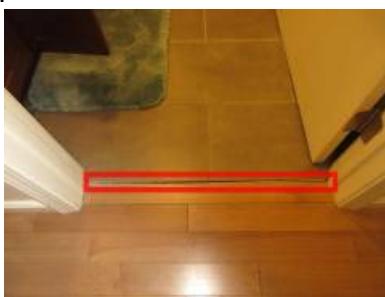
The hard surface flooring lacks a transition strip. The exposed edge of the flooring is a hazard. We recommend the installation of a floor edge transition strip.

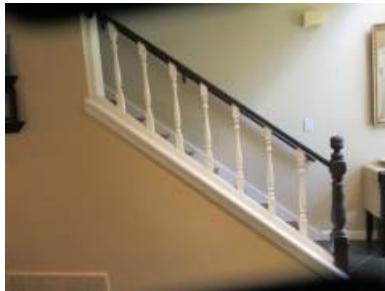
15.3 STAIRS

The stair railing baluster spacing is too wide. This is a hazard for small children. The baluster spacing should be reduced as a safety upgrade. Current standards require that a 4" sphere not pass through the railing.

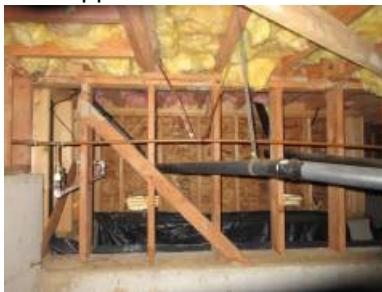
Shear panels are plywood or OSB panels that are mechanically fastened to both vertical and horizontal framing members in critical structural areas of the building. They prevent lateral movement of the structure during an earthquake. Shear panels are often visible in the crawlspace on cripple walls between the first floor and foundation. They may also be installed on interior walls that are covered with drywall. An examination of the crawlspace revealed the absence of shear panels on the cripple walls. The installation of shear panels on the cripple walls is recommended as an upgrade.

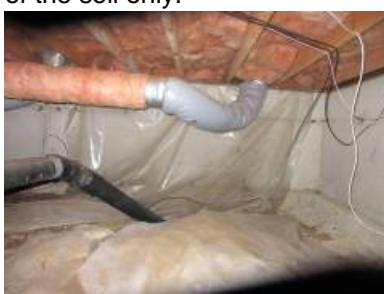
Portions of the foundation walls are covered with the plastic vapor retarder. This allows the transmission of water vapor from the soil up and into the exterior wall framing. The plastic vapor retarder should be removed from the foundation so that it covers at least 85% of the entire surface of the soil only.
