NOTICE TO BUYER: SELLER-PROCURED INSPECTION REPORT

Re: 13216 46th Place West
Mukilteo, WA.

REPORT SUMMARY

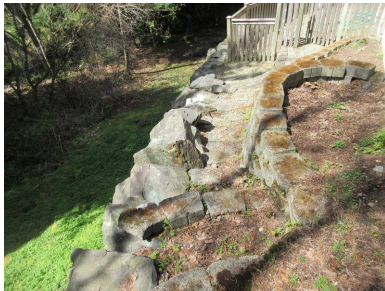
There is no guardrail along the steps. This is a hazard. The installation of a guardrail along the steps is recommended.

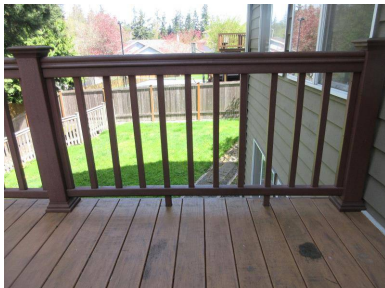
The spacing between the balusters is too wide. This is a hazard to small children. The balusters should be spaced close enough together so that a 4" sphere cannot pass through. Upgrading the deck railing is recommended if small children are present.

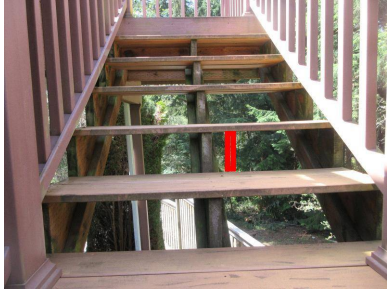
The stair rise spacing is too wide. This is a hazard for small children. The spacing should be reduced as a safety upgrade. Current standards require that a 4" sphere not pass through the opening.

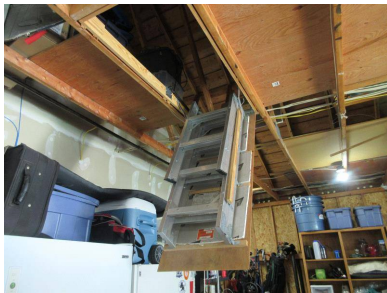
The attic area over the garage is accessible via a retractable fold down ladder in the garage. The ladder was tested and was found in need of repairs and adjustments. Caution should be used when using this ladder.

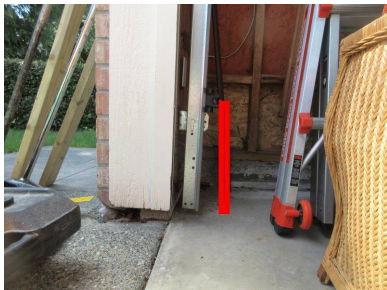
The Photo-eye beam was installed too high above the floor of the garage to adequately offer protection for small children and/or pets. We recommend that the photo-eye be lowered to within 4-6" of the floor.

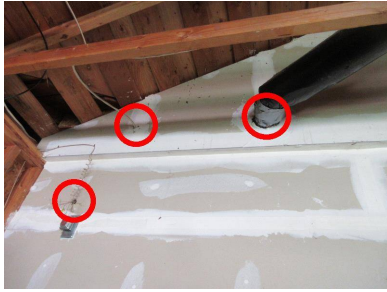
There are voids in the fire resistive barrier between the living space and garage that will allow flames to penetrate. The gypsum barrier slows the spread of a fire from the garage to the structure and/or living space. Patching the voids with a fire retardant caulk is recommended.

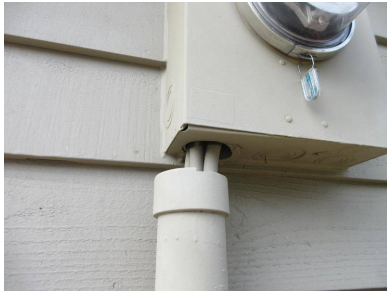
The electrical feed PVC coming out of the ground is separated from the meter housing. We recommend calling the power company and asking them to check and see if the settlement is causing downward tension on the conductor terminations in the meter base that could break the lugs.

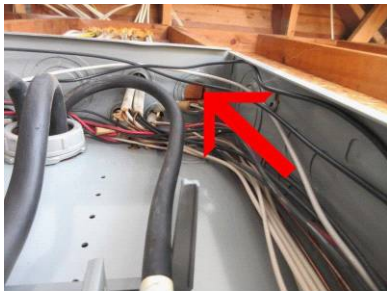
There are openings in the panel box where knock-outs have been removed. Missing knock-outs should be replaced with snap in metal plugs.

Observed within the panel

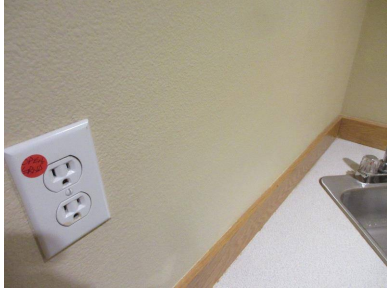
Testing revealed open grounds (ungrounded receptacles) in the bar sink area. Open grounds are a potential hazard and could damage some electronic equipment. All receptacles with open grounds should be repaired in accordance with applicable electrical codes.

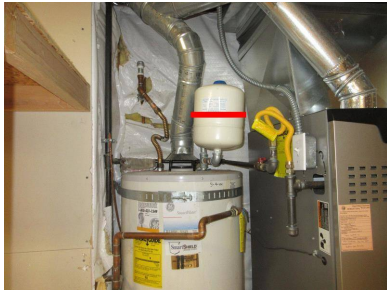
The expansion tank is not adequately secured to the wall. As code requirements start to call for engineered expansion tank supports we recommend the installation of seismic restraints to secure the expansion tank instead of allowing it to simply depend on piping connections that could result in damage to the water pipe and leakage during an earthquake.

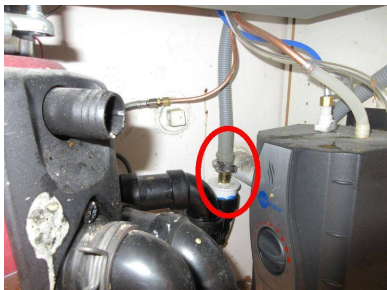
The dishwasher drain lacks an air gap. The dishwasher will function without one, but there is a risk of contamination of the inside of the dishwasher by waste water. The installation of an air gap above the flood rim of the sink is recommended.

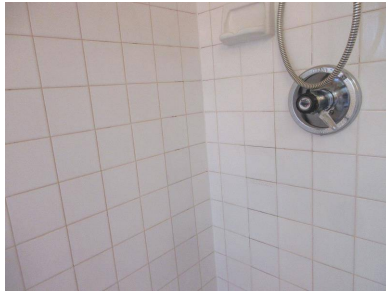
Grout is missing from between some of the wall tiles. This can allow water to enter through the tile and can damage the walls. Regrouting the wall tile is recommended.

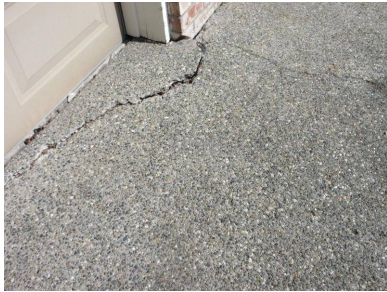
A corner of the driveway has cracked and settled differentially. This was probably caused by inadequate preparation of the soil prior to the placement of the concrete. This condition can be repaired by pressure grouting the sunken portion of the driveway or by removing and replacing it. The driveway remains functional despite this condition.

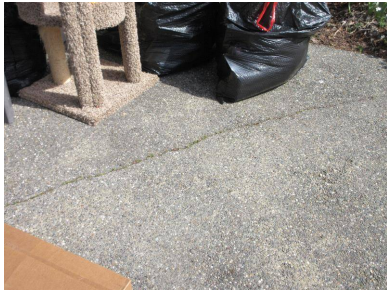
Cracks were observed in the concrete surface of the driveway. Minor cracks can be sealed to minimize moisture entry and further settlement of the concrete. Minor cracks are common and do not affect the serviceability of the concrete.

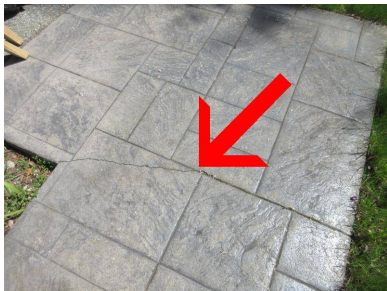
There are minor cracks in the walkway, however, they do not affect its functionality and it remains in serviceable condition.

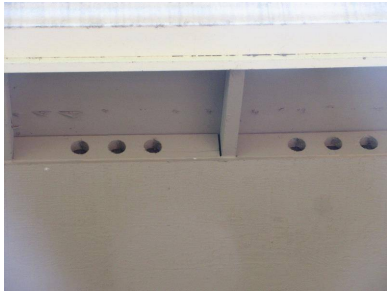
There are large gaps over 1/4" in size adjacent the soffit vent blocks. These gaps allow insects and rodents to enter the attic. Covering the gaps with screening, a strip of wood and/or caulking is recommended.

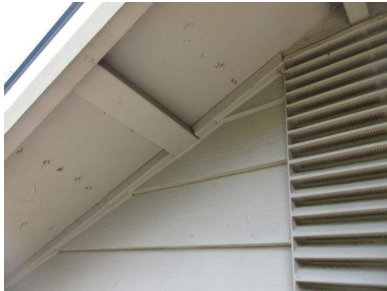
There are openings adjacent the ends of the outlook boards under the overhang through which insects and rodents can enter into the attic. These openings should be covered with wood, wire mesh or filled with aerosol foam.

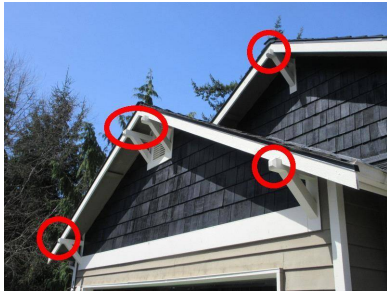
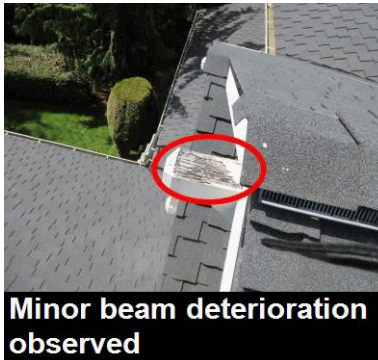
The beams that stick out beyond the drip edge of the roof are vulnerable to rot damage. They should be covered with a metal cap flashing or cut off flush with the edge of the overhang.

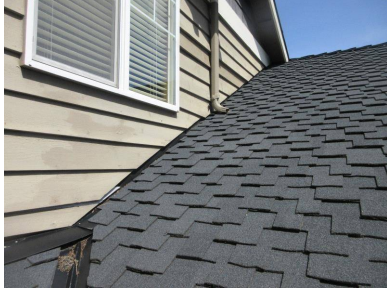
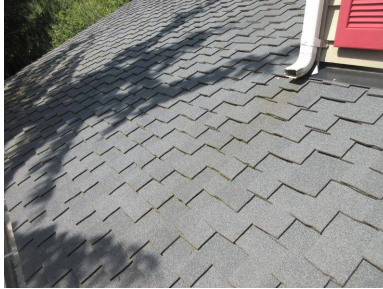
Downspouts draining directly onto the asphalt shingle surface causes excessive wear of the roofing material. Downspout extensions to the lower gutters should be installed to prevent excessive wear and tear of the roofing.

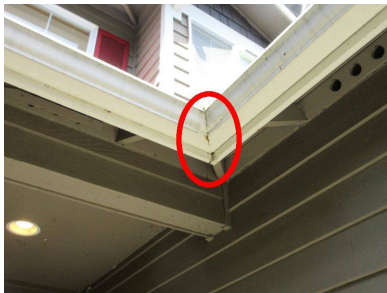
The gutters are leaking at the miter joints. The miter joints should be cleaned and sealed with "Gutter Seal" or a similar type gutter joint sealant.

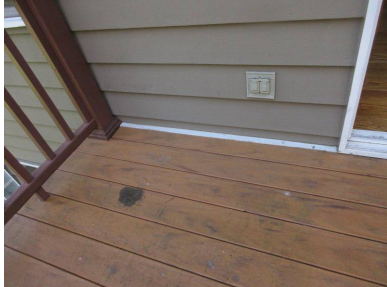
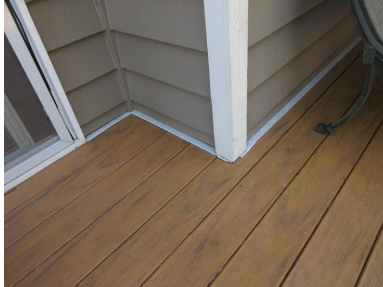
There is no flashing at the intersection between the deck and house. This will allow water to enter behind the siding. The installation of flashing in this area is recommended.

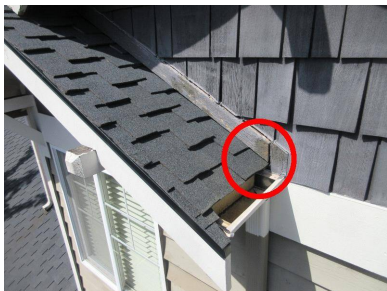
There is no kick out flashing at the roof edge to wall intersection above the gutter. This will allow water to enter the wall behind the siding. The installation of a kick-out flashing is recommended.

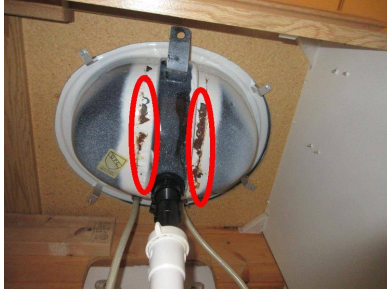
The overflow portion of the sink drain is rusted. This will cause the sink to leak. Replacement of the sink is recommended.

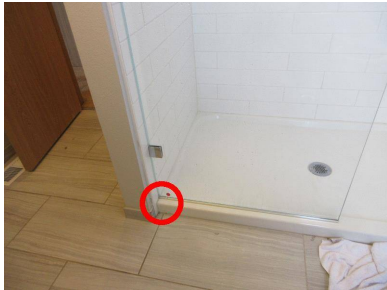
The glass enclosure has been leaking at the lower corners. No damage was visible, but resealing or repairing the enclosure is recommended as preventive maintenance.

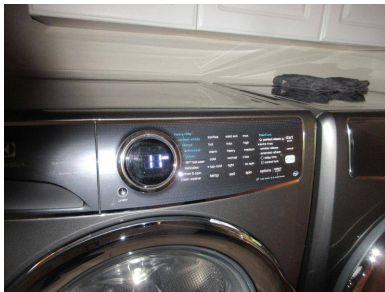
The washer would not respond to its control panel. Repairs are recommended.
