NOTICE TO BUYER: SELLER-PROCURED INSPECTION REPORT

**Renata Beglarian & Arman Avetisian
17016 NE 131st Pl,
Redmond WA 98052**

At your request, a visual inspection of the above referenced property was conducted on 06/10/2023. We have inspected the major structural components, plumbing, heating and electrical systems for signs of significant non-performance, excessive or unusual wear and general state of repair.

DATE OF INSPECTION: 6/10/2023.
 INSPECTOR'S NAME: Terry Clark.
 CLIENT NAME: Mr. Arman Avetisian & Ms. Renata Beglarian.
 MAILING ADDRESS: 17016 NE 131st Pl.
 Redmond WA.
 CLIENT E-MAIL ADDRESS armanavs999@gmail.com; bejlaren@gmail.com.
 ADDRESS OF PROPERTY 17016 Northeast 131st Pl.
 INSPECTED Redmond WA.

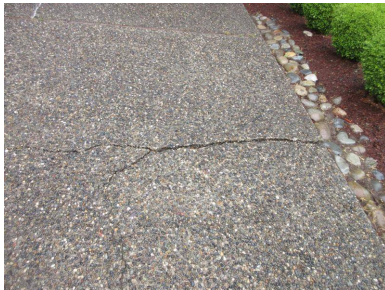
DRIVEWAY

The driveway has cracked and settled differentially. This was probably caused by inadequate preparation of the soil prior to the placement of the concrete. This condition can be repaired by pressure grouting the sunken portion of the driveway or by removing and replacing it. The driveway remains functional despite this condition.

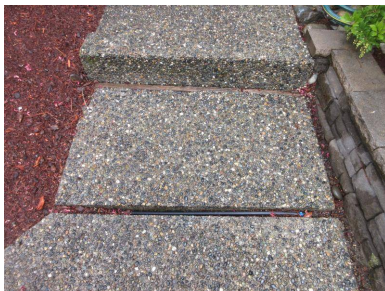
WALKWAY

The gaps separating the concrete walkway sections are a trip hazard. Replacement with mortar is recommended.

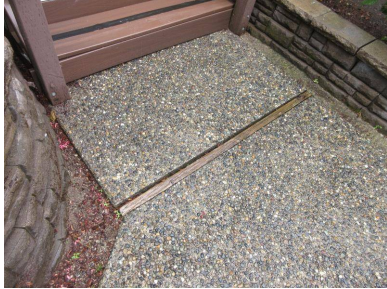
The wooden dividers separating the concrete walkway sections have deteriorated to a point where the gaps are a trip hazard. Replacement with mortar is recommended.

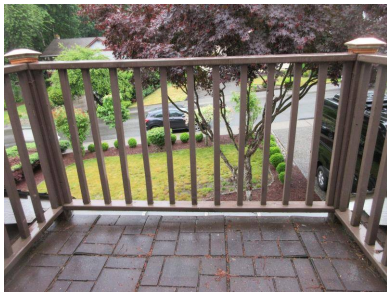
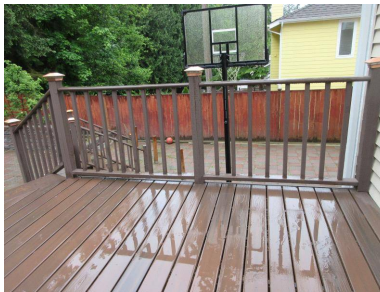
DECK RAILINGS

The spacing between the balusters is too wide. This is a hazard to small children. The balusters should be spaced close enough together so that a 4" sphere cannot pass through. Upgrading the deck railing is recommended if small children are present.

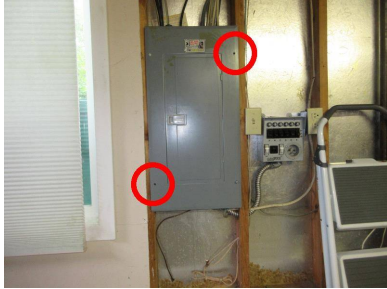
SERVICE PANEL

Screws that secure the panel cover to the panel box are missing. This is a potential hazard. Missing screws should be replaced with the original style blunt end screws.

Electrical system missing panel screws have been installed

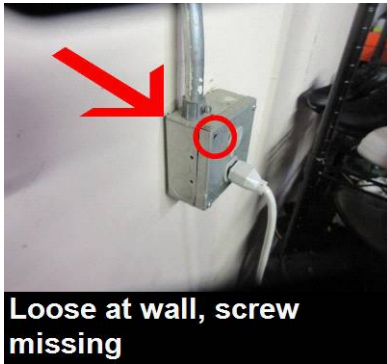
RECEPTACLES

The receptacle on the north wall of the family room and a junction box in the garage are loose. This is a potential shock and a fire hazard. All loose receptacles should be repaired as necessary.

Receptacle on the north wall has been secured

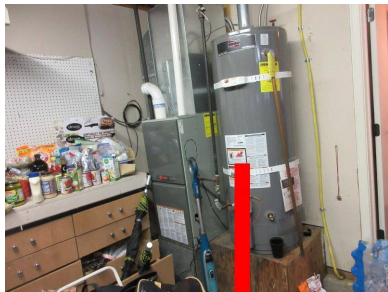
GAS PIPING

The gas pipes adjacent to the water heater are not protected by a bumper stop. A vertical steel pipe, bolted to the floor, is typically installed in front of the water heater to prevent a car bumper from damaging the gas lines.

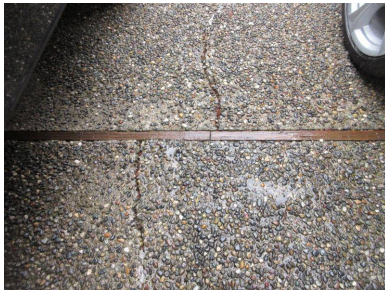
DRIVEWAY

Cracks were observed in the concrete surface of the driveway. Minor cracks can be sealed to minimize moisture entry and further settlement of the concrete. Minor cracks are common and do not affect the serviceability of the concrete.

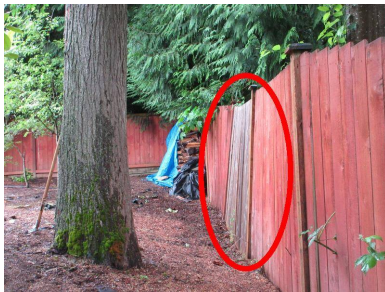
FENCES AND GATES

One or more of the fence posts are deteriorated. Fence posts should be repaired or replaced as necessary.

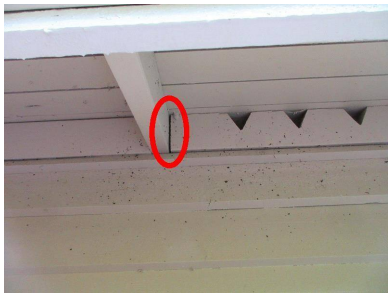
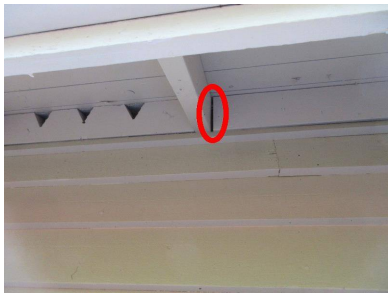
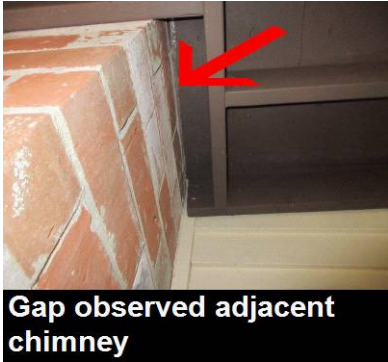
SOFFITS AND OVERHANGS

There are large gaps over 1/4" in size adjacent the soffit vent blocks. These gaps allow insects and rodents to enter the attic. Covering the gaps with screening, a strip of wood and/or caulking is recommended.

Gap on the exterior side of the chimney is fixed

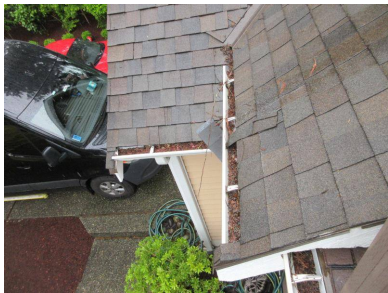
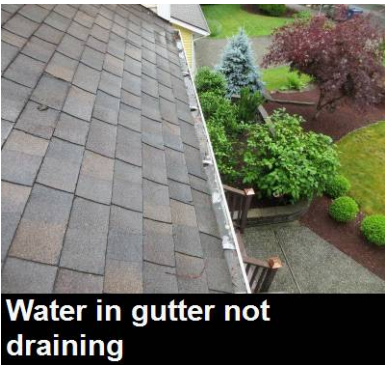
GUTTERS AND DOWNSPOUTS

There is a build-up of organic debris inside the gutters. Proper maintenance of gutters and downspouts is essential and should be performed routinely in order to prevent clogging. Maintenance consists primarily of keeping leaves and other organic debris out of the system. Failure to clean the gutters will result in water splash on the building when they overflow. Gutters can be damaged under the weight of the water and organic matter inside the gutter. Gutters should be cleaned as necessary to maintain a free flow of water into the downspouts.

Gutters and downspouts cleaning services were provided

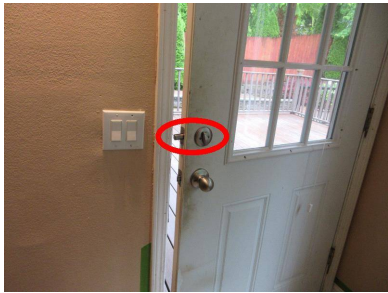
EXTERIOR DOORS

The rear entry door deadbolt is in need of minor adjustment and/or repair. Door hardware should be adjusted or replaced as necessary to restore full function.

Exterior door deadbolt is repaired

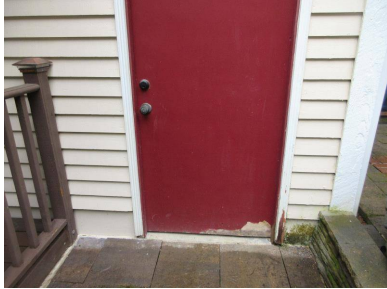
Wood doors are undesirable for use at any location that has chronic exposure to rainfall or water splash. Consideration should be given to upgrading the exposed wood doors to aluminum or vinyl clad doors.

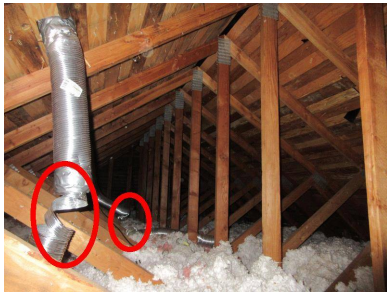
MECHANICAL VENTILATION SYSTEMS

Flexible plastic duct is used to direct air from the vent fans to the exterior. Several of the ducts for the bathroom vent fans have become detached in the attic. This allows moisture laden air to be discharged in the attic rather than outside. This is an undesirable condition that causes excessive moisture in the attic and can result in mold or fungus growth. The ducts should be reconnected and secured. This type of material is unreliable. Replacing the plastic duct with 4" smooth-wall sheet metal duct is recommended.

Mechanical ventilation system duct work in the attic is repaired

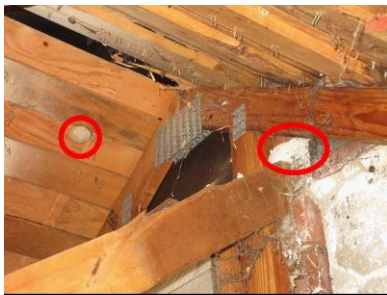
Observed adjacent the chimney in attic

There are yellow jacket nests in the attic. Yellow jackets are very aggressive in late summer and their sting is painful. Yellow jacket activity can be avoided by sealing all openings into the attic, particularly above the gable end walls and below vent blocks.

The first step in preventing rodents from entering the attic is to seal all possible entry points using wire mesh, caulking, wood, stainless steel wool, or aerosol foam. Careful work sealing cracks, holes and gaps over 1/4" in size will discourage activity.

Yellow jacket nest was removed

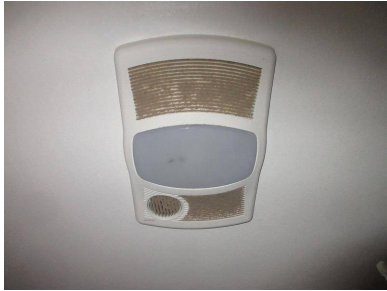
The vent fan register has become clogged. This reduces the fans efficiency. The fan register/cover should be cleaned.

Primary bath vent was cleaned by the cleaning crew

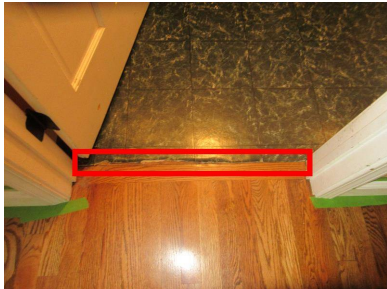
FLOORING MATERIAL

The vinyl flooring lacks a transition strip. The exposed edge of the flooring is vulnerable to damage. We recommend the installation of a transition strip.

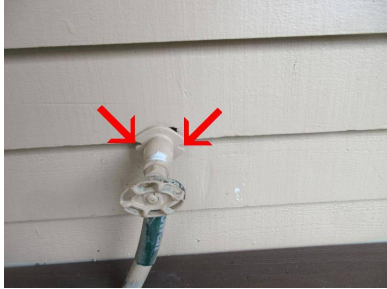
The hose bibb on the front of the house is loose. This could result in damage to the water pipe and leakage. The bibb should be securely fastened to the wall.

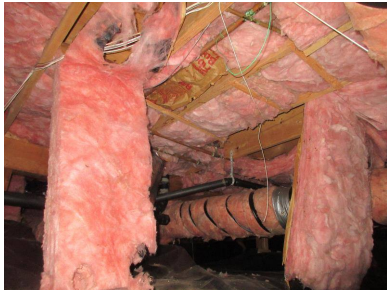
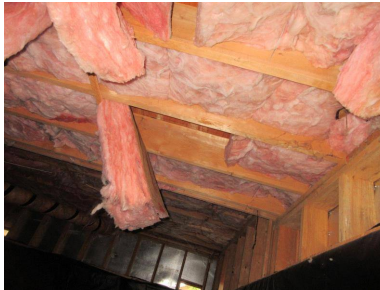
Some of the insulation batts were not properly secured and have falling down. The fallen batts should be reinstalled and secured.

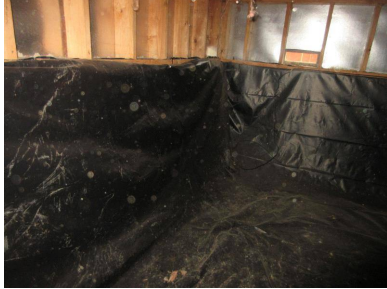
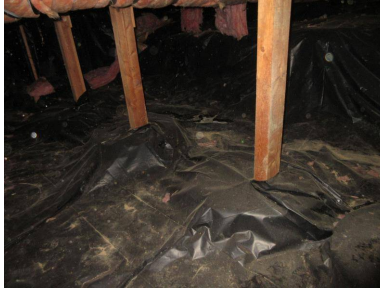
VAPOR RETARDER

The foundation walls are covered with the plastic vapor retarder. This allows the transmission of water vapor from the soil up and into the exterior wall framing. The plastic vapor retarder should be removed from the foundation.

The support post concrete piers are covered with the plastic vapor retarder. This allows the transmission of water vapor from the soil up and into the floor framing. The plastic vapor retarder should be removed from the piers.

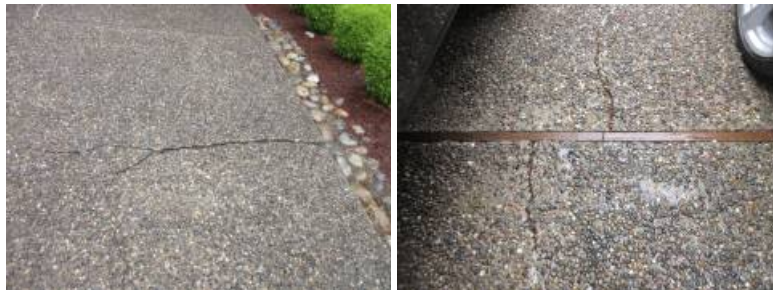
Cracks were observed in the concrete surface of the driveway. Minor cracks can be sealed to minimize moisture entry and further settlement of the concrete. Minor cracks are common and do not affect the serviceability of the concrete.

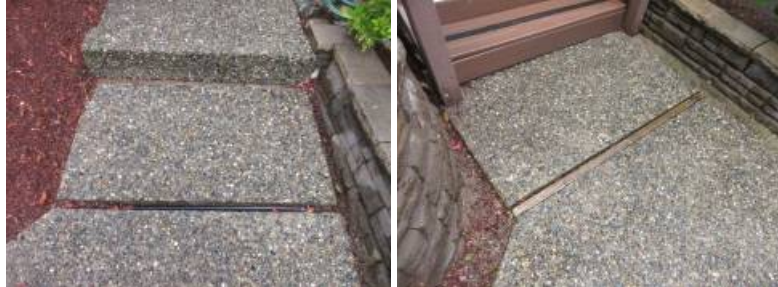
WALKWAY The gaps separating the concrete walkway sections are a trip hazard. Replacement with mortar is recommended.

Many legal and public works departments have defined a trip hazard as an irregularity in a walking surface exceeding one inch (1") in height. All walking surfaces should maintain, free of a vertical surface change of 3/4" or more, in the interest of public and personal safety.

The wooden dividers separating the concrete walkway sections have deteriorated to a point where the gaps are a trip hazard. Replacement with mortar is recommended.

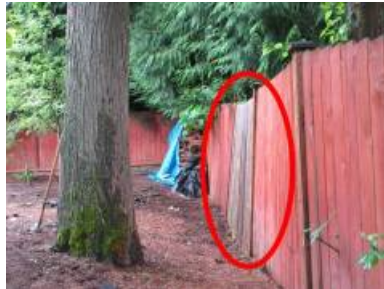
FENCES AND GATES

One or more of the fence posts are deteriorated. Fence posts should be repaired or replaced as necessary.

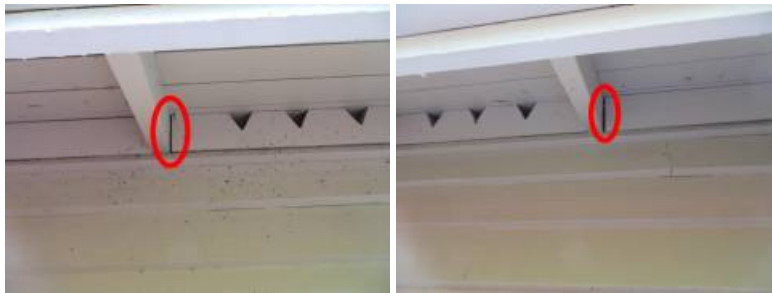
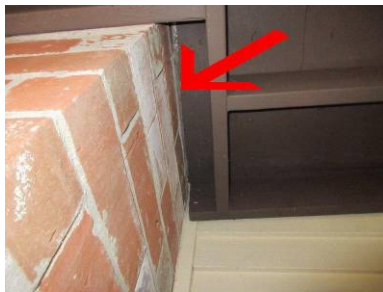
There are large gaps over 1/4" in size adjacent the soffit vent blocks. These gaps allow insects and rodents to enter the attic. Covering the gaps with screening, a strip of wood and/or caulking is recommended.

Gap observed adjacent chimney

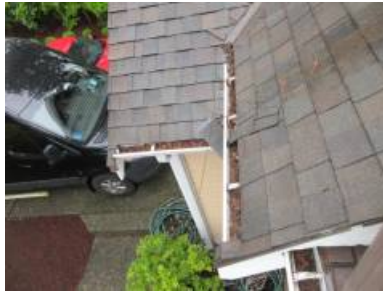
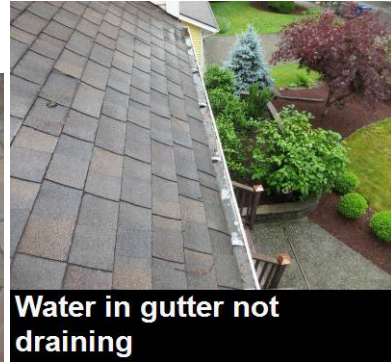
There is a build-up of organic debris inside the gutters. Proper maintenance of gutters and downspouts is essential and should be performed routinely in order to prevent clogging. Maintenance consists primarily of keeping leaves and other organic debris out of the system. Failure to clean the gutters will result in water splash on the building when they overflow. Gutters can be damaged under the weight of the water and organic matter inside the gutter. Gutters should be cleaned as necessary to maintain a free flow of water into the downspouts.

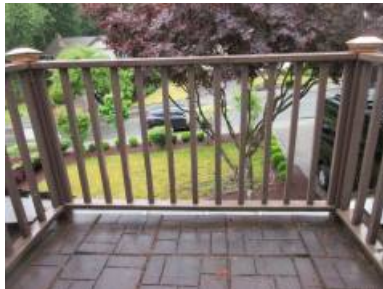
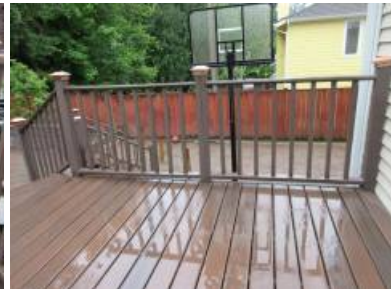
The spacing between the balusters is too wide. This is a hazard to small children. The balusters should be spaced close enough together so that a 4" sphere cannot pass through. Upgrading the deck railing is recommended if small children are present.

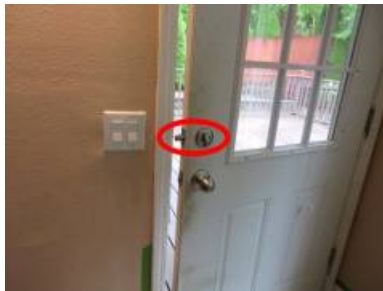
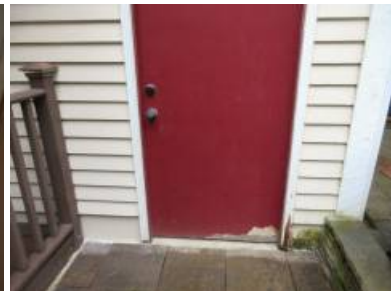
Wood doors are undesirable for use at any location that has chronic exposure to rainfall or water splash. Consideration should be given to upgrading the exposed wood doors to aluminum or vinyl clad doors.

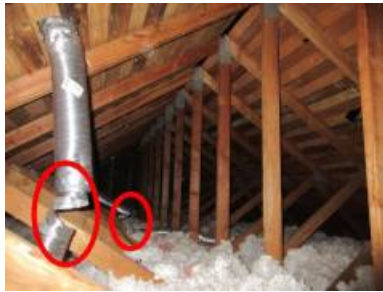
VENTILATION Flexible plastic duct is used to direct air from the vent fans to the exterior. Several of the ducts for the bathroom vent fans have become detached in the attic. This allows moisture laden air to be discharged in the attic rather than outside. This is an undesirable condition that causes excessive moisture in the attic and can result in mold or fungus growth. The ducts should be reconnected and secured. This type of material is unreliable. Replacing the plastic duct with 4" smooth-wall sheet metal duct is recommended.

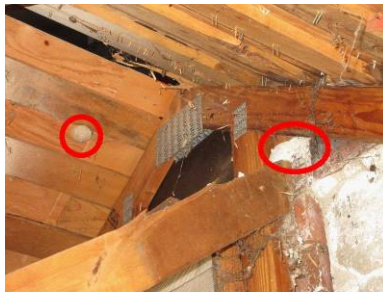
Observed adjacent the chimney in attic

There are yellow jacket nests in the attic. Yellow jackets are very aggressive in late summer and their sting is painful. Yellow jacket activity can be avoided by sealing all openings into the attic, particularly above the gable end walls and below vent blocks.

The first step in preventing rodents from entering the attic is to seal all possible entry points using wire mesh, caulking, wood, stainless steel wool, or aerosol foam. Careful work sealing cracks, holes and gaps over 1/4" in size will discourage activity.

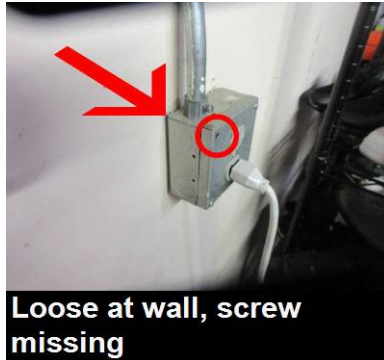
The receptacle on the north wall of the family room and a junction box in the garage are loose. This is a potential shock and a fire hazard. All loose receptacles should be repaired as necessary.

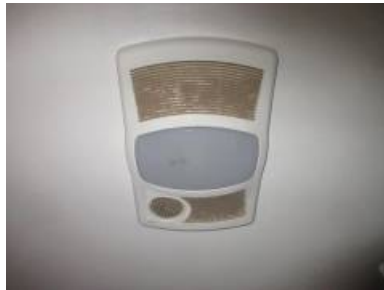
The vent fan register has become clogged. This reduces the fans efficiency. The fan register/cover should be cleaned.

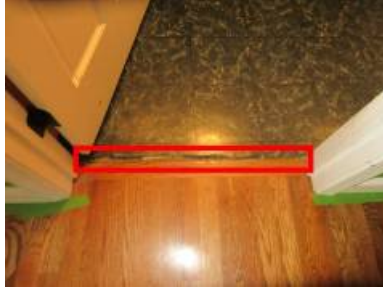
The vinyl flooring lacks a transition strip. The exposed edge of the flooring is vulnerable to damage. We recommend the installation of a transition strip.

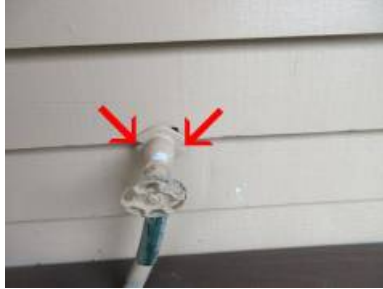
The hose bibb on the front of the house is loose. This could result in damage to the water pipe and leakage. The bibb should be securely fastened to the wall.

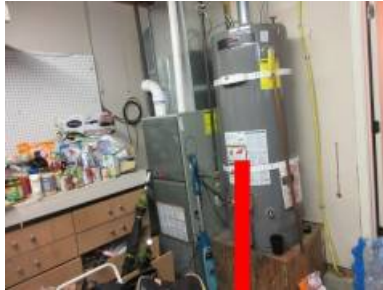
GAS PIPING

The gas pipes adjacent to the water heater are not protected by a bumper stop. A vertical steel pipe, bolted to the floor, is typically installed in front of the water heater to prevent a car bumper from damaging the gas lines.

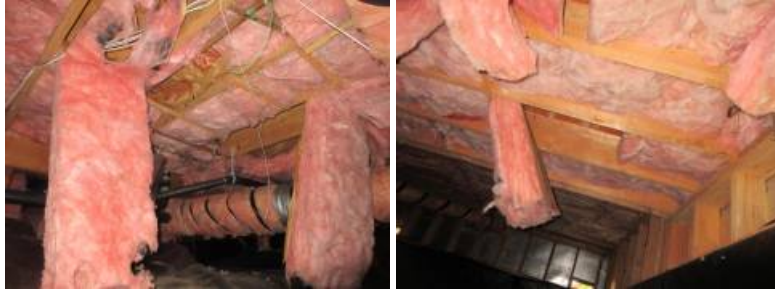
Some of the insulation batts were not properly secured and have falling down. The fallen batts should be reinstalled and secured.

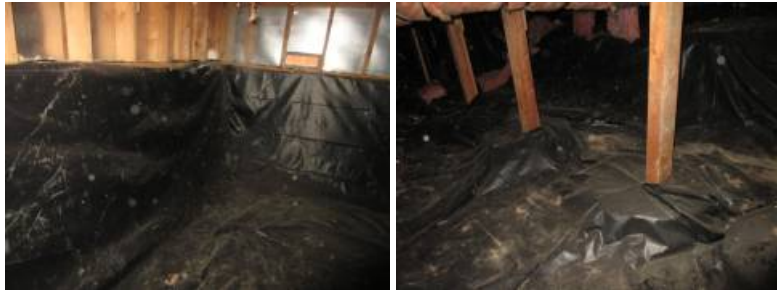
The support post concrete piers are covered with the plastic vapor retarder. This allows the transmission of water vapor from the soil up and into the floor framing. The plastic vapor retarder should be removed from the piers.
