NOTICE TO BUYER: SELLER-PROCURED INSPECTION REPORT

Greg and Angela Taylor
17422 NE 129th Street
Redmond, WA 98052

Per the seller, the following items listed on the pre-sale inspection summary dated July 6th, 2023 are being corrected by the seller as part of preparation for sale in good faith.

July 6, 2023

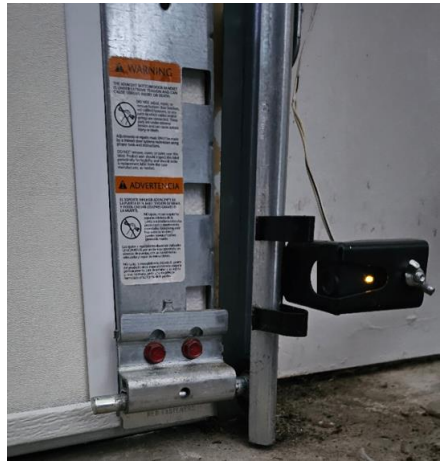
The Photo-eye beam was installed to high above the floor of the garage to adequately offer protection for small children and/or pets. We recommend that the photo-eye be lowered to within 4-6" of the floor.

- Garage Door Opener
 - *REPAIRED*: Photo-eye adjusted within 4"-6".

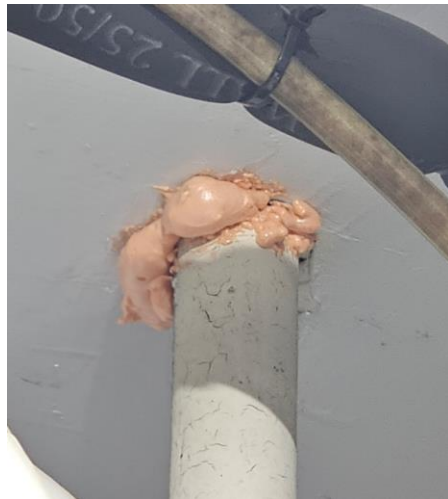
There are a couple of voids in the fire resistive barrier between the living space and garage that will allow flames to penetrate. The gypsum barrier slows the spread of a fire from the garage to the structure and/or living space. Patching the voids with a fire retardant caulk is recommended.

-
- Fire separations:
 - *REPAIRED*: Gaps sealed with fire rated foam and fire rated sealant.

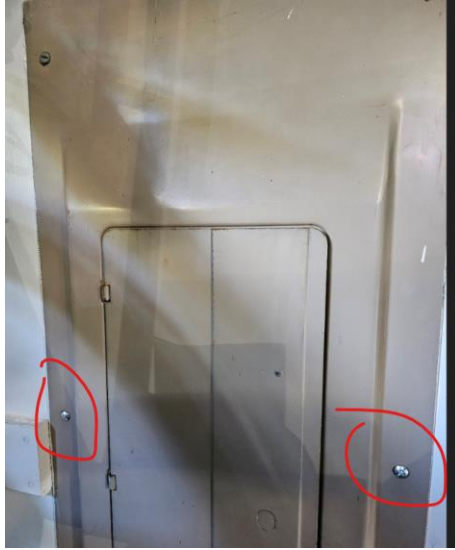
Screws that secure the panel cover to the panel box are missing. This is a potential hazard. Missing screws

- *REPAIRED*: two missing screws installed in panel. Correct panel specific screws installed.

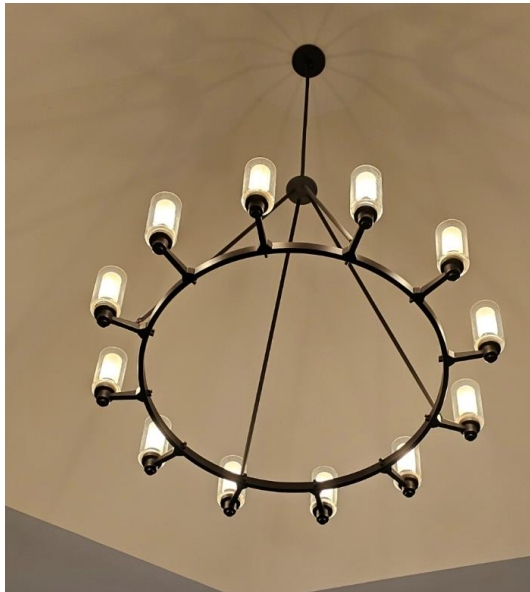
The staircase luminaries is not working. Testing the luminaries with a voltage tester revealed that there is current to them. Light bulbs should be replaced in non-functional luminaries and then they should be tested for proper operation.

-
- Luminaires in entryway:
 - *REPAIRED*: All light bulbs in entry luminaries replaced with new bulbs, all are functional.

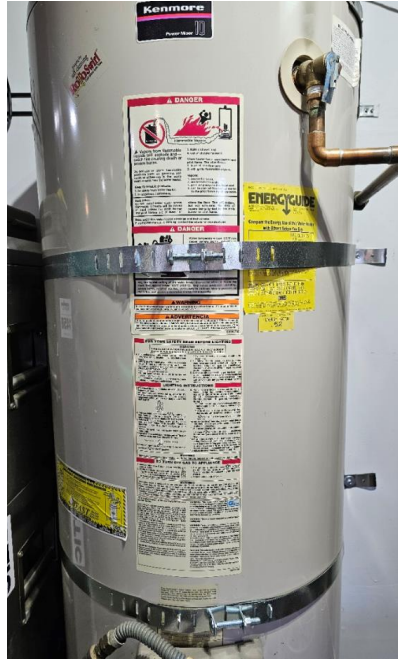
The seismic restraint for the water heater was minimal. Proper strapping is recommended to adequately secure the tank and provide potable water in the event of an earthquake.

- Seismic restraint
 - *REPAIRED*: New seismic restraint installed on water heater.

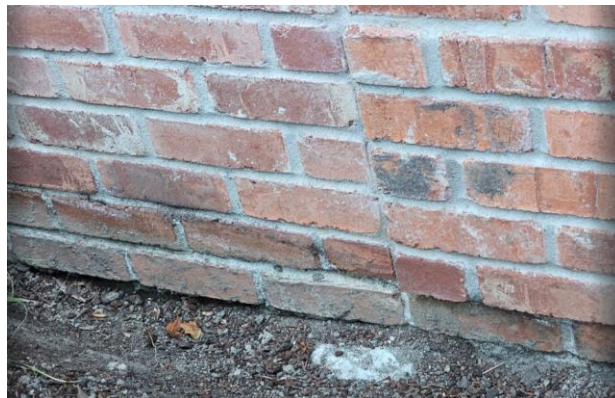
holes are covered at the bottom of the masonry wall. This allows moisture to become trapped behind the brick. Exposing weep holes is recommended to mitigate moisture damage.

- Weep holes: Soil/bark removed from brick façade.
 - *REPAIRED* Soil removed from brick

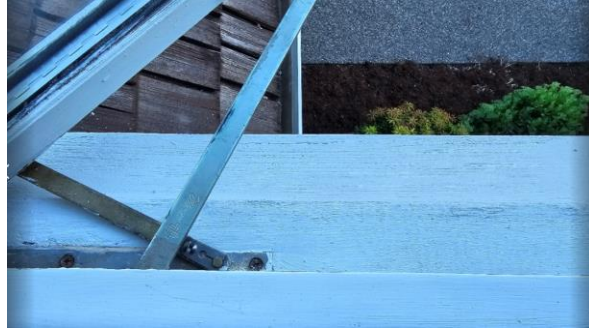
One of the bedroom window sills is water damaged. Repair or replacement of the damaged window sills is recommended.

- Windowsill damaged in bedroom
 - *REPAIRED*: Damaged area of noted Windowsill repaired and refinished.

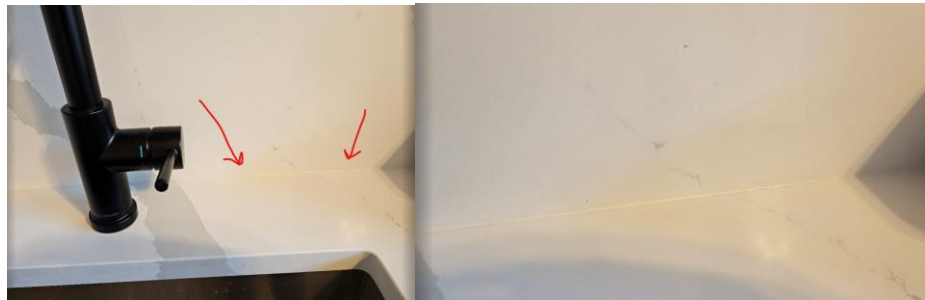
The backsplash caulking is cracked. Cracking of the caulk allows water to enter the gap and is difficult to clean. Caulking the cracks and/or gaps is recommended.

- Countertop backsplash
 - *REPAIRED* – backsplash sealed with silicon sealant where noted.

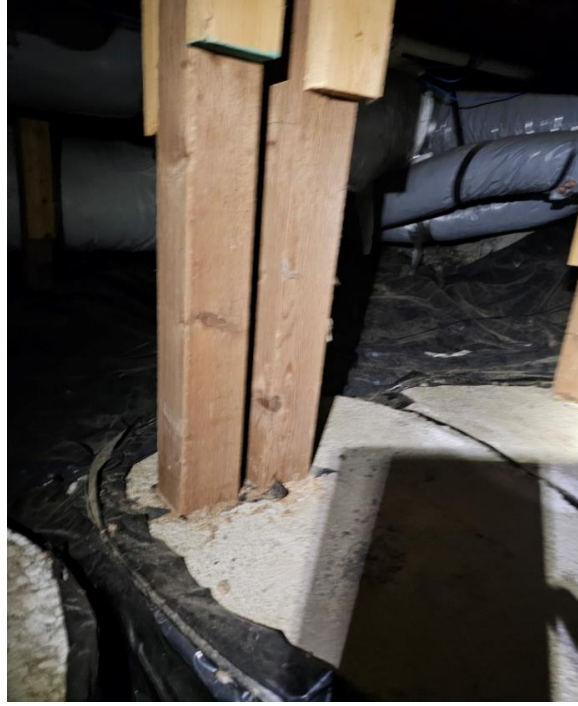
The support post concrete piers are covered with the plastic vapor retarder. This allows the transmission of water vapor from the soil up and into the floor framing. The plastic vapor retarder should be removed from the pier so that it covers at least 85% of the entire surface of the soil only.

- Vapor retarder:
 - *REPAIRED*: Vapor barrier has been modified around pillars to conform to the suggestions of recent inspection report. (Note: Crawlspace was refinished and reinsulated in July 2015 by Crawlspace @ Attics NW and resealed by Eastside exterminators in 2020)

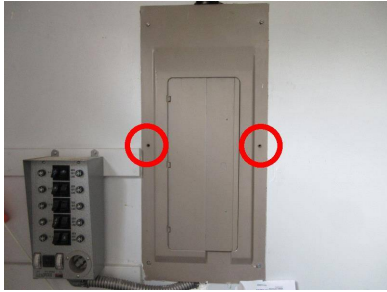
should be replaced with the original style blunt end screws.

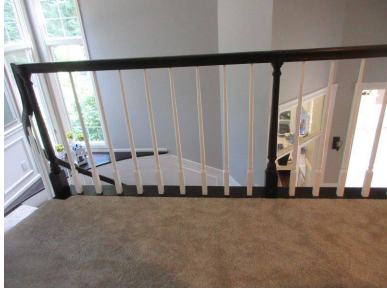
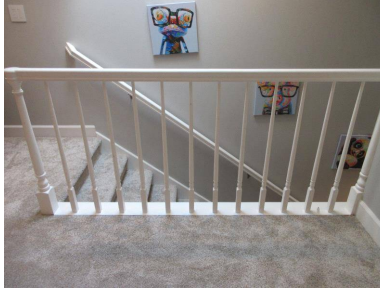
The spacing between the balusters is too wide. This is a hazard to small children. The balusters should be spaced close enough together so that a 4" sphere cannot pass through. Upgrading the guard railing is recommended if small children are present.

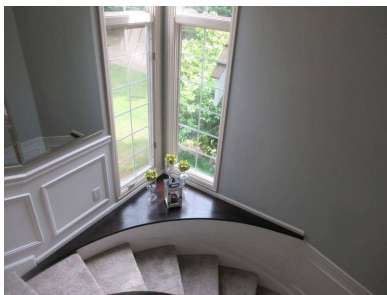
The stairway landings lower pane of window glass is not marked with an indicia indicating that it is tempered safety glass and we cannot verify that it is by visual examination. Nonconforming glass would be hazardous if broken. The installation of safety glass is recommended as a safety upgrade.

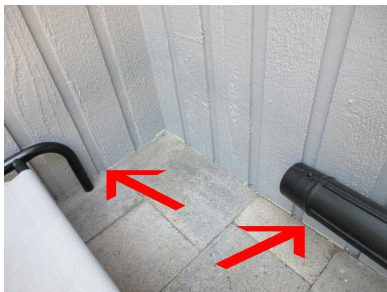
Untreated wood in direct contact with concrete was observed along the patio stoop. Untreated wood should be raised 1-2" above the concrete. Treating the wood with a preservative sometimes will prevent wood destroy organism damage.

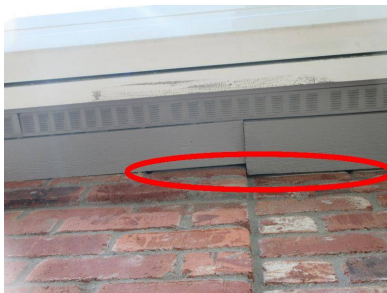
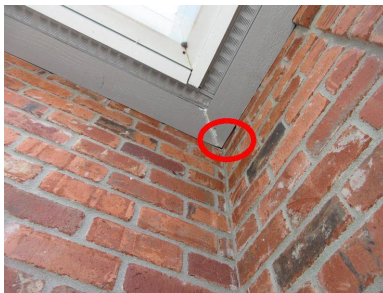
Gaps over 1/4" in size adjacent the brick cladding and soffits that will allow insects and rodents to enter the structure. Covering any gaps with screening, a strip of trim and/or caulking is recommended.

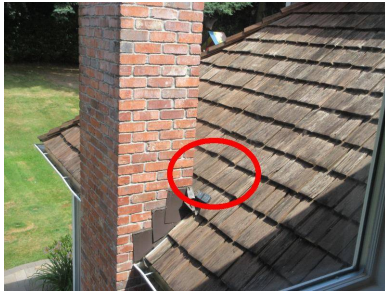
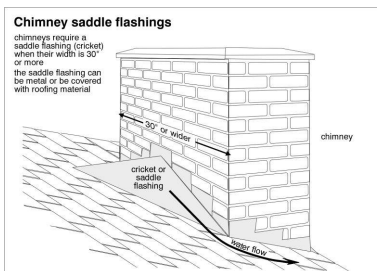
There is no cricket on the up-slope side of the living room fireplace chimney. This is conducive to leakage. Consideration should be given to installing a cricket to divert water around the chimney.

Moss/vegetation was observed in several areas around corbels and the upper portion of the chimney. This will lead to accelerated deterioration of the brick masonry mortar. We recommend removal of all organic growth. Damaged areas can be repaired by filling in cutout or defective mortar joints with fresh mortar. (Tuck pointing)

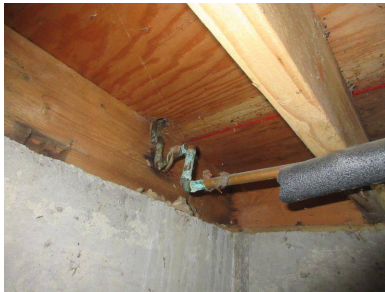
There are water pipes in the crawlspace that are not adequately insulated and could freeze. The installation of foam pipe insulation on all exposed water pipes is recommended.

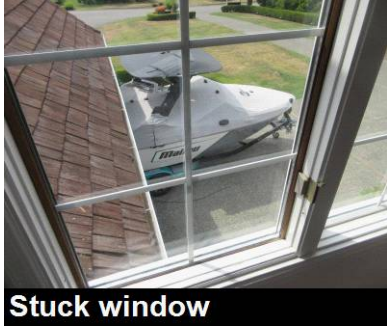
Several of the windows are stuck. They should be adjusted or repaired as necessary to restore proper operation.

Stuck window

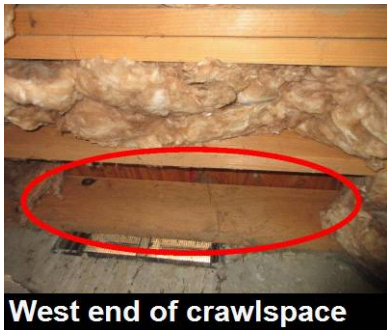
Some of the insulation batts are missing and several were not properly secured and have falling down. The fallen batts should be reinstalled and secured. The missing batts should be replaced.

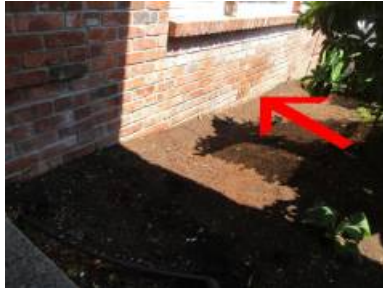
The brick is a veneer installed over the wood wall structure. It is not a structural component of the wall. Weep holes are covered at the bottom of the masonry wall. This allows moisture to become trapped behind the brick. Exposing weep holes is recommended to mitigate moisture damage.

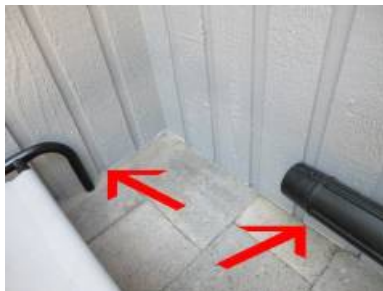
Untreated wood in direct contact with concrete was observed along the patio stoop. Untreated wood should be raised 1-2" above the concrete. Treating the wood with a preservative sometimes will prevent wood destroy organism damage.

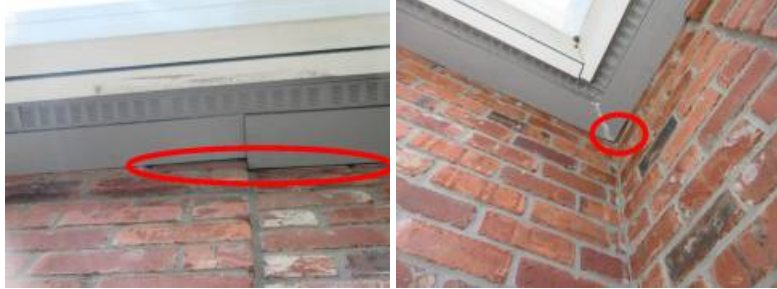
Gaps over 1/4" in size adjacent the brick cladding and soffits that will allow insects and rodents to enter the structure. Covering any gaps with screening, a strip of trim and/or caulking is recommended.

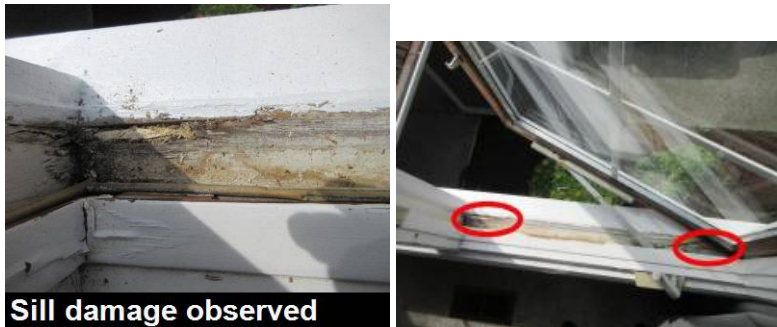
One of the bedroom window sills is water damaged. Repair or replacement of the damaged window sills is recommended.

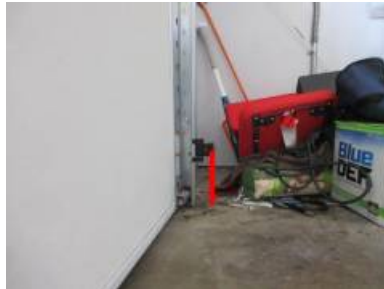
The Photo-eye beam was installed too high above the floor of the garage to adequately offer protection for small children and/or pets. We recommend that the photo-eye be lowered to within 4-6" of the floor.

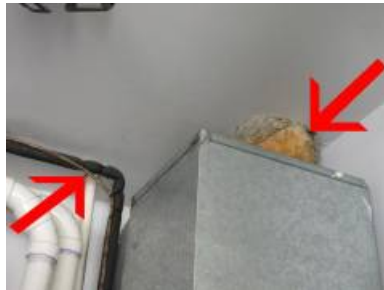
There are a couple of voids in the fire resistive barrier between the living space and garage that will allow flames to penetrate. The gypsum barrier slows the spread of a fire from the garage to the structure and/or living space. Patching the voids with a fire retardant caulk is recommended.

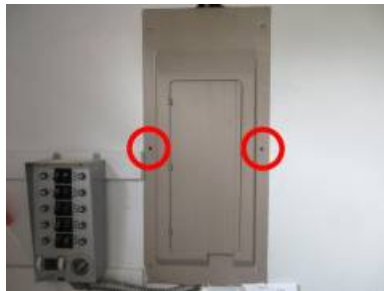
Screws that secure the panel cover to the panel box are missing. This is a potential hazard. Missing screws should be replaced with the original style blunt end screws.

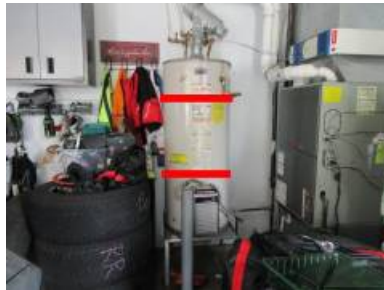
<i>BURNER</i>	The gas burner is properly installed and is functioning as intended.
<i>GAS PIPING</i>	The flex connector is properly installed and is performing its intended function.
<i>VENT</i>	The water heater uses a type B vent from the top of the draft hood to the exterior. The visible portion of the B vent is properly installed and is functioning as intended.
<i>COMBUSTION AIR</i>	The combustion air provides the oxygen for the fuel burning appliances. Combustion air also aids in the movement of combustion gases up the flue. Adequate ventilation around all fuel burning appliances is vital for their safe operation. The air can come from inside the house or from outside providing that the amount of air reaching the appliance is sufficient to maintain efficient combustion and draft. The combustion air supply is adequate.
<i>SEISMIC RESTRAINT</i>	The seismic restraint for the water heater was minimal. Proper strapping is recommended to adequately secure the tank and provide potable water in the event of an earthquake.

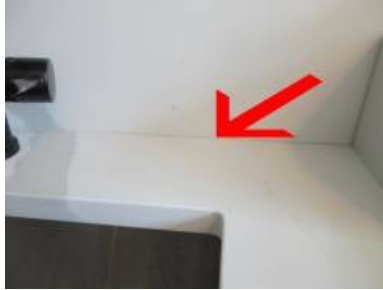
The backsplash caulking is cracked. Cracking of the caulk allows water to enter the gap and is difficult to clean. Caulking the cracks and/or gaps is recommended.

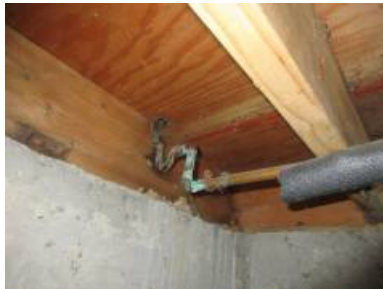
There are water pipes in the crawlspace that are not adequately insulated and could freeze. The installation of foam pipe insulation on all exposed water pipes is recommended.

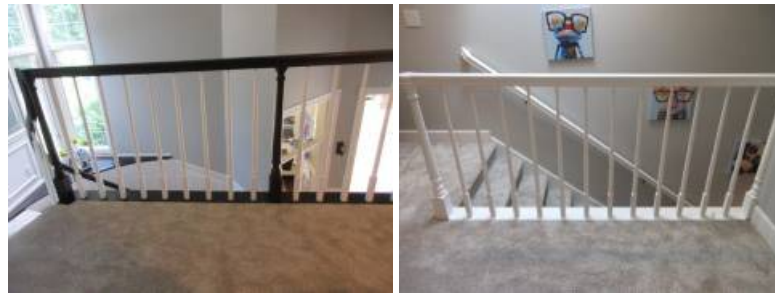
The spacing between the balusters is too wide. This is a hazard to small children. The balusters should be spaced close enough together so that a 4" sphere cannot pass through. Upgrading the guard railing is recommended if small children are present.

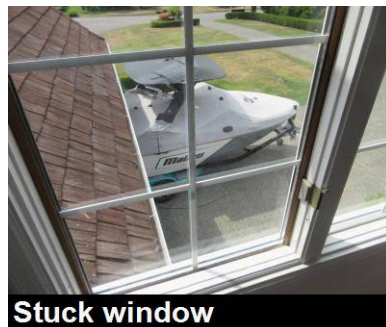
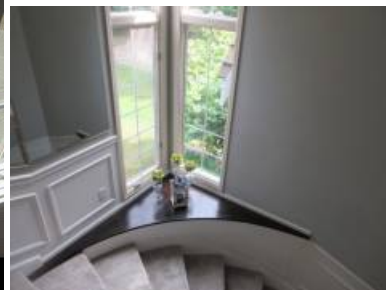
The stairway landings lower pane of window glass is not marked with an indicia indicating that it is tempered safety glass and we cannot verify that it is by visual examination. Nonconforming glass would be hazardous if broken. The installation of safety glass is recommended as a safety upgrade.

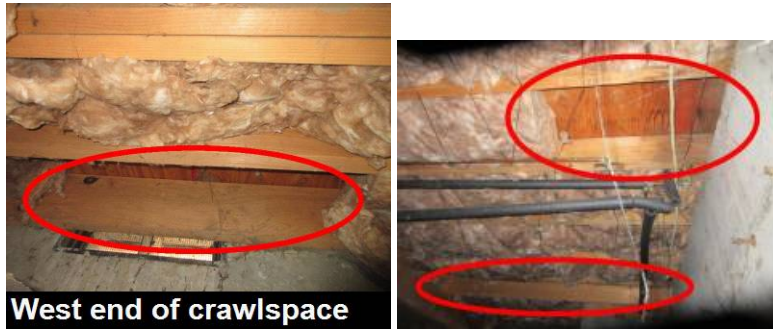
Some of the insulation batts are missing and several were not properly secured and have falling down. The fallen batts should be reinstalled and secured. The missing batts should be replaced.

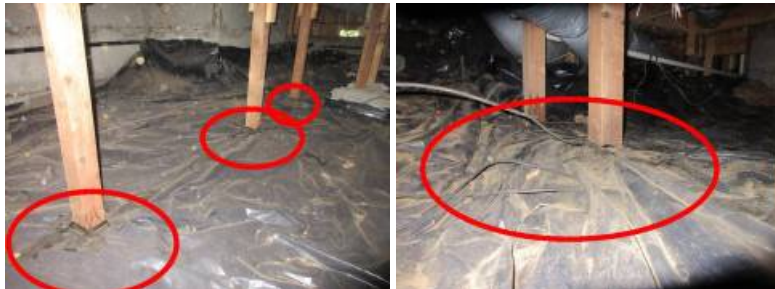
The support post concrete piers are covered with the plastic vapor retarder. This allows the transmission of water vapor from the soil up and into the floor framing. The plastic vapor retarder should be removed from the pier so that it covers at least 85% of the entire surface of the soil only.
