**NOTICE TO BUYER: SELLER-PROCURED INSPECTION REPORT**

Shane and Stephanie Meyer  
13620 178th Ave NE  
Redmond WA 98052

**Re: 13620 178th Ave. NE**  
**Redmond, WA.**

DATE OF INSPECTION: 7/24/2023.  
 INSPECTOR'S NAME: Terry Clark.  
 CLIENT NAME: Mr. & Mrs. Shane & Stephanie Meyer.  
 MAILING ADDRESS: 13620 178th Ave. NE  
 Redmond WA.  
 CLIENT E-MAIL ADDRESS janeite75@gmail.com; [sdm292@gmail.com](mailto:sdm292@gmail.com).  
 ADDRESS OF PROPERTY 13620 178th Ave. NE  
 INSPECTED Redmond WA.

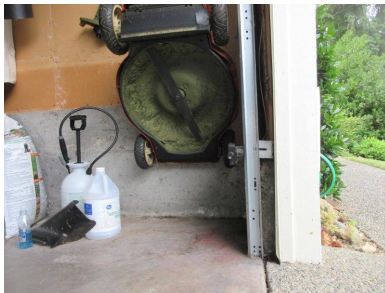
#### ATTACHED GARAGE GARAGE DOOR OPENER

The Photo-eye beam was installed to high above the floor of the garage to adequately offer protection for small children and/or pets. We recommend that the photo-eye be lowered to within 4-6" of the floor.

- The lowering of the garage door photo-eye beam.

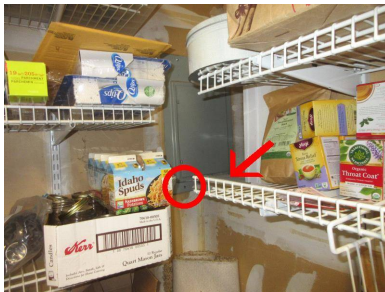
#### SERVICE PANEL

Screws that secure the panel cover to the panel box are missing. This is a potential hazard. Missing screws should be replaced with the original style blunt end screws.

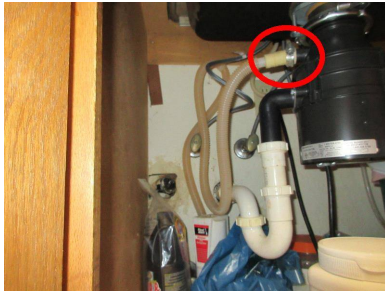
*AIR GAP*

The dishwasher drain lacks an air gap. The dishwasher will function without one, but there is a risk of contamination of the inside of the dishwasher by waste water. The installation of an air gap above the flood rim of the sink is recommended.

- **The grounding of the receptacle in the living room.**
- **The installation of an air gap for the dishwasher drain.**

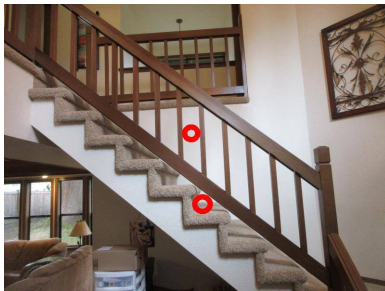
*STAIRS*

The stair railing baluster spacing is too wide. This is a hazard for small children. The baluster spacing should be reduced as a safety upgrade. Current standards require that a 4-3/8" sphere not pass through the railing.

The stair railing spacing at the stair treads is too wide. This is a hazard for small children. The railing spacing should be reduced as a safety upgrade. Current standards require that a 6" sphere not pass through or under the railing.

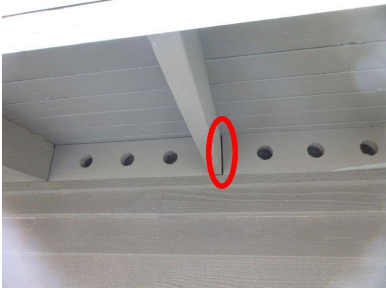
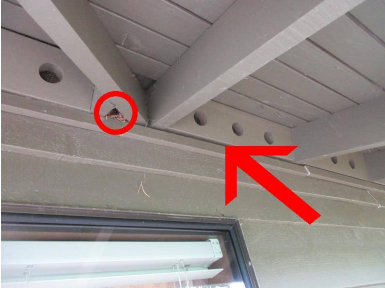
There are large gaps over 1/4" in size adjacent the soffit vent blocks. These gaps allow insects and rodents to

enter the attic. Covering the gaps with screening, a strip of wood and/or caulking is recommended.

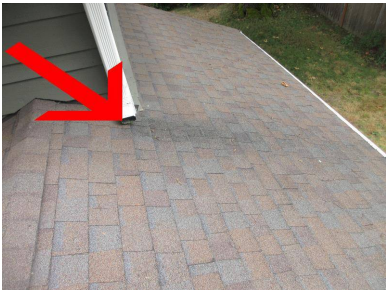
**GUTTERS AND DOWNSPOUTS**

Downspouts draining directly onto the asphalt shingle surface causes excessive wear of the roofing material. Downspout extensions to the lower gutters should be installed to prevent excessive wear and tear of the roofing.

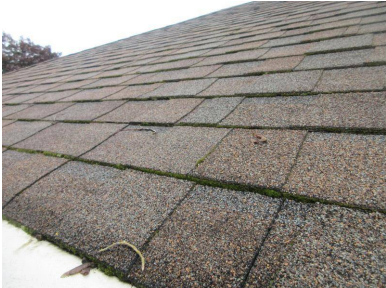
**MAINTENANCE AND REPAIRS**

The roof is in need of routine maintenance. The surface should be treated for moss, lichen, and algae growth, then brushed and washed off with a high volume low pressure hose to remove moss and organic debris. Performing this maintenance will improve the appearance and increase the life expectancy of the roof.

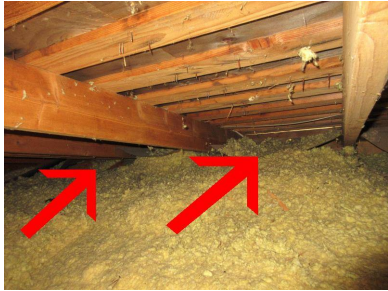
**VENTILATION**

Wind baffles locations are compromised in some areas of the attic. The proper placement of wind baffles in front of all soffit vents is recommended.

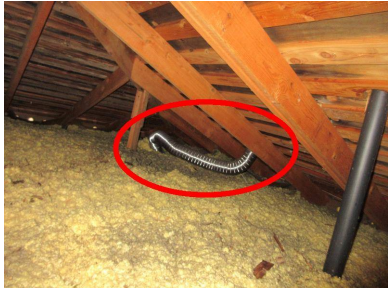
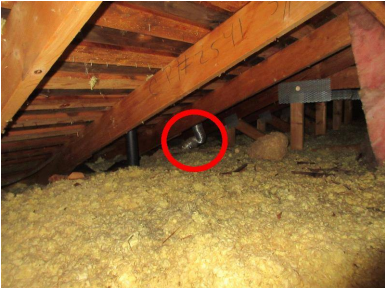
**MECHANICAL VENTILATION SYSTEMS**

Flexible plastic duct is used to direct air from the vent fans to the exterior. This type of material is unreliable. Replacing the plastic duct with 4" smooth-wall sheet metal duct is recommended.

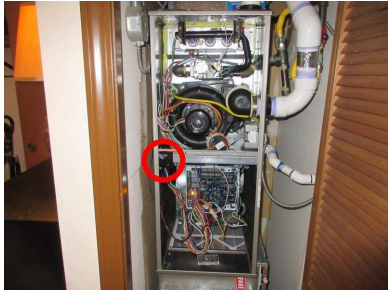
BLOWER

The blower door cut-out switch has been disabled. This is a potential hazard. The cut-out switch should be not be restricted.

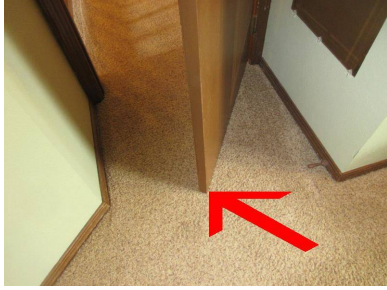
One of the bedroom doors rubs on the carpeting. This can damage the carpet and prevents air circulation under the door. Doors should be undercut 3/4".

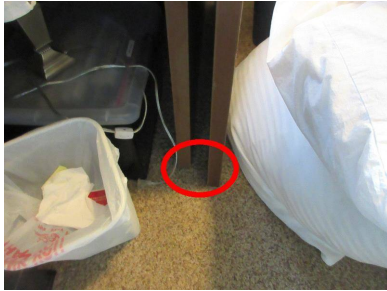
**CLOSET DOORS**

The floor guides are missing from the bypass closet doors in the bedrooms. Missing floor guides could result in damage to the doors. The installation of floor guides is recommended.

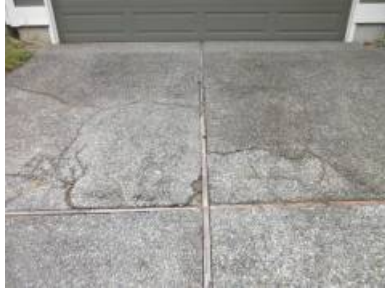
*DRIVEWAY* The driveway has cracked and settled differentially. This was probably caused by inadequate preparation of the soil prior to the placement of the concrete. This condition can be repaired by pressure grouting the sunken portion of the driveway or by removing and replacing it. The driveway remains functional despite this condition.

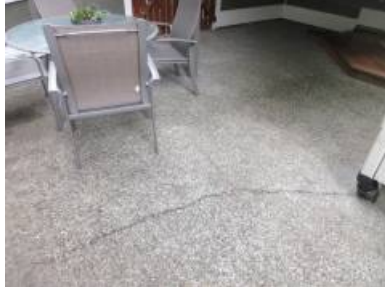
*PATIO*

Cracks were observed in the concrete surface of the patio. Minor cracks can be sealed to minimize moisture entry and further settlement of the concrete.

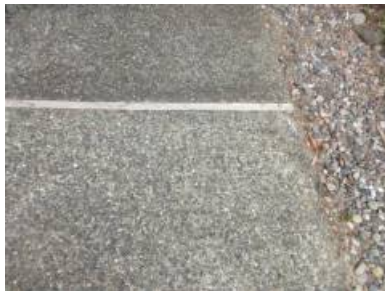
When the wooden dividers separating the concrete walkway sections have deteriorated to a point where they become a trip hazard. Replacement with mortar is recommended.

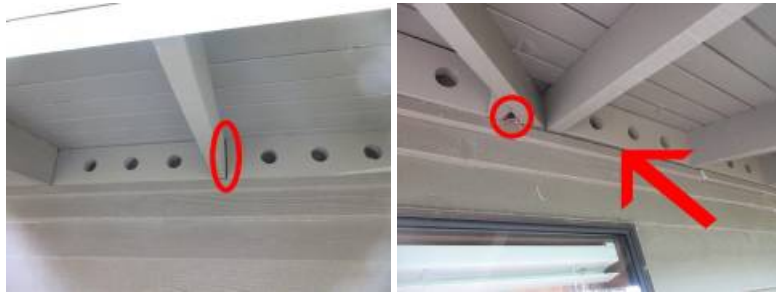
There are large gaps over 1/4" in size adjacent the soffit vent blocks. These gaps allow insects and rodents to enter the attic. Covering the gaps with screening, a strip of wood and/or caulking is recommended.

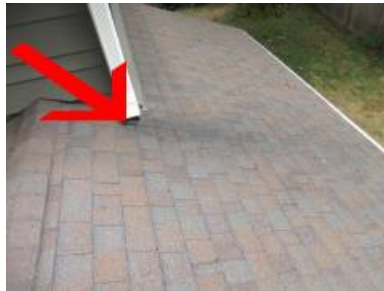
Downspouts draining directly onto the asphalt shingle surface causes excessive wear of the roofing material. Downspout extensions to the lower gutters should be installed to prevent excessive wear and tear of the roofing.

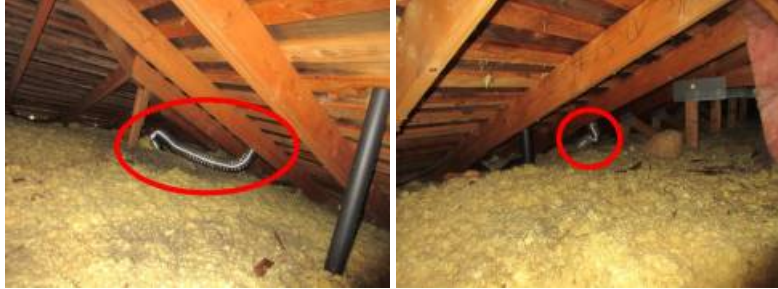
Flexible plastic duct is used to direct air from the vent fans to the exterior. This type of material is unreliable. Replacing the plastic duct with 4" smooth-wall sheet metal duct is recommended.

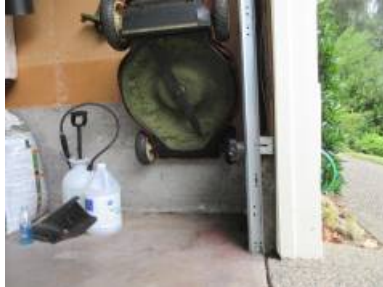
The Photo-eye beam was installed to high above the floor of the garage to adequately offer protection for small children and/or pets. We recommend that the photo-eye be lowered to within 4-6" of the floor.

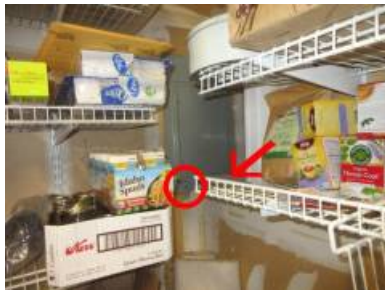
Screws that secure the panel cover to the panel box are missing. This is a potential hazard. Missing screws should be replaced with the original style blunt end screws.

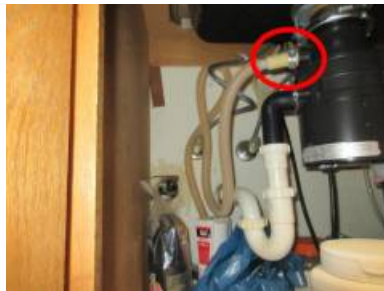
The dishwasher drain lacks an air gap. The dishwasher will function without one, but there is a risk of contamination of the inside of the dishwasher by waste water. The installation of an air gap above the flood rim of the sink is recommended.

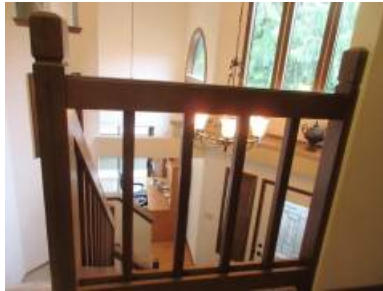
#### GUARD RAILINGS

The spacing between the balusters is too wide. This is a hazard to small children. The balusters should be spaced close enough together so that a 4" sphere cannot pass through. Upgrading the guard railing is recommended if small children are present.

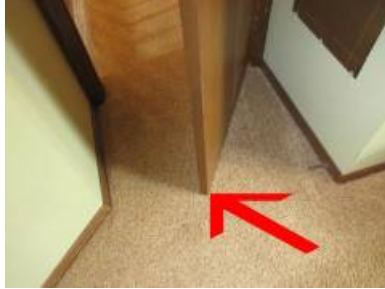
One of the bedroom doors rubs on the carpeting. This can damage the carpet and prevents air circulation under the door. Doors should be undercut 3/4".

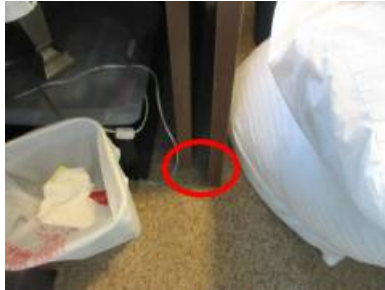
The floor guides are missing from the bypass closet doors in the bedrooms. Missing floor guides could result in damage to the doors. The installation of floor guides is recommended.
