NOTICE TO BUYER: SELLER-PROCURED INSPECTION REPORT

**Michael Cypher, Michelle Wicks Cypher
16865 Ladd St SE
Monroe, WA 98272**

At your request, a visual inspection of the above referenced property was conducted on 02/08/2024. We have inspected the major structural components, plumbing, heating and electrical systems for signs of significant non-performance, excessive or unusual wear and general state of repair.

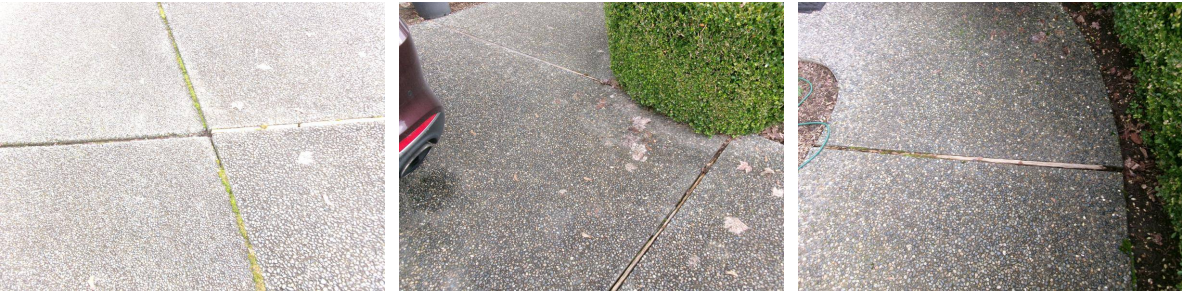
One or more of the wooden dividers separating the concrete driveway sections were infested by wood destroying organisms and have deteriorated to a point where they are becoming a trip hazard. Replacement with mortar is recommended.

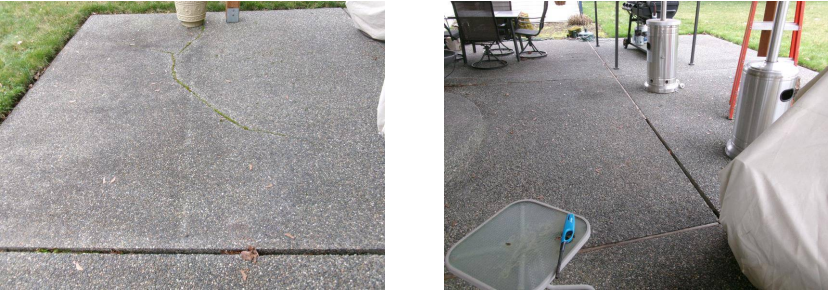
One or more of the wooden dividers separating the concrete patio sections were infested by wood destroying organisms and have deteriorated to a point where they are becoming a trip hazard. Replacement with mortar is recommended.

Cracks were observed in the concrete surface of the patio. Minor cracks can be sealed to minimize moisture entry and further settlement of the concrete.

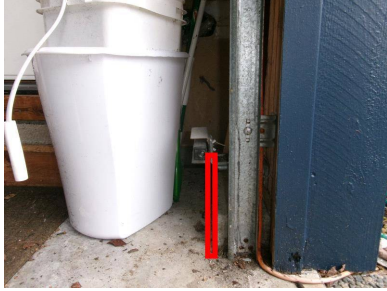
The Photo-eye beam was installed too high above the floor of the garage to adequately offer protection for small children and/or pets. We recommend that the photo-eye be lowered to within 4-6" of the floor.

Garage Door Opener – photo beam sensor has been lowered to less than 6 inches.

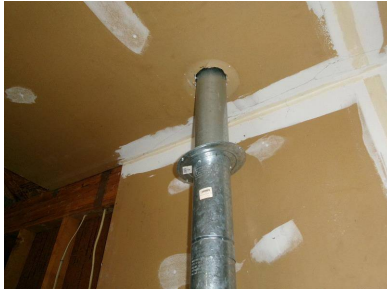
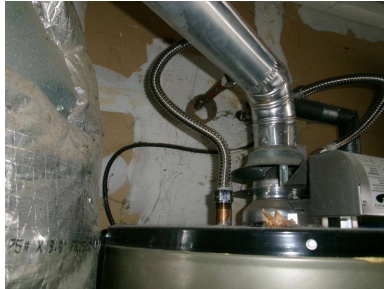
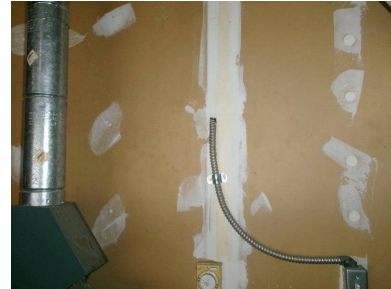
There are voids in the fire resistive barrier between the living space and garage that will allow flames to penetrate. The gypsum barrier slows the spread of a fire from the garage to the structure and/or living space. Patching the voids with a fire retardant caulk is recommended.

Fire Separation – Pipe collar reinstalled, and voids filled with fire rated foam insulation.

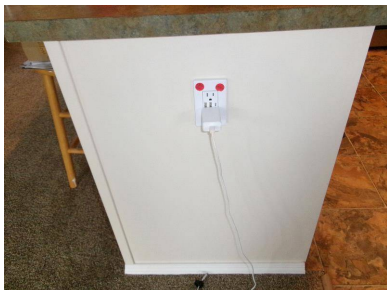
The polarity is reversed in at least one receptacle in the kitchen. Reversed polarity means that the hot and neutral wires are reversed at the back of the receptacle. This defect is a shock hazard and can damage some electronic equipment. All receptacles exhibiting reversed polarity should be rewired.

There are several loose receptacles throughout the home. This is a potential shock and a fire hazard. All loose receptacles should be repaired as necessary.

Electrical System – Receptacles – Electrician as corrected the polarity of the kitchen receptacle, secured all loose receptacles and

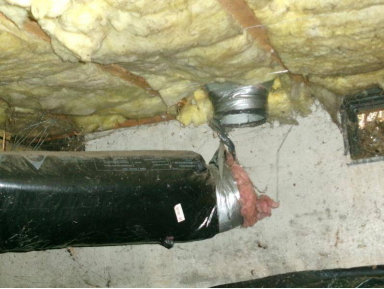
The heating duct in the crawlspace under the office is detached. It should be reattached and secured in accordance with the manufacturer's specifications.

Forced Air Heating System – Ducts – the duct in the crawlspace under the dining room/office was reattached.

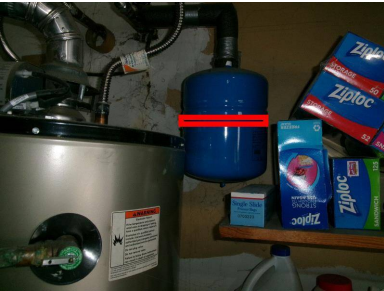
The expansion tank is not adequately secured to the wall. As code requirements start to call for engineered expansion tank supports we recommend the installation of seismic restraints to secure the expansion tank instead of allowing it to simply depend on piping connections that could result in damage to the water pipe and leakage during an earthquake.

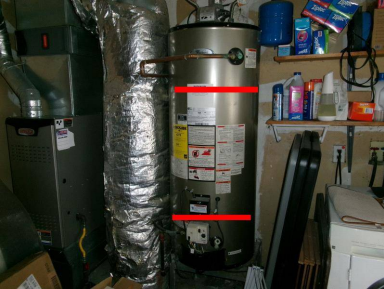
The water heater is not secured to the wall. A seismic restraint should be installed to secure the water heater and prevent it from falling over during an earthquake. This prevents the gas and water lines from rupturing.

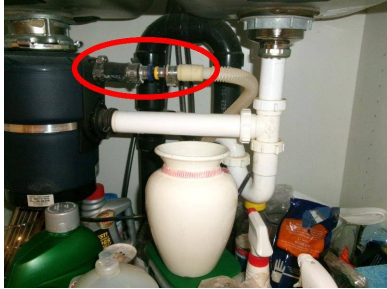
The dishwasher drain lacks an air gap. The dishwasher will function without one, but there is a risk of contamination of the inside of the dishwasher by waste water. The installation of an air gap above the flood rim of the sink is recommended.

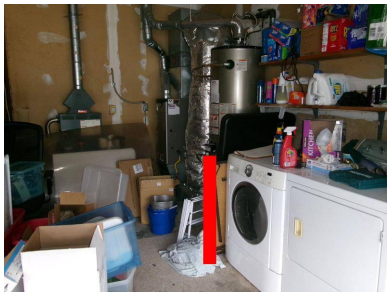
The gas pipes adjacent the furnace and water heater are not protected by a bumper stop. A vertical steel pipe, bolted to the floor, is typically installed in front of the water heater and furnace to prevent a car bumper from damaging the gas lines.

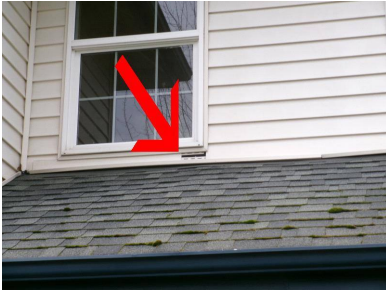
The lower section of siding is loose. Repairs are recommended.

Primary Exterior Wall Cladding – siding was repaired and back in place.

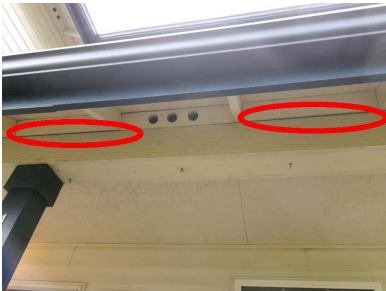
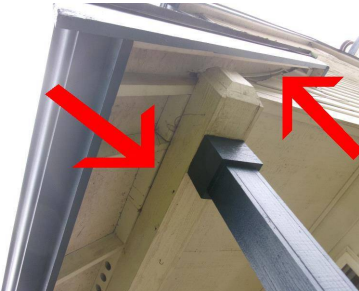
There are large gaps over 1/4" in size adjacent the soffit vent blocks. These gaps allow insects and rodents to enter the attic. Covering the gaps with screening, a strip of wood and/or caulking is recommended.

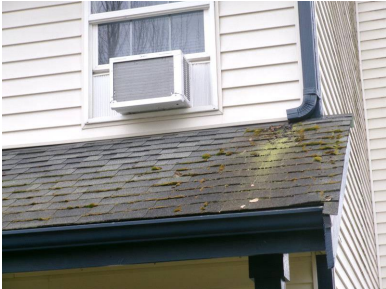
Downspouts draining directly onto the asphalt shingle surface causes excessive wear of the roofing material. Downspout extensions to the lower gutters should be installed to prevent excessive wear and tear of the roofing.

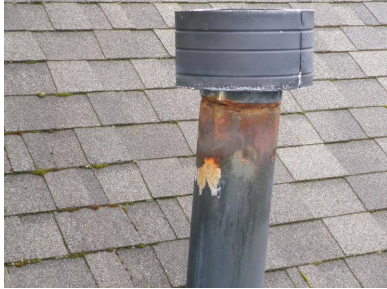
The gas appliance vent is corroded above the roof line. Cleaning and painting the vent will prolong its service life.

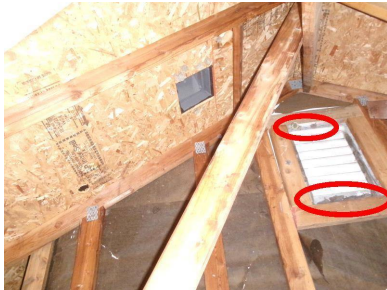
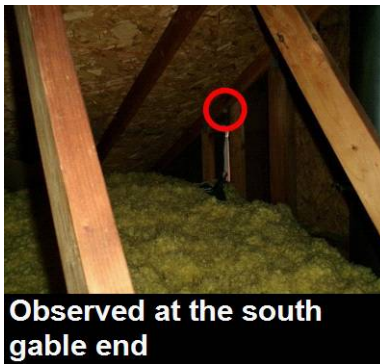
There are yellow jacket nests in the attic. Yellow jackets are very aggressive in late summer and their sting is painful. Yellow jacket activity can be avoided by sealing all openings into the attic, particularly above the gable end walls and below vent blocks.

Attic Pest Control – had a pest control expert come and removed all the yellow jacket nests.

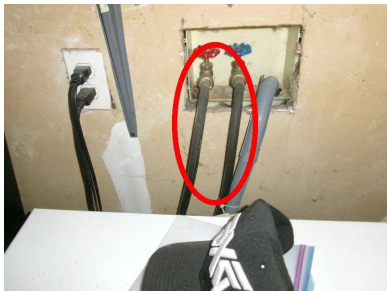
Upgrading the washer connections to high pressure (steel braided) lines is recommended.

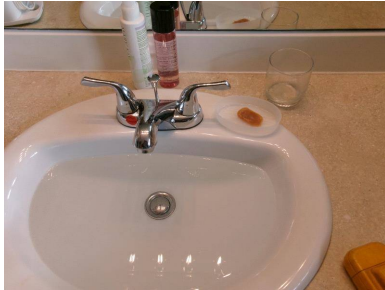
The sink fixture is loose at its base. The fixture should be adequately secured.

The backsplash caulking is cracked. Cracking of the caulk allows water to enter the gap and is difficult to clean. Caulking the cracks and/or gaps is recommended.

Primary Bedroom Bathroom: Added splash guards to the tub. The sink fixture was tightened. Cracks were caulked.

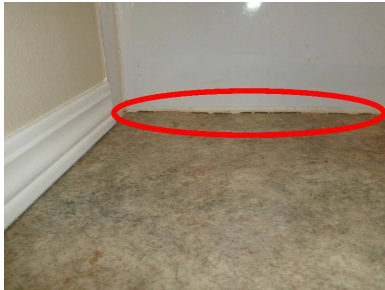
The caulking is cracked at the intersection between the tub/shower and floor. This can lead to water damage to the flooring and substrate. Caulking this area with a flexible caulk is recommended.

Upper Floor Hallway Bathroom – Caulking replaced at the intersection between the tub/shower and the floor.

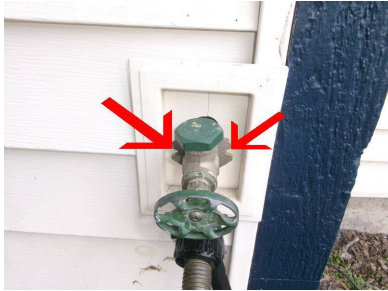
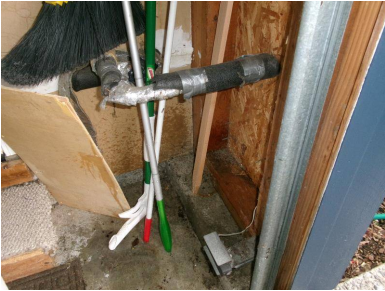
The hose bibb on the front of the building is damaged. This is indicative of a frozen valve and pipes. Repair of pipes and replacement of the hose bibb is recommended. The other hose bibb was functional.

The hose bibb on the rear of the house is loose. This could result in damage to the water pipe and leakage. The bibb should be securely fastened to the wall.

Plumbing System – Hose bibbs and exterior Supply Pipes: Hose bibb and pipe at the front of the building was replaced by plumber and insulation added to the pipe. Hose bibb covers were added to the front and back of the house.

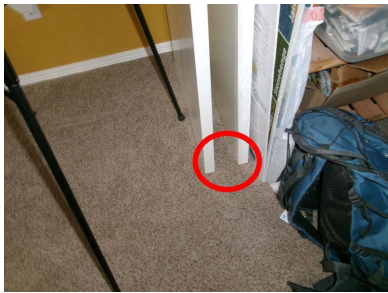
The floor guides are missing from the bypass closet doors in the bedroom. Missing floor guides could result in damage to the doors. The installation of floor guides is recommended.

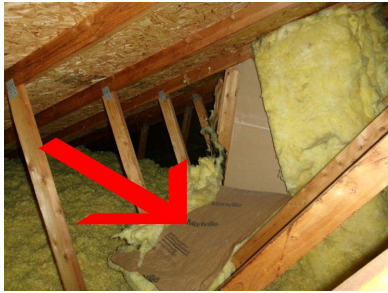
One of the insulation batts was not properly secured and has falling down. The fallen batts should be reinstalled and secured.

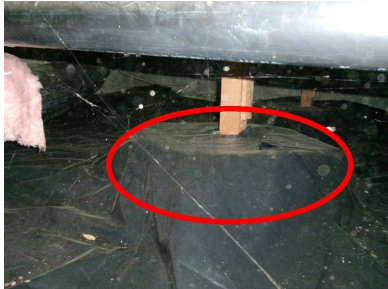
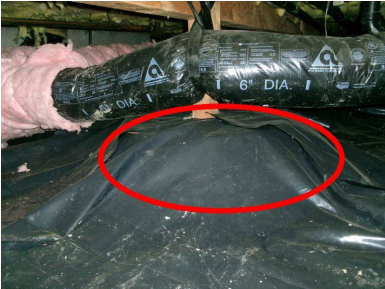
The support post concrete piers are covered with the plastic vapor retarder. This allows the transmission of water vapor from the soil up and into the floor framing. The plastic vapor retarder should be removed from the pier so that it covers at least 85% of the entire surface of the soil only.

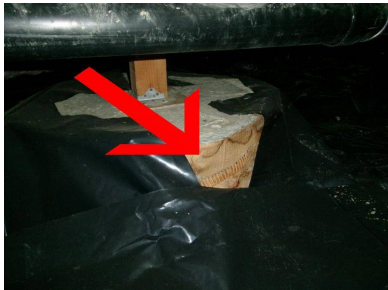
Cellulose forms were left in place on the pier footings. This cellulose is conducive to the infestation of various wood destroying organisms. The removal of the cellulose is recommended.

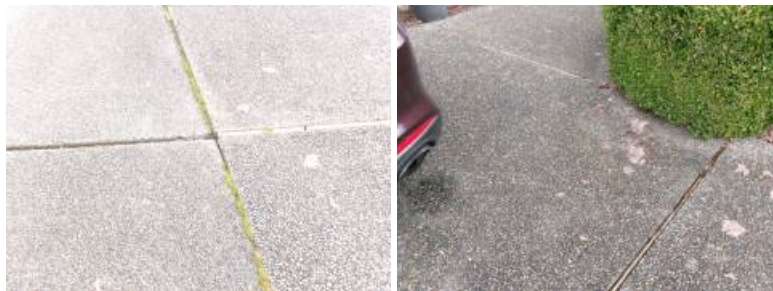
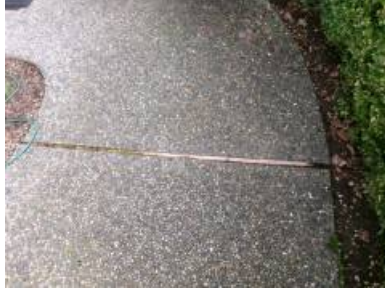
One or more of the wooden dividers separating the concrete driveway sections were infested by wood destroying organisms and have deteriorated to a point where they are becoming a trip hazard. Replacement with mortar is recommended.

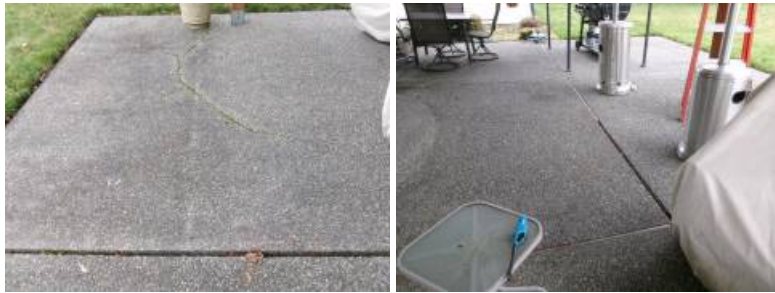
Cracks were observed in the concrete surface of the patio. Minor cracks can be sealed to minimize moisture entry and further settlement of the concrete.

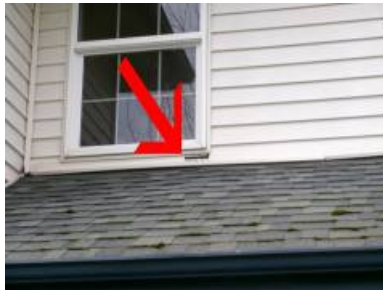
The lower section of siding is loose. Repairs are recommended.

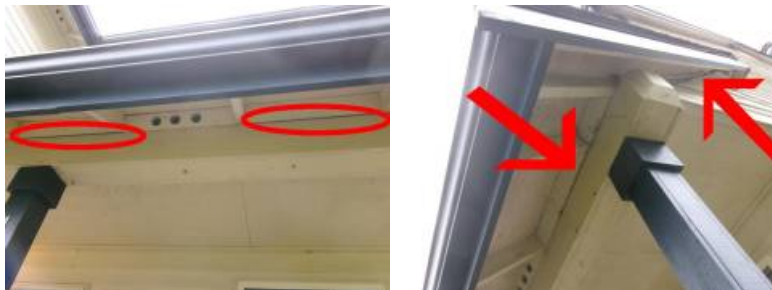
There are large gaps over 1/4" in size adjacent the soffit vent blocks. These gaps allow insects and rodents to enter the attic. Covering the gaps with screening, a strip of wood and/or caulking is recommended.

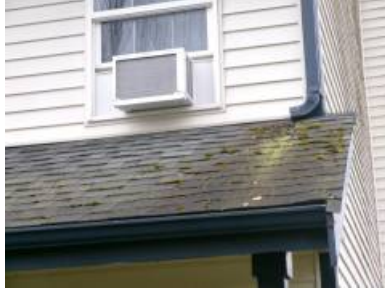
Downspouts draining directly onto the asphalt shingle surface causes excessive wear of the roofing material. Downspout extensions to the lower gutters should be installed to prevent excessive wear and tear of the roofing.

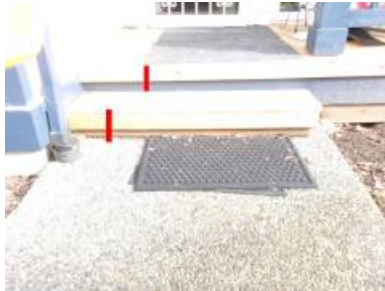
The steps are non-conforming due to the variable and/or excessive rise. Stair design standards require that step risers do not exceed 8" and that the variation in rise not exceed 3/8" in order to reduce falls from tripping. To increase the margin of safety, consideration should be given to reconfiguring the steps so that rise and run do not vary by more than 3/8". If this proves to be too impractical or expensive, then we recommend exercising caution when using.

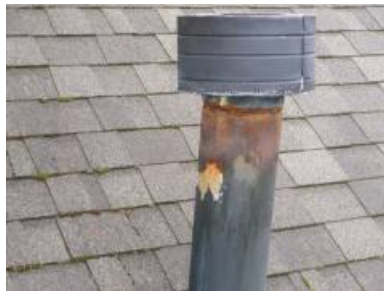
The gas appliance vent is corroded above the roof line. Cleaning and painting the vent will prolong its service life.

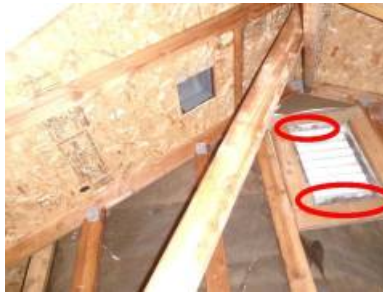
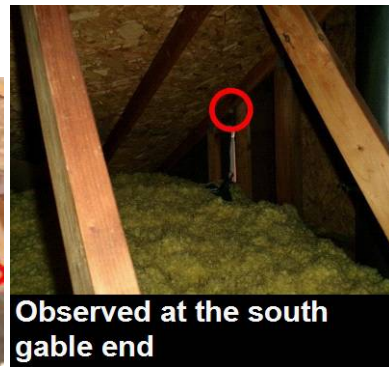
There are yellow jacket nests in the attic. Yellow jackets are very aggressive in late summer and their sting is painful. Yellow jacket activity can be avoided by sealing all openings into the attic, particularly above the gable end walls and below vent blocks.

Observed at the south gable end

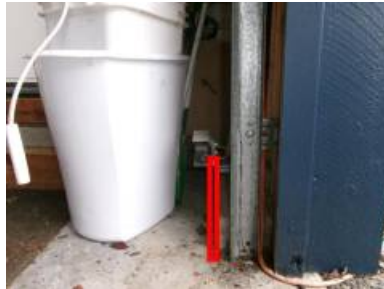
The Photo-eye beam was installed to high above the floor of the garage to adequately offer protection for small children and/or pets. We recommend that the photo-eye be lowered to within 4-6" of the floor.

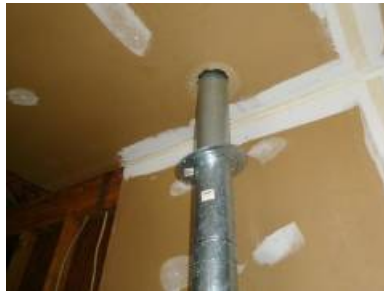
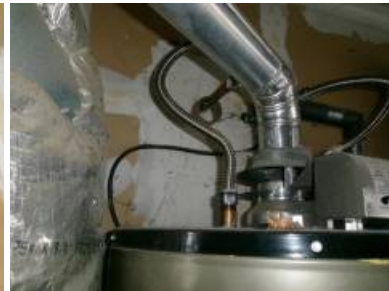
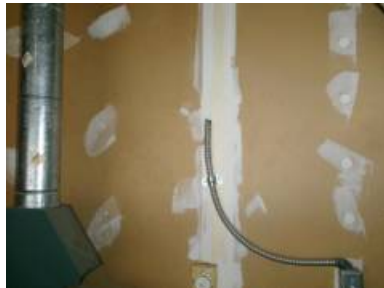
There are voids in the fire resistive barrier between the living space and garage that will allow flames to penetrate. The gypsum barrier slows the spread of a fire from the garage to the structure and/or living space. Patching the voids with a fire retardant caulk is recommended.

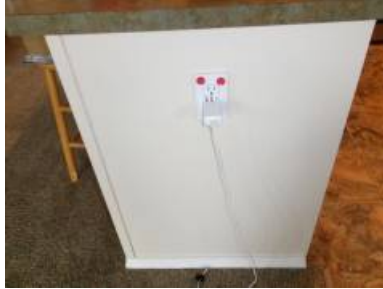
<i>WIRING</i>		There were no defects observed in the visible and accessible wiring.
<i>ALUMINUM WIRING</i>		This house uses stranded aluminum wire for service entrance conductors and for dedicated major appliance circuits. This type of aluminum wire circuitry is typically found in most houses and is considered safe and reliable when installed correctly.
<i>RECEPTACLES</i>		All of the readily accessible receptacles were tested. Testing revealed defects requiring repair. These defects are outlined below. The polarity is reversed in at least one receptacle in the kitchen. Reversed polarity means that the hot and neutral wires are reversed at the back of the receptacle. This defect is a shock hazard and can damage some electronic equipment. All receptacles exhibiting reversed polarity should be rewired. There are several loose receptacles throughout the home. This is a potential shock and a fire hazard. All loose receptacles should be repaired as necessary.

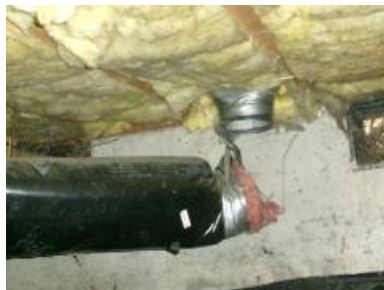
The heating duct in the crawlspace under the office is detached. It should be reattached and secured in accordance with the manufacturer's specifications.

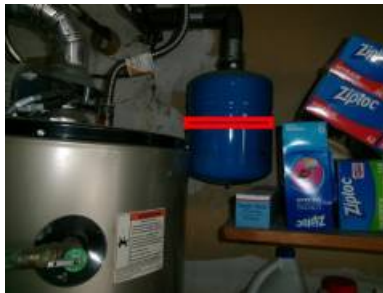
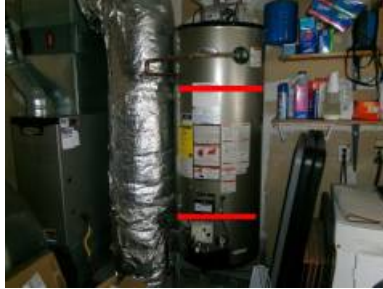
<i>SEISMIC RESTRAINT</i>	The water heater is not secured to the wall. A seismic restraint should be installed to secure the water heater and prevent it from falling over during an earthquake. This prevents the gas and water lines from rupturing.

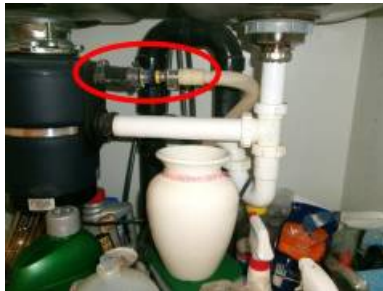
<i>COUNTERTOPS</i>	The countertops are covered with plastic laminate. The counter tops are properly installed and are in good condition.
<i>CABINETS</i>	The finish on the kitchen cabinets is slightly worn. The cabinets are otherwise in good condition.
<i>FLOORING MATERIAL</i>	The floor is covered with sheet vinyl. The floor is properly installed and is in good condition.
<i>VENTILATION</i>	Ventilation in the kitchen is provided by a fan built into the bottom of the microwave oven over the stove. The vent is ducted to the exterior. The vent fan is properly installed and is performing its intended function.
<i>SINK FAUCET</i>	The sink faucet is properly installed and is in good condition.
<i>SINK</i>	The kitchen sink is properly installed and is in good condition.
<i>DRAINS, TRAPS AND TRAP ARMS</i>	The sink drain is properly installed and is performing its intended function.
<i>AIR GAP</i>	The dishwasher drain lacks an air gap. The dishwasher will function without one, but there is a risk of contamination of the inside of the dishwasher by waste water. The installation of an air gap above the flood rim of the sink is recommended.

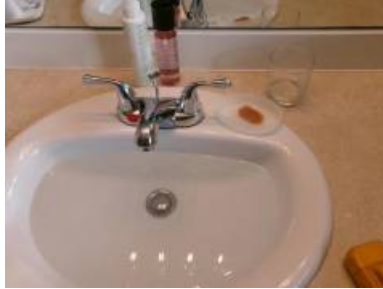
<i>FAUCET FIXTURES</i>	The faucet fixture was tested and was functioning as intended. The sink fixture is loose at its base. The fixture should be adequately secured.
<i>CABINETS</i>	The finish on the bathroom cabinet is slightly worn. The cabinet is otherwise in good condition.
<i>COUNTERTOP</i>	The countertop is covered with limestone tile. The countertop is properly installed and in good condition. The backsplash caulking is cracked. Cracking of the caulk allows water to enter the gap and is difficult to clean. Caulking the cracks and/or gaps is recommended.

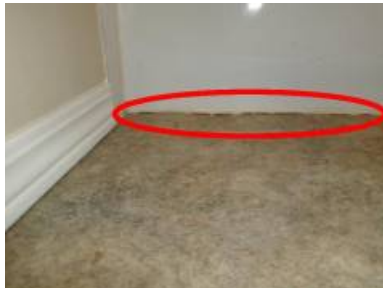
The caulking is cracked at the intersection between the tub/shower and floor. This can lead to water damage to the flooring and substrate. Caulking this area with a flexible caulk is recommended.

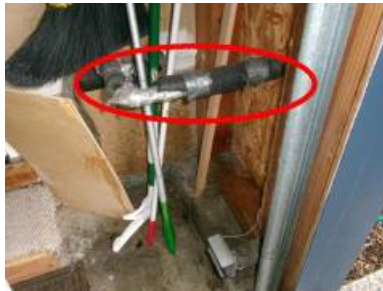
Testing of the water pipes included operating hose bibbs. This test revealed a leak visible in the garage. Repairs by a qualified plumbing contractor are recommended.

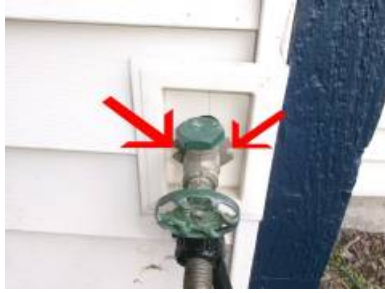
The hose bibb on the rear of the house is loose. This could result in damage to the water pipe and leakage. The bibb should be securely fastened to the wall.

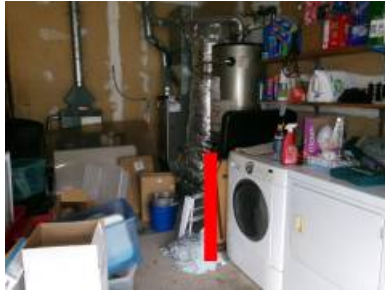
The gas pipes adjacent the furnace and water heater are not protected by a bumper stop. A vertical steel pipe, bolted to the floor, is typically installed in front of the water heater and furnace to prevent a car bumper from damaging the gas lines.

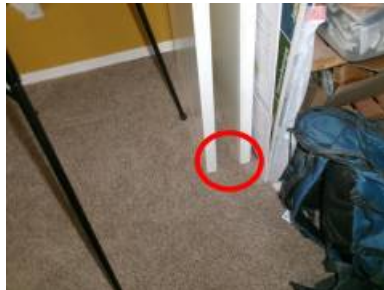
The floor guides are missing from the bypass closet doors in the bedroom. Missing floor guides could result in damage to the doors. The installation of floor guides is recommended.

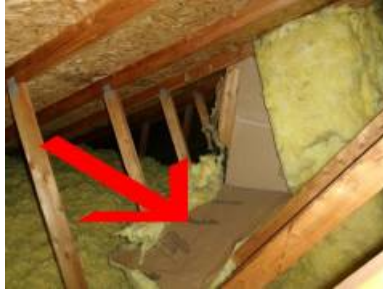
One of the insulation batts was not properly secured and has falling down. The fallen batts should be reinstalled and secured.

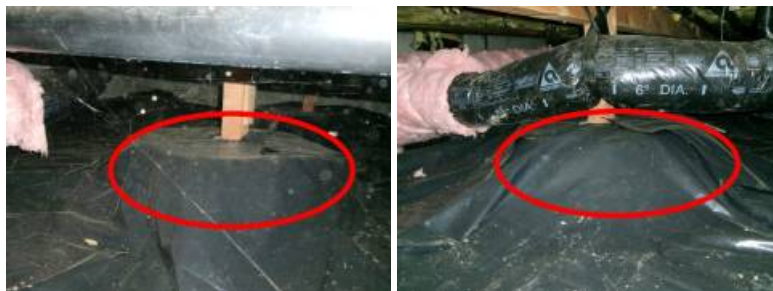
The support post concrete piers are covered with the plastic vapor retarder. This allows the transmission of water vapor from the soil up and into the floor framing. The plastic vapor retarder should be removed from the pier so that it covers at least 85% of the entire surface of the soil only.

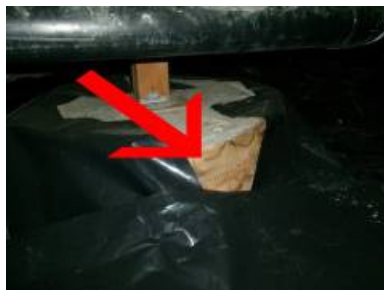
Cellulose forms were left in place on the pier footings. This cellulose is conducive to the infestation of various wood destroying organisms. The removal of the cellulose is recommended.
