At your request, a visual inspection of the above referenced property was conducted on 03/04/2024. We have inspected the major structural components, plumbing, heating and electrical systems for signs of significant non-performance, excessive or unusual wear and general state of repair.

DATE OF INSPECTION: 3/4/2024.  
INSPECTOR'S NAME: Terry Clark.  
CLIENT NAME: Mr. Russell Chiupka.  
MAILING ADDRESS: 11635 91st Pl. NE  
Kirkland WA.  
CLIENT E-MAIL ADDRESS [russell.chiupka@gmail.com.](mailto:russell.chiupka@gmail.com)  
ADDRESS OF PROPERTY 11635 91st Pl. NE  
INSPECTED Kirkland, WA.

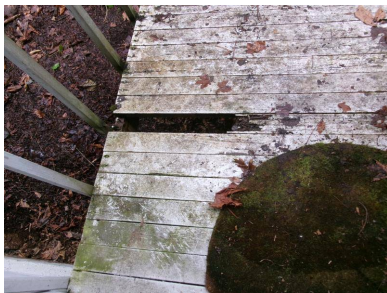
### *PORCH*

A significant portion of the wood porch is rotted. This is a hazard. Rot weakens the wood and can result in catastrophic failure of the structure. Rebuilding the porch structure is recommended.

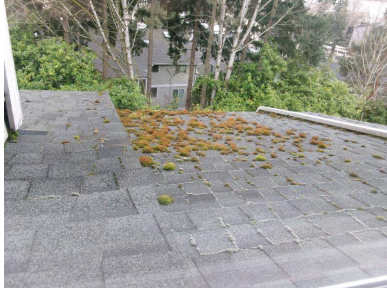
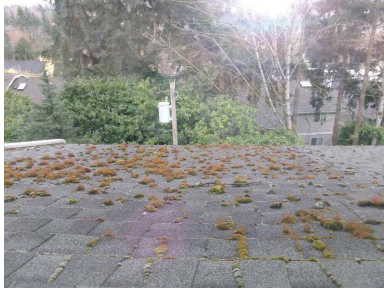
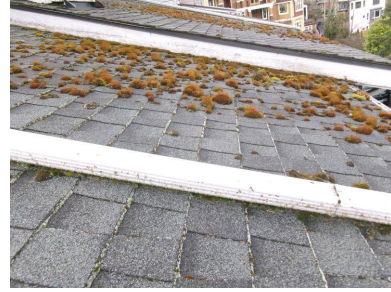
### *MAINTENANCE AND REPAIRS*

The roof is in need of overdue maintenance. The surface should be treated for moss, lichen, and algae growth, then brushed and washed off with a high volume low pressure hose to remove moss and organic debris. Performing this maintenance will improve the appearance and increase the life expectancy of the roof.

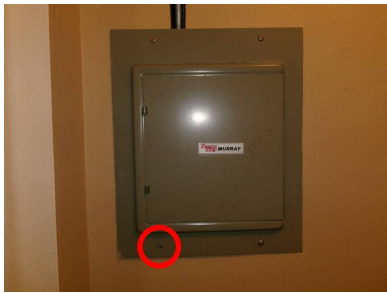
### *SERVICE PANEL*

Screws that secure the panel cover to the panel box are missing. This is a potential hazard. Missing screws should be replaced with the original style blunt end screws.

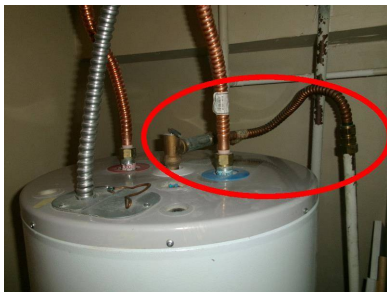
### *PRESSURE RELIEF VALVE*

The pressure relief valve drain pipe has a reverse slope which traps water in the pipe. This can result in failure of the pressure relief valve. The drain pipe should be reconfigured so that it slopes 1/4" per foot to the drain outlet. If this is not possible or practical, a small (1/16") drain hole can be drilled in the bottom of the pipe at the lowest point.

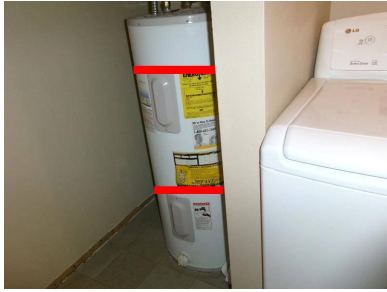
### *SEISMIC RESTRAINT*

The water heater is not secured to the wall. A seismic restraint should be installed to secure the water heater and prevent it from falling over during an earthquake. This prevents the gas and water lines from rupturing.

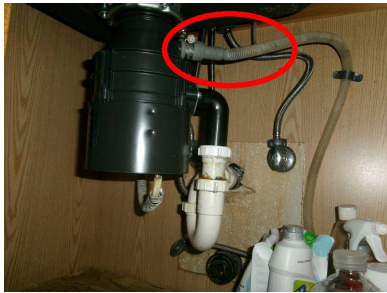
##### *AIR GAP*

The dishwasher drain lacks an air gap. The dishwasher will function without one, but there is a risk of contamination of the inside of the dishwasher by waste water. The installation of an air gap above the flood rim of the sink is recommended.

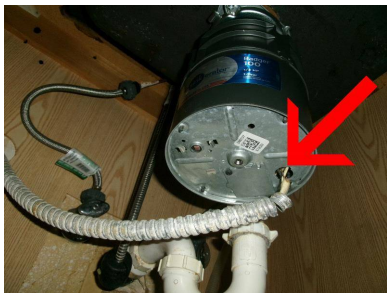
The garbage disposal was tested and was functioning as intended. The wiring conduit is not clamped where it enters the disposal. This could damage the wires or cause a ground fault. The conduit should be clamped in accordance with industry standards.

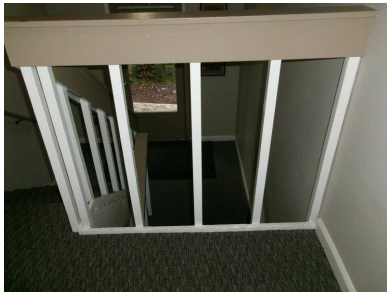
### *STAIRS*

The stair railing baluster spacing is too wide. This is a hazard for small children. The baluster spacing should be reduced as a safety upgrade. Current standards require that a 4-3/8" sphere not pass through the railing.

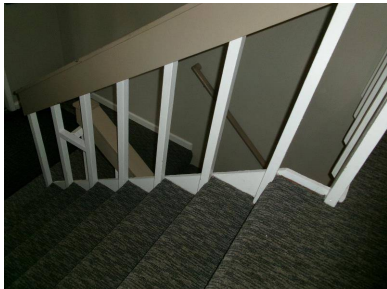
### *GUARD RAILINGS*

The spacing between the balusters is too wide. This is a hazard to small children. The balusters should be spaced close enough together so that a 4" sphere cannot pass through. Upgrading the guard railing is recommended if small children are present.

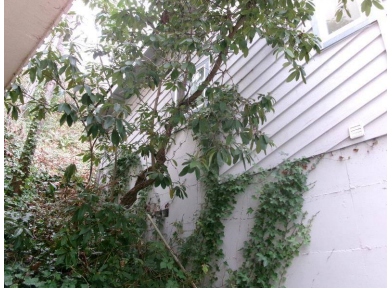
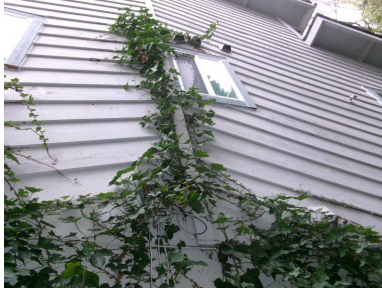
Vines are touching several sides of the building. Vines can damage the roof, windows and other exterior building components. Consideration should be given to removing vines that are attached to the house. Vines

could be trellised away from the structure to allow for air flow.

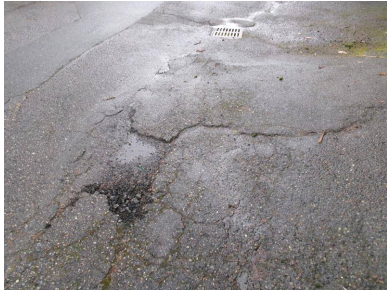
#### **DRIVEWAY**

There is settlement damage visible in the asphalt driveway. The damage is not affecting the function of the driveway. Patching and/or filling the voids is optional. Cracks observed in the asphalt surface of the driveway can be sealed to minimize moisture entry and further settlement of the asphalt. Seal coating the surface of the asphalt is recommended to maximize the service life of the paving. Asphalt sealers are available at most home improvement stores.

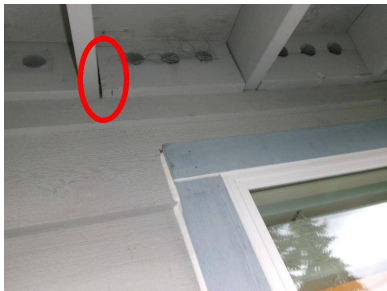
##### **SOFFITS AND OVERHANGS**

There are large gaps over 1/4" in size adjacent the soffit vent blocks. These gaps allow insects and rodents to enter the attic. Covering the gaps with screening, a strip of wood and/or caulking is recommended.

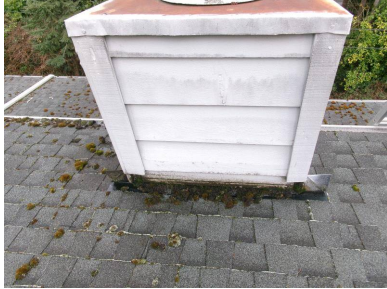
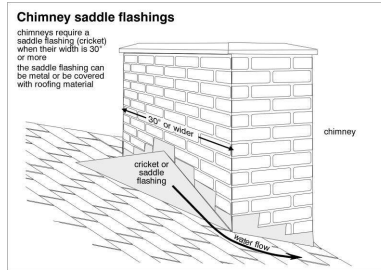
##### **CHIMNEYS**

There is no cricket on the up-slope side of the living room fireplace chimney. This is conducive to leakage. Consideration should be given to installing a cricket to divert water around the chimney.

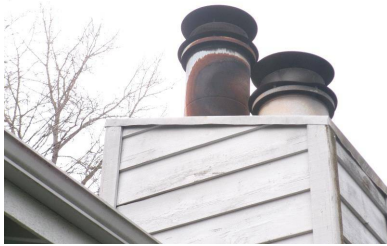
The metal fireplace chimney is corroded above the roof line. Cleaning and painting the vent will prolong its service life.

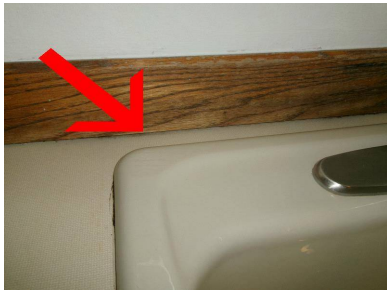
### COUNTERTOPS

The backsplash is not caulked. This allows water and food to enter the gap between the back splash and counter and is difficult to clean. Caulking should be installed at this location.

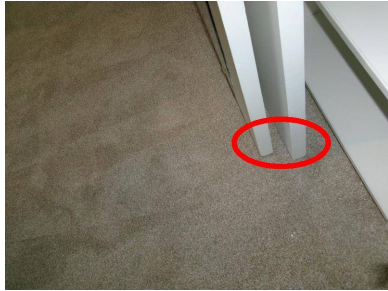
The floor guides are missing from the bypass closet doors in the bedroom. Missing floor guides could result in damage to the doors. The installation of floor guides is recommended.

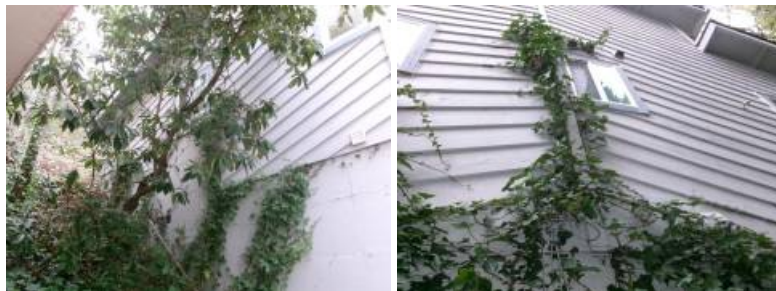
Vines are touching several sides of the building. Vines can damage the roof, windows and other exterior building components. Consideration should be given to removing vines that are attached to the house. Vines could be trellised away from the structure to allow for air flow.

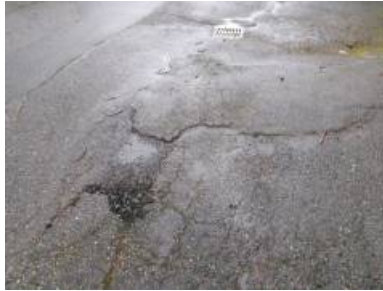
### DRIVEWAY

There is settlement damage visible in the asphalt driveway. The damage is not affecting the function of the driveway. Patching and/or filling the voids is optional. Cracks

observed in the asphalt surface of the driveway can be sealed to minimize moisture entry and further settlement of the asphalt. Seal coating the surface of the asphalt is recommended to maximize the service life of the paving. Asphalt sealers are available at most home improvement stores.

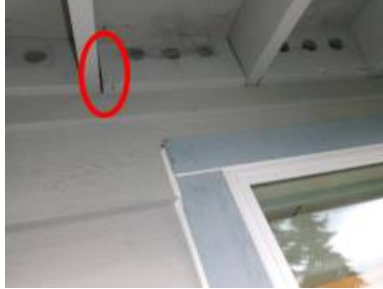
There are large gaps over 1/4" in size adjacent the soffit vent blocks. These gaps allow insects and rodents to enter the attic. Covering the gaps with screening, a strip of wood and/or caulking is recommended.

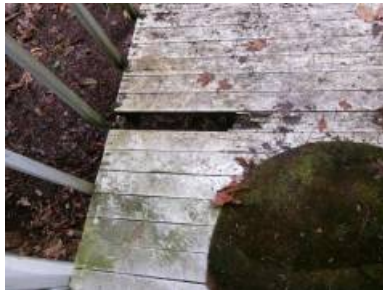
**PORCH** A significant portion of the wood porch is rotted. This is a hazard. Rot weakens the wood and can result in catastrophic failure of the structure. Rebuilding the porch structure is recommended.

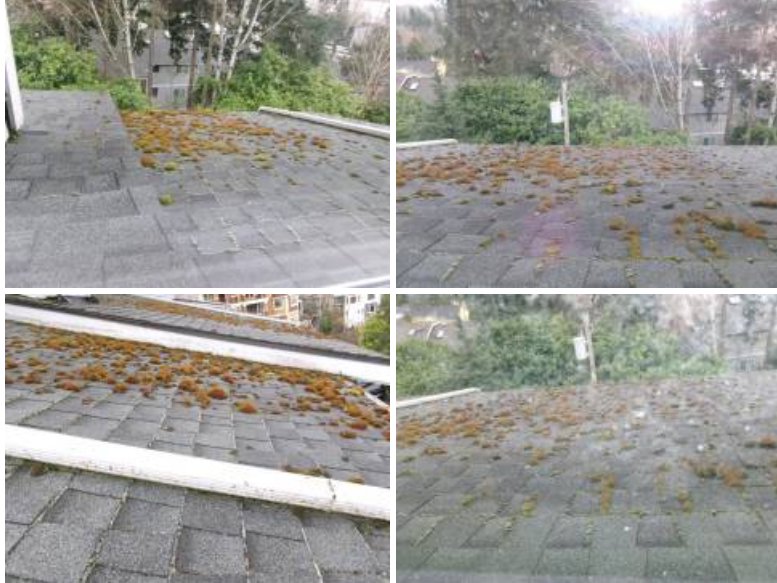
The roof is in need of overdue maintenance. The surface should be treated for moss, lichen, and algae growth, then brushed and washed off with a high volume low pressure hose to remove moss and organic debris. Performing this maintenance will improve the appearance and increase the life expectancy of the roof.

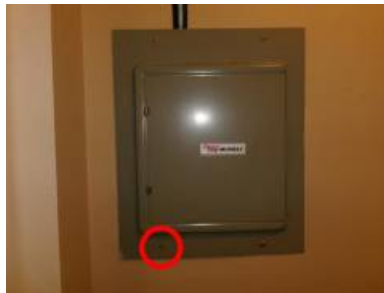
Screws that secure the panel cover to the panel box are missing. This is a potential hazard. Missing screws should be replaced with the original style blunt end screws.

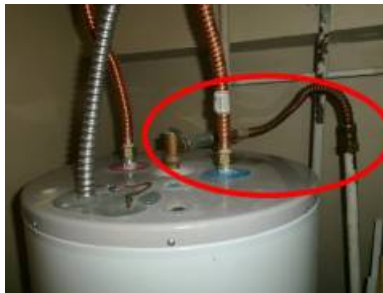
The pressure relief valve drain pipe has a reverse slope which traps water in the pipe. This can result in failure of the pressure relief valve. The drain pipe should be reconfigured so that it slopes 1/4" per foot to the drain outlet. If this is not possible or practical, a small (1/16") drain hole can be drilled in the bottom of the pipe at the lowest point.

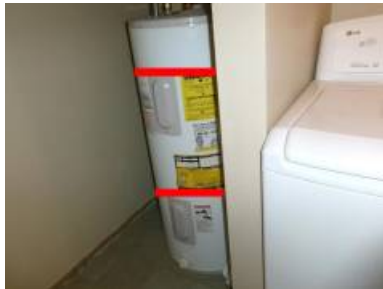
The water heater is not secured to the wall. A seismic restraint should be installed to secure the water heater and prevent it from falling over during an earthquake. This prevents the gas and water lines from rupturing.

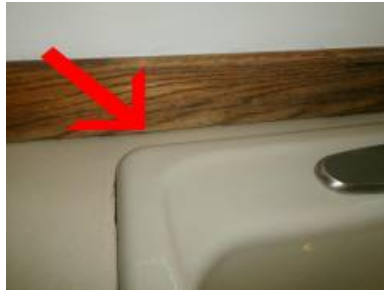
The backsplash is not caulked. This allows water and food to enter the gap between the back splash and counter and is difficult to clean. Caulking should be installed at this location.

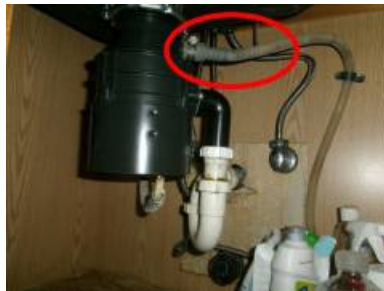
The dishwasher drain lacks an air gap. The dishwasher will function without one, but there is a risk of contamination of the inside of the dishwasher by waste water. The installation of an air gap above the flood rim of the sink is recommended.

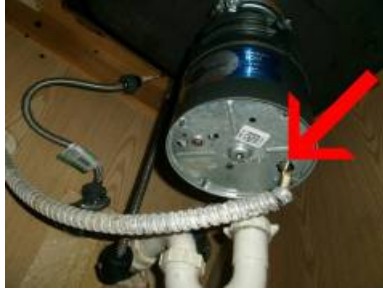
The garbage disposal was tested and was functioning as intended. The wiring conduit is not clamped where it enters the disposal. This could damage the wires or cause a ground fault. The conduit should be clamped in accordance with industry standards.

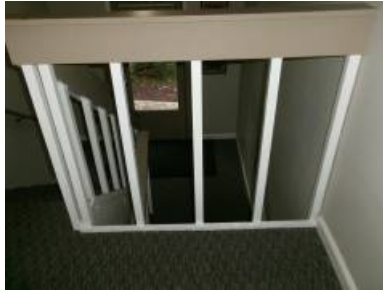
The stair railing baluster spacing is too wide. This is a hazard for small children. The baluster spacing should be reduced as a safety upgrade. Current standards require that a 4-3/8" sphere not pass through the railing.

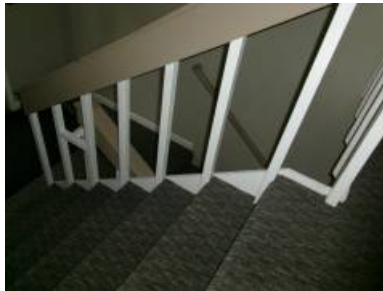
#### GUARD RAILINGS

The spacing between the balusters is too wide. This is a hazard to small children. The balusters should be spaced close enough together so that a 4" sphere cannot pass through. Upgrading the guard railing is recommended if small children are present.

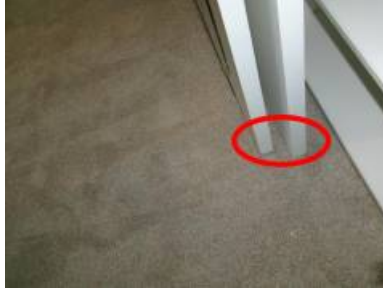
The floor guides are missing from the bypass closet doors in the bedroom. Missing floor guides could result in damage to the doors. The installation of floor guides is recommended.
