March 5, 2024

**Mr. & Mrs. Greg & Karen Wisont**  
**16910 NE 131st Place**  
**Redmond, WA.**

At your request, a visual inspection of the above referenced property was conducted on 03/04/2024. We have inspected the major structural components, plumbing, heating and electrical systems for signs of significant non-performance, excessive or unusual wear and general state of repair.

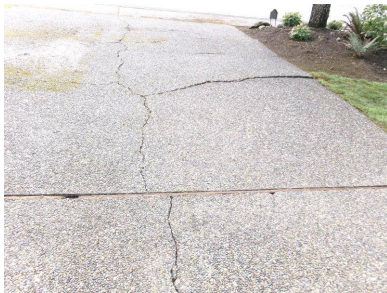
#### DRIVEWAY

The driveway has cracked and settled differentially. This was probably caused by inadequate preparation of the soil prior to the placement of the concrete. This condition can be repaired by pressure grouting the sunken portion of the driveway or by removing and replacing it. The driveway remains functional despite this condition.

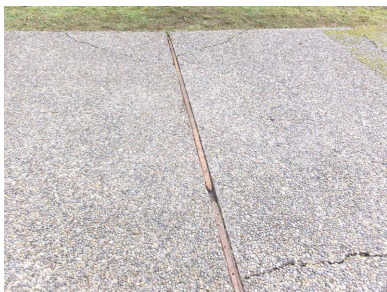
One or more of the wooden dividers separating the concrete driveway sections were infested by wood destroying organisms and have deteriorated to a point where they are becoming a trip hazard. Replacement with mortar is recommended.

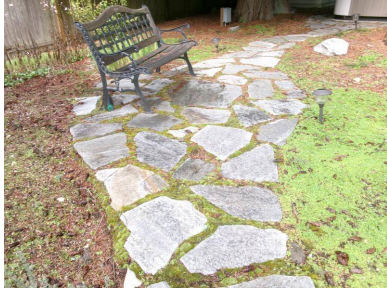
#### PATIO

The walking surface was not even and trip hazards were present. We recommend all walking surfaces be maintained free of trip hazards.

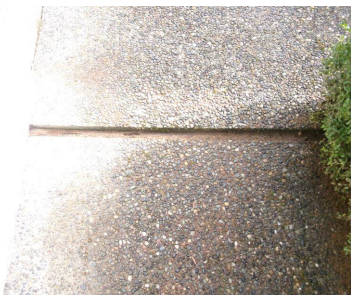
**WALKWAY**

One or more of the wooden dividers separating the concrete walkway sections were infested by wood destroying organisms and have deteriorated to a point where they are becoming a trip hazard. Replacement with mortar is recommended.

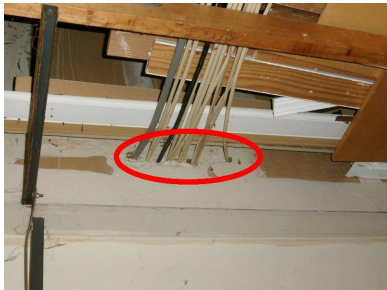
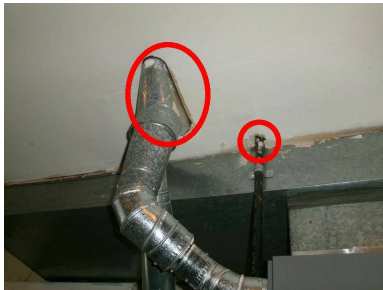
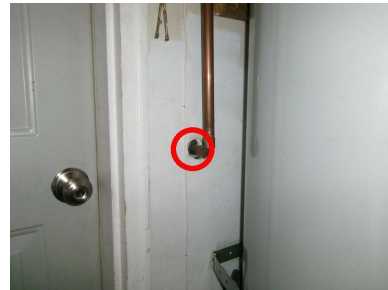
ATTACHED GARAGE  
FIRE SEPARATION

There are voids in the fire resistive barrier between the living space and garage that will allow flames to penetrate. The gypsum barrier slows the spread of a fire from the garage to the structure and/or living space. Patching the voids with a fire retardant caulk is recommended.

- Garage fire separation: Fire retardant caulk has been applied as recommended
- Electrical system service panel: Blunt end screws have been placed as recommended
- Electrical receptacles: Loose receptacle in laundry room corrected; cover plates installed as recommended; GFCI receptacle replaced as recommended
- Ceiling fan: Remote control is present in the bedroom and working
- Heating system blower: Cut-out switch has been enabled and is not restricted, per recommendation
- Toilet in main floor powder room: New wax seal has been installed and toilet re-mounted to the floor as recommended
- Dishwasher: Unit has been secured as recommended

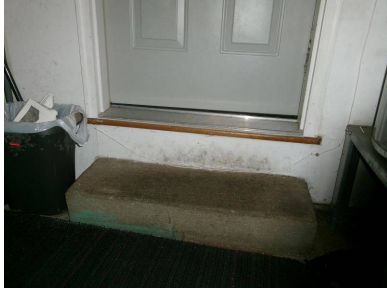
**STAIRS**

The garage steps are non-conforming due to the variable and/or excessive rise. Stair design standards require that stair risers do not exceed 8" and that the variation in rise not exceed 3/8" in order to reduce falls from tripping. To increase the margin of safety, consideration should be given to reconfiguring the steps so that rise and run do not vary by more than 3/8". If this proves to be too impractical or expensive, then we recommend exercising caution when using these steps.

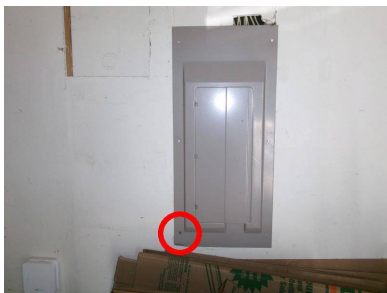
### *SERVICE PANEL*

Screws that secure the panel cover to the panel box are missing. This is a potential hazard. Missing screws should be replaced with the original style blunt end screws.

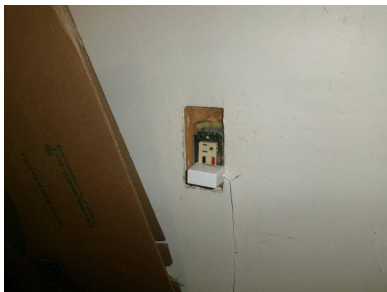
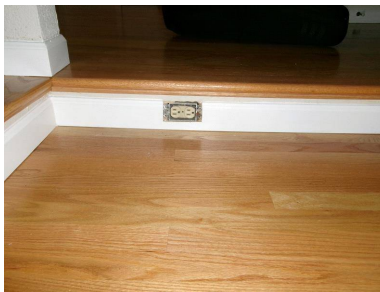
Cover plates are missing from several receptacles. This is a shock and fire hazard. The installation of cover plates on all receptacles is recommended.

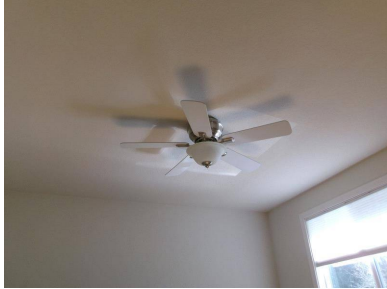
### *CEILING FAN*

The bedroom ceiling fan/light remote was not present and its function was not verified.

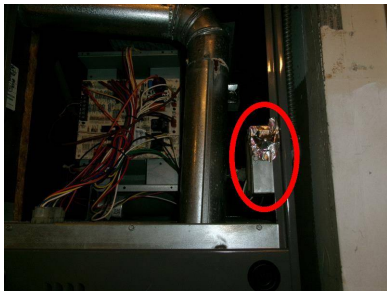
#### *BLOWER*

The blower door cut-out switch has been disabled. This is a potential hazard. The cut-out switch should be not be restricted.

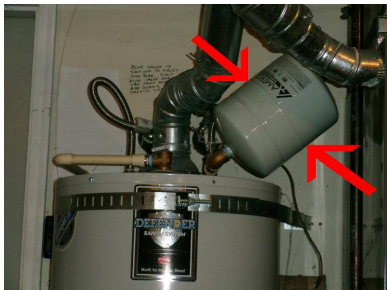
### *EXPANSION TANK*

The expansion tank is not adequately secured to the wall. As code requirements start to call for engineered expansion tank supports we recommend the installation of seismic restraints to secure the expansion tank instead of allowing it to simply depend on piping connections that could result in damage to the water pipe and leakage during an earthquake.

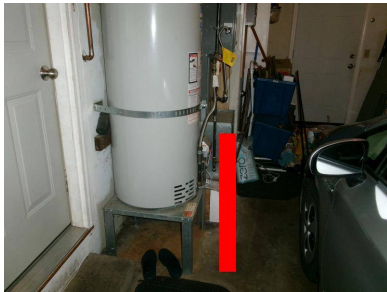
*GAS PIPING*

The gas pipes in front of the furnace and water heater are not protected by a bumper stop. A vertical steel pipe, bolted to the floor, is typically installed in front of the water heater to prevent a car bumper from damaging the gas lines.

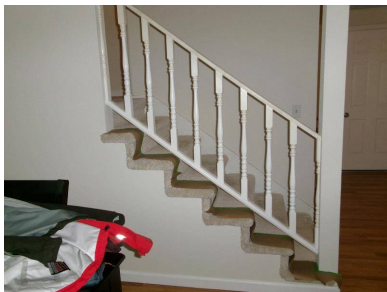
*STAIRS*

The stair railing baluster spacing is too wide. This is a hazard for small children. The baluster spacing should be reduced as a safety upgrade. Current standards require that a 4-3/8" sphere not pass through the railing.

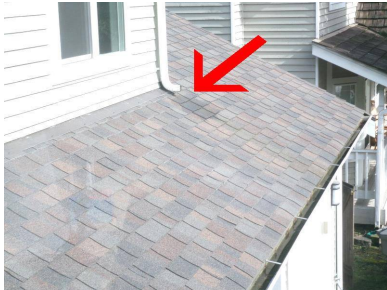
Downspouts draining directly onto the asphalt shingle surface causes excessive wear of the roofing material. Downspout extensions to the lower gutters should be installed to prevent excessive wear and tear of the roofing.

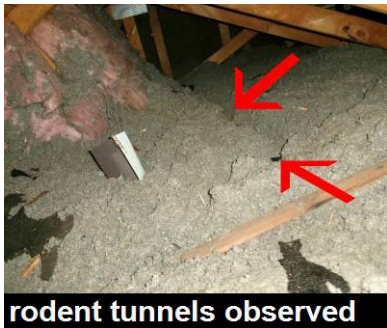
#### *PEST CONTROL*

There is evidence of rodent activity in the attic. The first step in eliminating rodents from the attic is to seal all possible entry points using wire mesh, caulking, wood, stainless steel wool, or aerosol foam. Careful work sealing cracks, holes and gaps will discourage further activity. Once this work is completed, snap traps baited with peanut butter should be installed and monitored. The absence of rodents in the traps typically means that the rodents have been excluded from the area.

- Oven broiler element: To be repaired or replaced prior to closing
- Attic pest control: Seller disputes any rodent activity in the attic or perimeter of the house; there has been no evidence of such activity. Seller will arrange for professional pest inspection and remediation as necessary prior to closing.

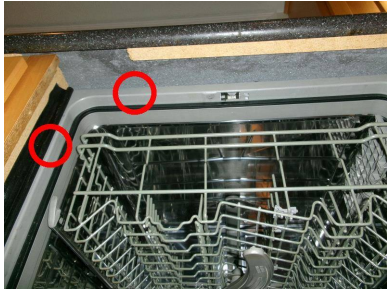
#### *DISHWASHER*

The dishwasher is not secured to the cabinet or countertop. This allows the appliance to move around. The dishwasher should be secured to the cabinet or to the bottom of the countertop in accordance with industry standards.

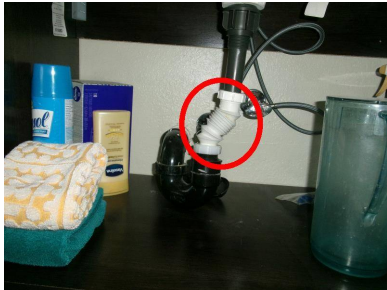
MAIN FLOOR POWDER ROOM  
DRAINS, TRAPS AND TRAP ARMS

Improper, non-conforming material has been used for the drain pipe fitting. This material will not function reliably. Replacement with industry standard fittings is recommended.

- Powder room drain pipe fitting: Seller has had no issue with existing fittings but will consider replacement if requested.

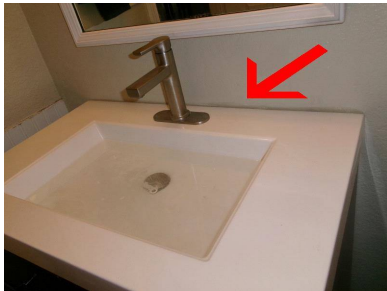
COUNTERTOP

The backsplash is missing. The installation of a backsplash is recommended.

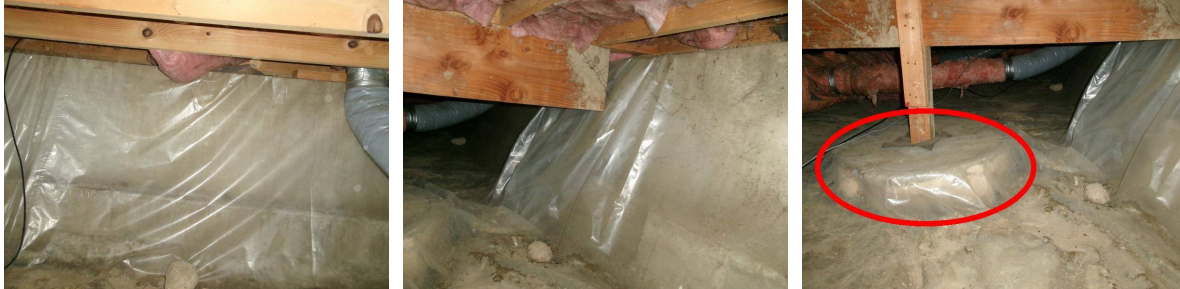
The foundation walls are covered with the plastic vapor retarder. This allows the transmission of water vapor from the soil up and into the exterior wall framing. The plastic vapor retarder should be removed from the foundation so that it covers at least 85% of the entire surface of the soil only.

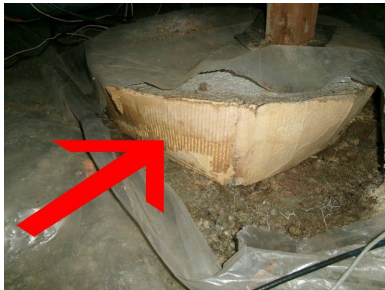
**PEST CONTROL**

Cellulose forms were left in place on the pier footings. This cellulose is conducive to the infestation of various wood destroying organisms. The removal of the cellulose is recommended.

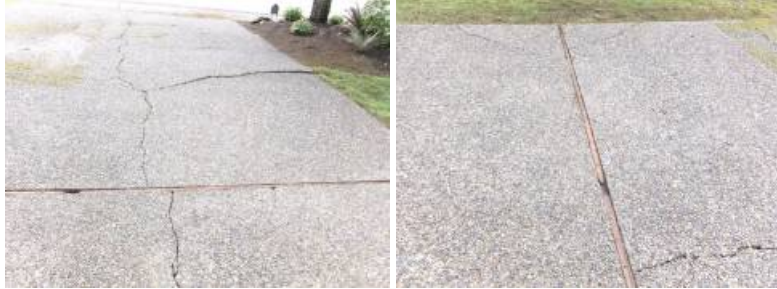
One or more of the wooden dividers separating the concrete driveway sections were infested by wood destroying organisms and have deteriorated to a point where they are becoming a trip hazard. Replacement with mortar is recommended.

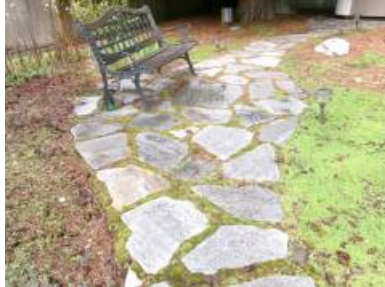
*PATIO*

The walking surface was not even and trip hazards were present. We recommend all walking surfaces be maintained free of trip hazards.

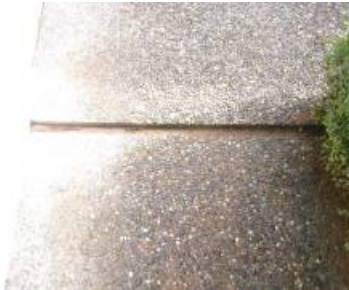
*WALKWAY*

Many legal and public works departments have defined a trip hazard as an irregularity in a walking surface exceeding one inch (1") in height. All walking surfaces should maintain, free of a vertical surface change of 3/4" or more, in the interest of public and personal safety.

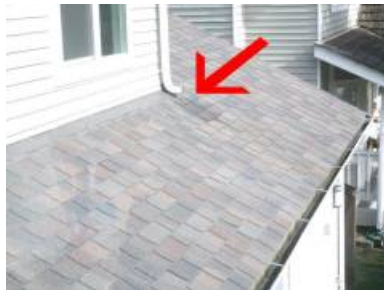
Downspouts draining directly onto the asphalt shingle surface causes excessive wear of the roofing material. Downspout extensions to the lower gutters should be installed to prevent excessive wear and tear of the roofing.

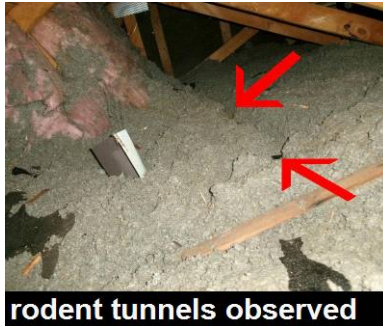
There is evidence of rodent activity in the attic. The first step in eliminating rodents from the attic is to seal all possible entry points using wire mesh, caulking, wood, stainless steel wool, or aerosol foam. Careful work sealing cracks, holes and gaps will discourage further activity. Once this work is completed, snap traps baited with peanut butter should be installed and monitored. The absence of rodents in the traps typically means that the rodents have been excluded from the area.

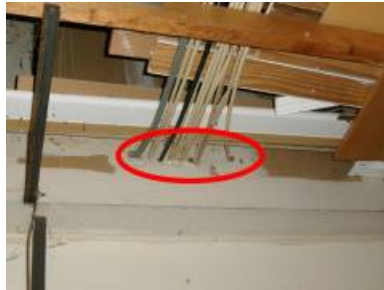
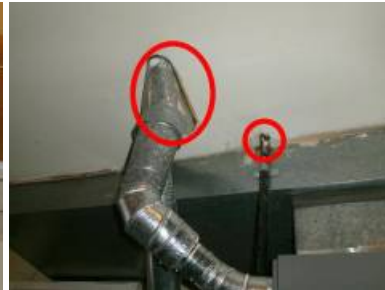
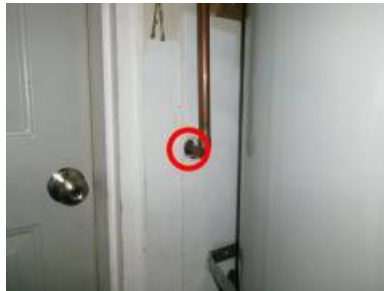
There are voids in the fire resistive barrier between the living space and garage that will allow flames to penetrate. The gypsum barrier slows the spread of a fire from the garage to the structure and/or living space. Patching the voids with a fire retardant caulk is recommended.

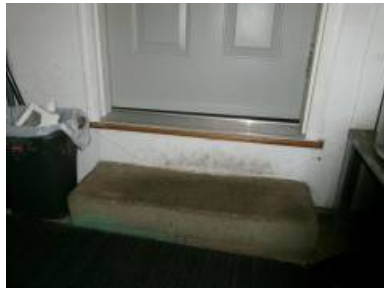
The garage steps are non-conforming due to the variable and/or excessive rise. Stair design standards require that stair risers do not exceed 8" and that the variation in rise not exceed 3/8" in order to reduce falls from tripping. To increase the margin of safety, consideration should be given to reconfiguring the steps so that rise and run do not vary by more than 3/8". If this proves to be too impractical or expensive, then we recommend exercising caution when using these steps.

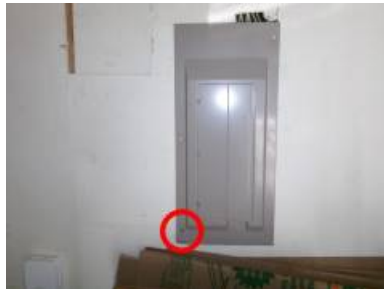
Screws that secure the panel cover to the panel box are missing. This is a potential hazard. Missing screws should be replaced with the original style blunt end screws.

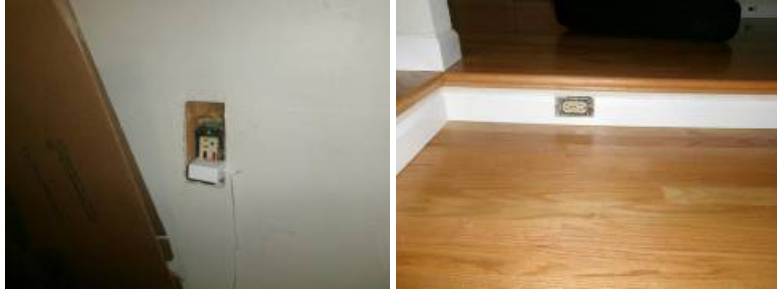
Cover plates are missing from several receptacles. This is a shock and fire hazard. The installation of cover plates on all receptacles is recommended.

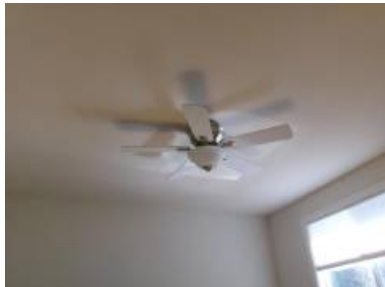
The bedroom ceiling fan/light remote was not present and its function was not verified.

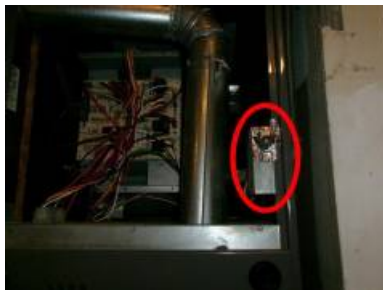
The blower door cut-out switch has been disabled. This is a potential hazard. The cut-out switch should be not be restricted.

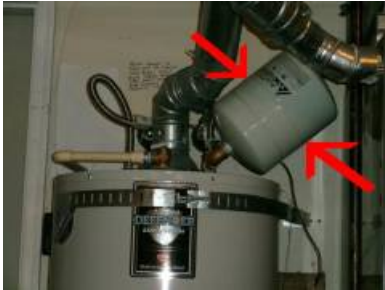
<i>LOCATION OF UNIT</i>	The water heater is located in the garage.
<i>GENERAL INFORMATION</i>	The water heater fuel is natural gas. The capacity of the water heater is 50 gallons. The input rating of the burner is approximately 40,000 BTU. The water heater is approximately 14 years old. Water heaters of this type typically last about 10-15 years.
<i>PRESSURE RELIEF VALVE</i>	The pressure relief valve is properly installed. The valve was not tested, as this could cause the valve to leak.
<i>SHUTOFF VALVE</i>	The shutoff valve for the water supply to the water heater is properly installed and is functioning as intended.
<i>WATER CONNECTIONS AT TANK</i>	The water connections at the tank are properly installed and are performing their intended function.
<i>EXPANSION TANK</i>	The expansion tank is not adequately secured to the wall. As code requirements start to call for engineered expansion tank supports we recommend the installation of seismic restraints to secure the expansion tank instead of allowing it to simply depend on piping connections that could result in damage to the water pipe and leakage during an earthquake.

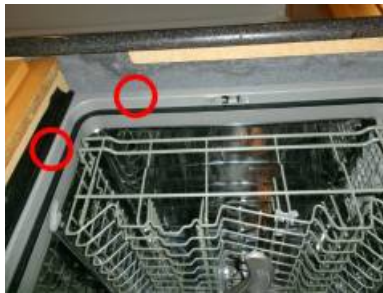
The dishwasher is not secured to the cabinet or countertop. This allows the appliance to move around. The dishwasher should be secured to the cabinet or to the bottom of the countertop in accordance with industry standards.

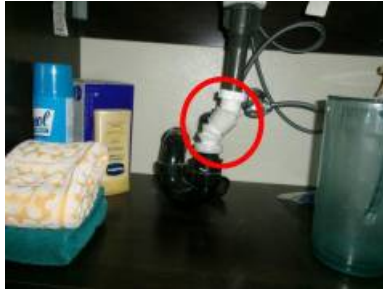
**DRAINS, TRAPS AND TRAP ARMS** Improper, non-conforming material has been used for the drain pipe fitting. This material will not function reliably. Replacement with industry standard fittings is recommended.

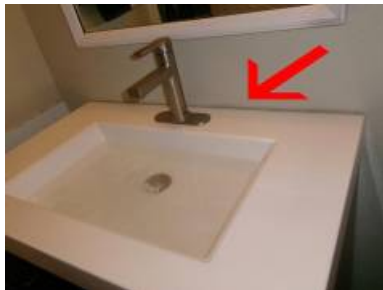
The backsplash is missing. The installation of a backsplash is recommended.

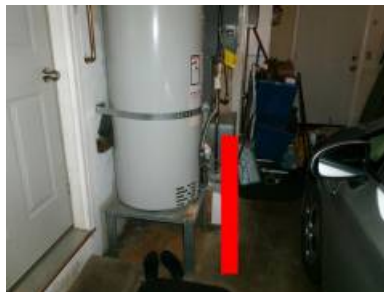
The gas pipes in front of the furnace and water heater are not protected by a bumper stop. A vertical steel pipe, bolted to the floor, is typically installed in front of the water heater to prevent a car bumper from damaging the gas lines.

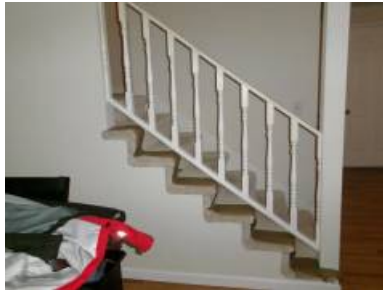
The stair railing baluster spacing is too wide. This is a hazard for small children. The baluster spacing should be reduced as a safety upgrade. Current standards require that a 4-3/8" sphere not pass through the railing.

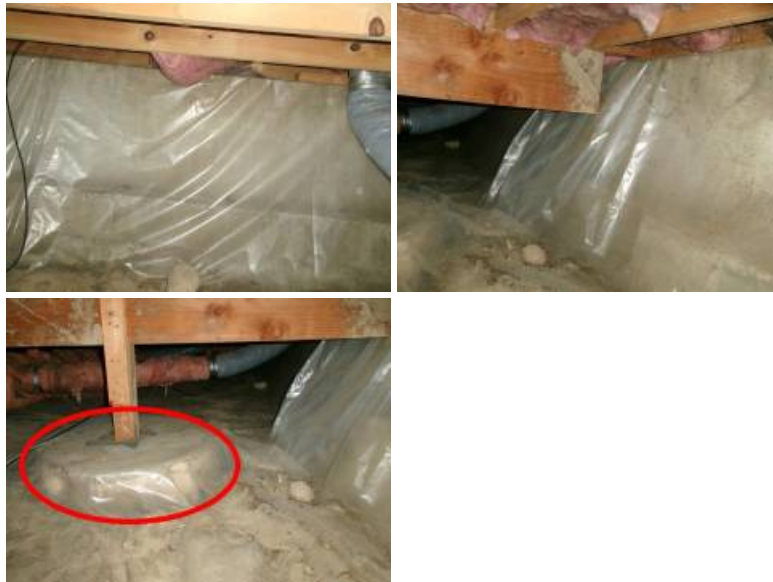
The foundation walls are covered with the plastic vapor retarder. This allows the transmission of water vapor from the soil up and into the exterior wall framing. The plastic vapor retarder should be removed from the foundation so that it covers at least 85% of the entire surface of the soil only.

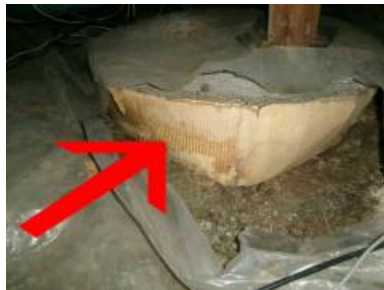
- PEST CONTROL*                            Cellulose forms were left in place on the pier footings. This cellulose is conducive to the infestation of various wood destroying organisms. The removal of the cellulose is recommended.

Good building practice requires that foundation walls or pier footings supporting wood frame construction, should extend at least 8" above the finish grade with at least a 6" clearance between the top of the soil and the bottom of the wood finish materials. Untreated wood should be raised 1-2" above surrounding flatwork and should have a moisture barrier such as 30 lb. asphalt impregnated felt installed between the concrete and wood. For additional information and treatment options, you should retain the services of a qualified pest control operator.
