NOTICE TO BUYER: SELLER-PROCURED INSPECTION REPORT

The following notice is given with respect to the Purchase and Sale Agreement dated _____ between _____ (“Buyer”) and **Estate of Mary K Howard** _____ (“Seller”) concerning **3671 225th Pl SE 1301 Issaquah WA 98029** (“the Property”).

Disposition of Pre-inspection Action Items

As written by Kellie Howard on the Howard Estate 3/14/24

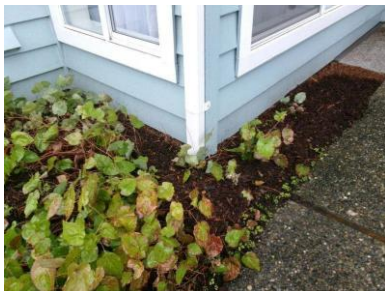
PEST CONTROL

Soil is close to or in contact with siding in some areas around the building exterior. Good building practice requires that foundation walls or pier footings supporting wood frame construction, extend at least 8" above the finish grade with at least a 6" clearance between the top of the soil and the bottom of the wood finish materials. Soil in direct contact with wood creates a hospitable environment for wood destroying organisms. Establishing these minimum clearances is recommended.

Both issues have been brought to the attention of the HOA. They fall under their responsibility.
