NOTICE TO BUYER: SELLER-PROCURED INSPECTION REPORT

March 2, 2025

Re: 17433 NE 139th Pl.
Redmond, WA.

At your request, a visual inspection of the above referenced property was conducted on 03/01/2025. We have inspected the major structural components, plumbing, heating and electrical systems for signs of significant non-performance, excessive or unusual wear and general state of repair.

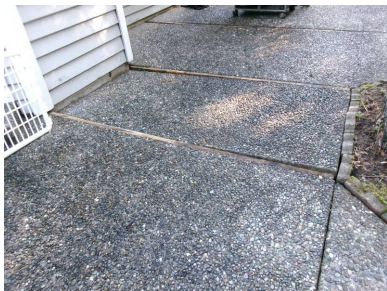
The patio has settled differentially. This was probably caused by inadequate preparation of the soil prior to the placement of the concrete. This condition can be repaired by pressure grouting the sunken portion of the patio or by removing and replacing it. The patio remains functional despite this condition. However, the raised edges of the concrete can be a trip hazard for some people. Repairs should be made as necessary.

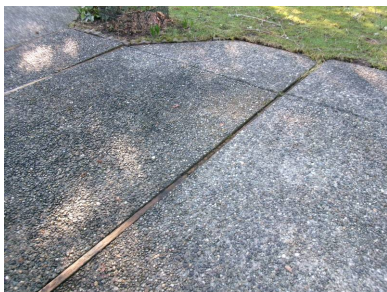
The wooden dividers separating the concrete patio sections have deteriorated to a point where the gaps are a trip hazard. Replacement with mortar is recommended.

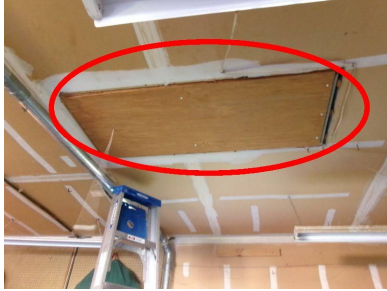
barrier on the ceiling slows the spread of a fire from the garage to the attic. The installation of a layer of 5/8" gypsum type X board over the 1/4" plywood is recommended.

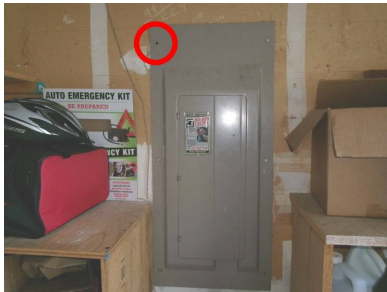
Screws that secure the panel cover to the panel box are missing. This is a potential hazard. Missing screws should be replaced with the original style blunt end screws.

- Passage door: Self-closing hinge installed.
- Electrical service panel: Missing screw replace.
- Receptacle with open ground: Fixed.
- Loose receptacles: Fixed.
- Kitchen receptacles: Replaced with GFCI.
- Water heater pressure relief valve: CPVC drain pipe installed.
- Soffit vent blocks: Gaps caulked.
- Chimney moss: removed.
- Kitchen countertop: Backsplash caulked.
- Powder room drain: Replaced with industry standard fitting.
- Primary bathroom shower: Sealing added at lower left corner.
- Garage window: Screen replaced.

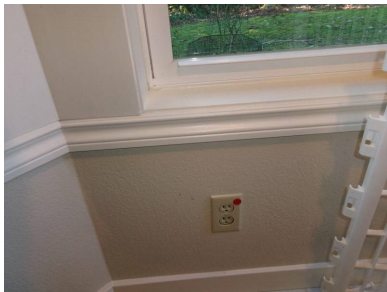
There are numerous loose receptacles throughout the home. This is a potential shock and a fire hazard. All loose receptacles should be repaired as necessary.

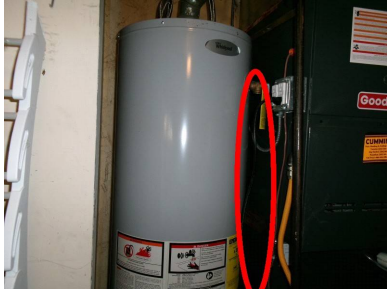
The pressure relief valve lacks a drain pipe. This is a scald hazard. The installation of a 3/4" copper, CPVC plastic or galvanized steel drain pipe is recommended. Ideally, the drain should be routed to the exterior. However, running the pipe straight down to the floor eliminates the scald hazard.

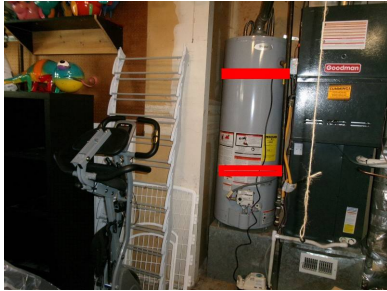
The water heater is not secured to the wall. A seismic restraint should be installed to secure the water heater and prevent it from falling over during an earthquake. This prevents the gas and water lines from rupturing.

- Water heater seismic restraint: Installed.

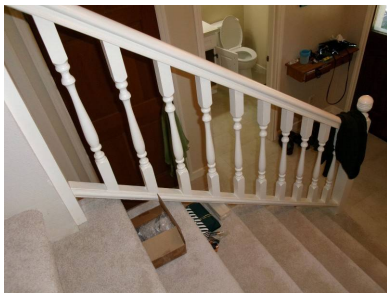
The stair railing baluster spacing is too wide. This is a hazard for small children. The baluster spacing should be reduced as a safety upgrade. Current standards require that a 4-3/8" sphere not pass through the railing.

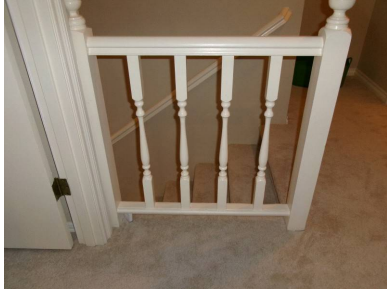
GUARD RAILINGS

The spacing between the balusters is too wide. This is a hazard to small children. The balusters should be

spaced close enough together so that a 4" sphere cannot pass through. Upgrading the guard railing is recommended if small children are present.

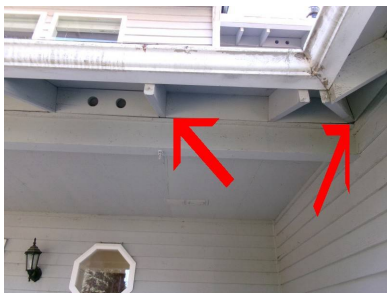
There are large gaps over 1/4" in size adjacent the soffit vent blocks. These gaps allow insects and rodents to enter the structure. Covering the gaps with screening, a strip of wood and/or caulking is recommended.

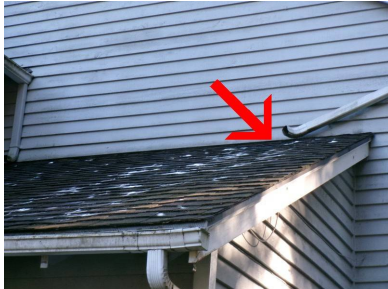
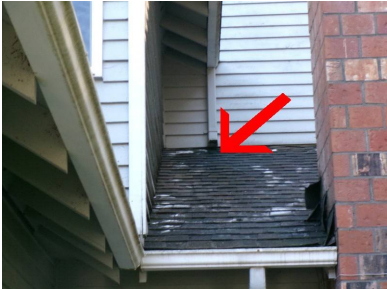
GUTTERS AND DOWNSPOUTS

Downspouts draining directly onto the asphalt shingle surface causes excessive wear of the roofing material. Downspout extensions to the lower gutters should be installed to prevent excessive wear and tear of the roofing.

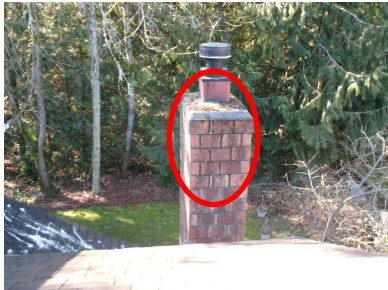
CHIMNEYS

Moss/vegetation was observed in several areas around the upper portion of the chimney. This will lead to accelerated deterioration of the brick masonry mortar. We recommend removal of all organic growth. Damaged areas can be repaired by filling in cutout or defective mortar joints with fresh mortar. (Tuck pointing)

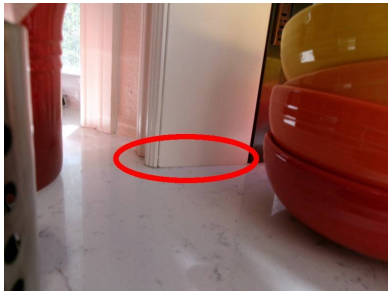
COUNTERTOPS

The backsplash is not caulked. This allows water and food to enter the gap between the back splash and counter and is difficult to clean. Caulking should be installed at this location.

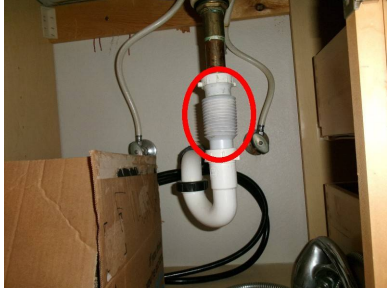
Improper, non-conforming material has been used for the drain pipe fitting. This material will not function reliably. Replacement with industry standard fittings is recommended.

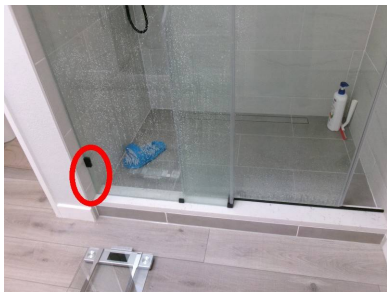
The glass enclosure has been leaking at the lower left corner. No damage was visible, but resealing or repairing the enclosure is recommended as preventive maintenance.

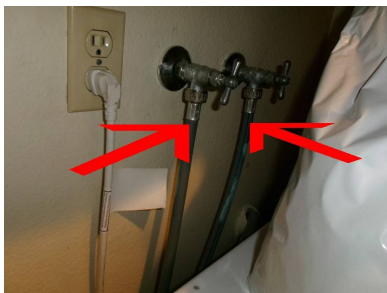
LAUNDRY ROOM
APPLIANCES

Upgrading the washer connections to high pressure (steel braided) lines is recommended.

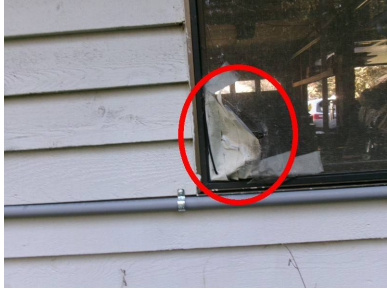
INTERIOR
WINDOWS

The garage window screen is damaged. Damaged screens should be repaired or replaced so that the window(s) can be left open for ventilation as designed.

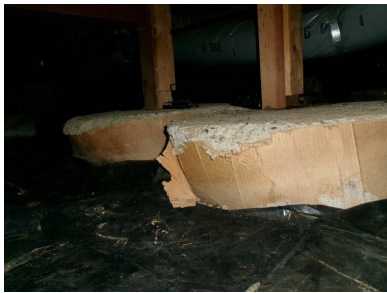
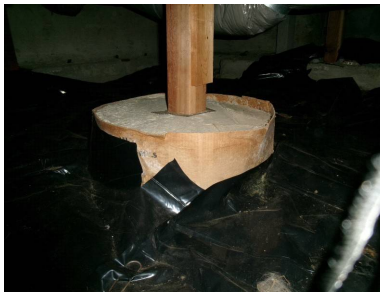
PEST CONTROL

Cellulose forms were left in place on the pier footings. This cellulose is conducive to the infestation of various wood destroying organisms. The removal of the cellulose is recommended.

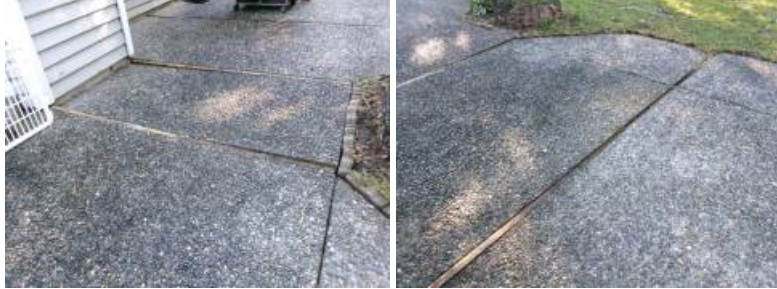
PATIO The patio has settled differentially. This was probably caused by inadequate preparation of the soil prior to the placement of the concrete. This condition can be repaired by pressure grouting the sunken portion of the patio or by removing and replacing it. The patio remains functional despite this condition. However, the raised edges of the concrete can be a trip hazard for some people. Repairs should be made as necessary.

The wooden dividers separating the concrete patio sections have deteriorated to a point where the gaps are a trip hazard. Replacement with mortar is recommended.

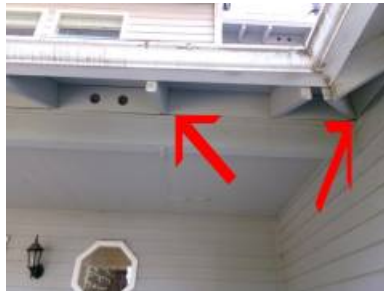
There are large gaps over 1/4" in size adjacent the soffit vent blocks. These gaps allow insects and rodents to enter the structure. Covering the gaps with screening, a strip of wood and/or caulking is recommended.

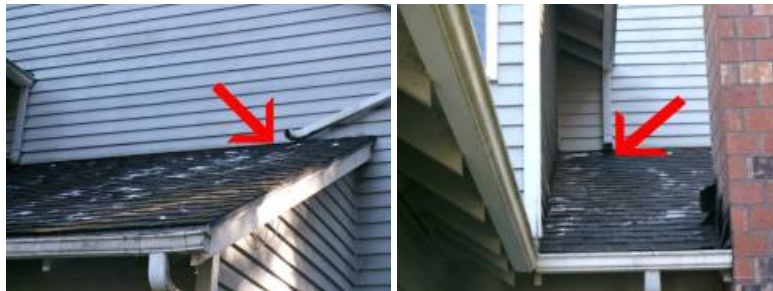
Downspouts draining directly onto the asphalt shingle surface causes excessive wear of the roofing material. Downspout extensions to the lower gutters should be installed to prevent excessive wear and tear of the roofing.

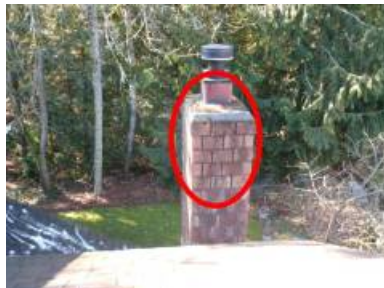
Moss/vegetation was observed in several areas around the upper portion of the chimney. This will lead to accelerated deterioration of the brick masonry mortar. We recommend removal of all organic growth. Damaged areas can be repaired by filling in cutout or defective mortar joints with fresh mortar. (Tuck pointing)

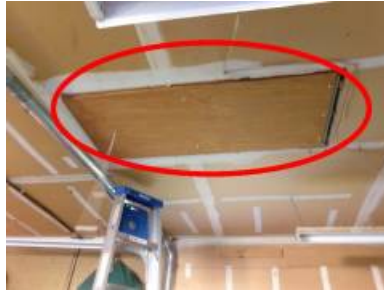
The pull down ladder is a breach in the fire resistive barrier in the garage. This is a safety concern. The gypsum barrier on the ceiling slows the spread of a fire from the garage to the attic. The installation of a layer of 5/8" gypsum type X board over the 1/4" plywood is recommended.

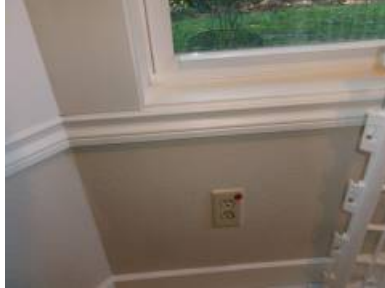
There are numerous loose receptacles throughout the home. This is a potential shock and a fire hazard. All loose receptacles should be repaired as necessary.

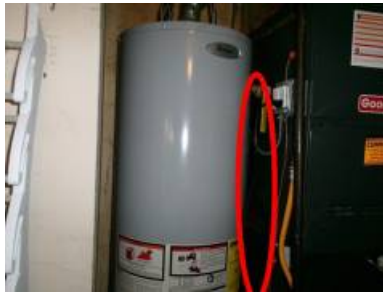
The pressure relief valve lacks a drain pipe. This is a scald hazard. The installation of a 3/4" copper, CPVC plastic or galvanized steel drain pipe is recommended. Ideally, the drain should be routed to the exterior. However, running the pipe straight down to the floor eliminates the scald hazard.

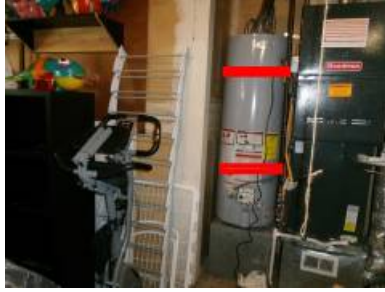
SEISMIC RESTRAINT The water heater is not secured to the wall. A seismic restraint should be installed to secure the water heater and prevent it from falling over during an earthquake. This prevents the gas and water lines from rupturing.

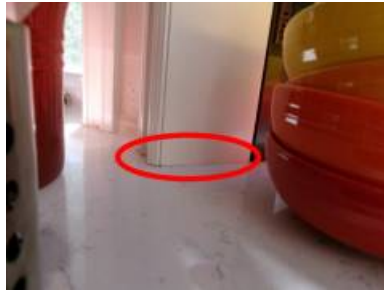
The backsplash is not caulked. This allows water and food to enter the gap between the back splash and counter and is difficult to clean. Caulking should be installed at this location.

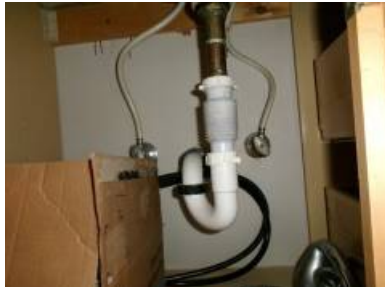
<i>LOCATION</i>	Upper Floor Hallway.
<i>BATHTUB</i>	The bathtub is properly installed and is in good condition.
<i>TUB WALLS</i>	The tub walls are properly installed and are in good condition. Most ceramic tile is applied directly over gypsum board rather than on a concrete board such as "Durock" or "Wonder Board". Where the tile is applied directly over the gypsum board, it is critical that the tile grout be maintained to prevent water intrusion behind the tile. Missing or cracked grout should be repaired. Inside corners, and penetrations in the tile should be kept sealed with a high quality caulk.
<i>FLOORING MATERIAL</i>	The floor is covered with ceramic tile. The tile is properly installed and is in good condition.
<i>TOILET</i>	The toilet was flushed and was functioning as intended.
<i>SINK</i>	The bathroom sink is properly installed and is in good condition.
<i>DRAINS, TRAPS AND TRAP ARMS</i>	The sink drain is properly installed and is performing its intended function. Improper, non-conforming material has been used for the drain pipe fitting. This material will not function reliably. Replacement with industry standard fittings is recommended.

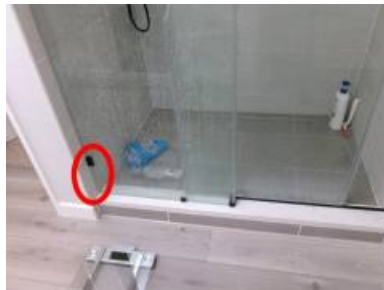
The glass enclosure has been leaking at the lower left corner. No damage was visible, but resealing or repairing the enclosure is recommended as preventive maintenance.

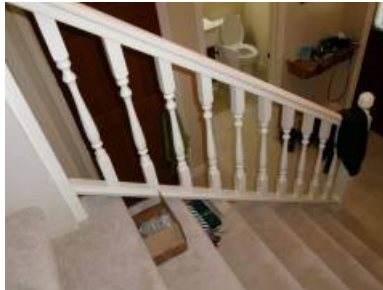
The stair railing baluster spacing is too wide. This is a hazard for small children. The baluster spacing should be reduced as a safety upgrade. Current standards require that a 4-3/8" sphere not pass through the railing.

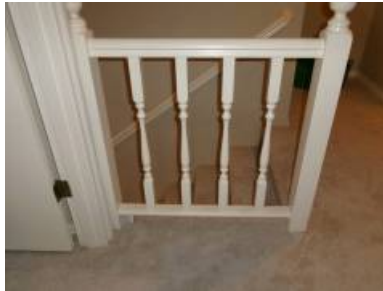
GUARD RAILINGS

The spacing between the balusters is too wide. This is a hazard to small children. The balusters should be spaced close enough together so that a 4" sphere cannot pass through. Upgrading the guard railing is recommended if small children are present.

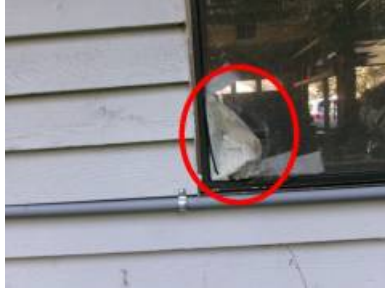
The garage window screen is damaged. Damaged screens should be repaired or replaced so that the window(s) can be left open for ventilation as designed.

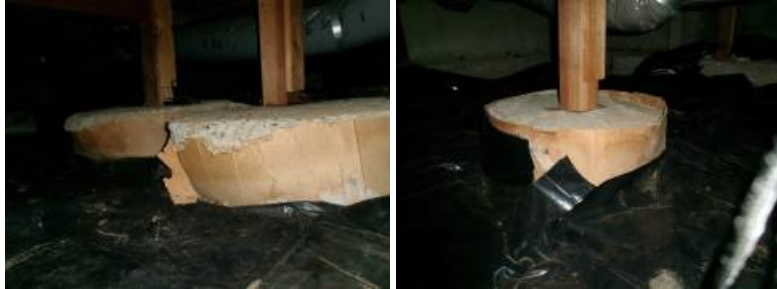
moisture barrier such as 30 lb. asphalt impregnated felt installed between the concrete and wood. For additional information and treatment options, you should retain the services of a qualified pest control operator.
