NOTICE TO BUYER: SELLER-PROCURED INSPECTION REPORT

13817 178th Ave NE

At your request, a visual inspection of the above referenced property was conducted on 12/11/2020. We have inspected the major structural components, plumbing, heating and electrical systems for signs of significant non-performance, excessive or unusual wear and general state of repair.

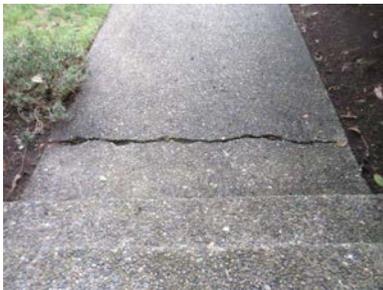
2.5 WALKWAY

The gaps separating the concrete walkway sections are a trip hazard. Replacement with mortar is recommended.

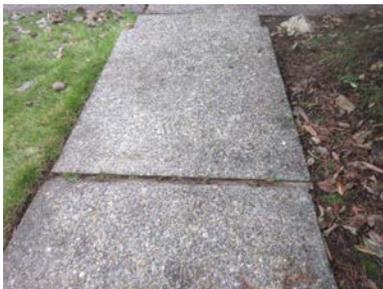
One or more of the wooden dividers separating the concrete walkway sections were infested by wood destroying organisms and have deteriorated to a point where they are becoming a trip hazard. Replacement with mortar is recommended.

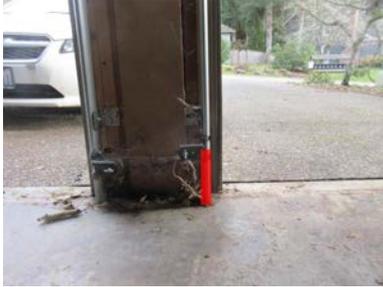
6.3 GARAGE DOOR OPENER

The Photo-eye beam for the south garage door was installed too high above the floor of the garage to adequately offer protection for small children and/or pets. We recommend that the photo-eye be lowered to within 4-6" of the floor.

6.3 Garage Door Opener. Photo-Eye beam has been lowered to within 4-6 inches of the floor.

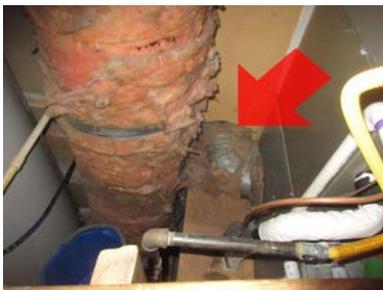
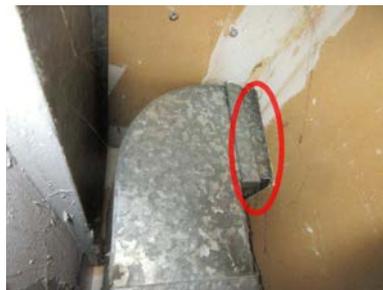
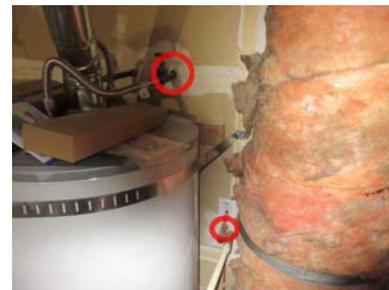
6.4 FIRE SEPARATION

There are voids in the fire resistive barrier between the living space and garage that will allow flames to penetrate. The gypsum barrier slows the spread of a fire from the garage to the structure and/or living space. Patching the voids with a fire retardant caulk is recommended.

6.4 Fire Separation. Voids filled with fire-retardant caulk or fire-retardant foam.

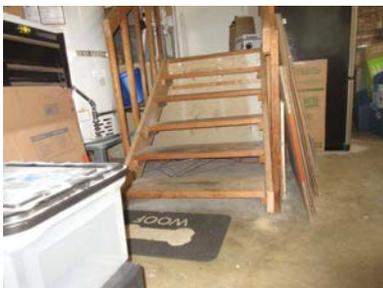
The stair rise spacing is too wide. This is a hazard for small children. The spacing should be reduced as a safety upgrade. Current standards require that a 4" sphere not pass through the opening.

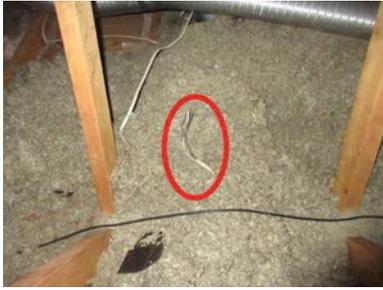
7.10 WIRING

There is an abandoned electrical cable with exposed conductors in the attic. This is a potential shock hazard. The cable should be terminated in a covered junction box or removed.

7.10 Wiring. Removed the abandoned cable.

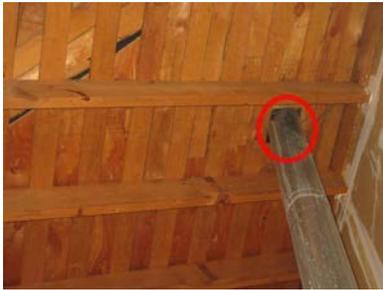
10.9 VENT

The water heater vent connector is too close to combustible material. The minimum clearance of 6" is required between the single wall vent connector and the combustible surface. The double wall type B vent requires only 1" of clearance.

10.9 Vent. Replace the current water heater vent with type B vent with 1" of clearance.

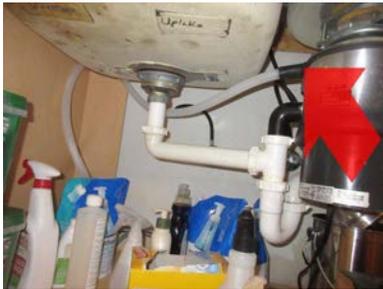
11.8 AIR GAP

The dishwasher drain lacks an air gap. The dishwasher will function without one, but there is a risk of contamination of the inside of the dishwasher by waste water. The installation of an air gap is recommended.

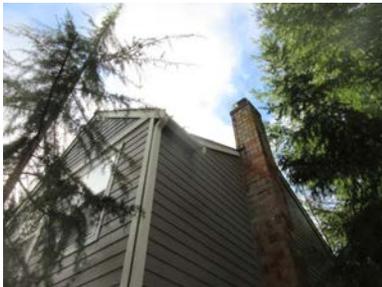
Trees are touching the building on the north and east sides. Low hanging tree branches can damage the roof, gutters, siding, doors and/or windows. Tree branches should be trimmed back where necessary.

2.3 Vegetation. Trim back the tree branches where necessary.

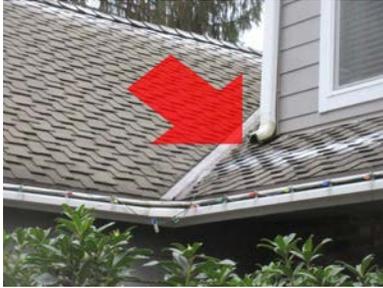
Downspouts draining directly onto the asphalt shingle surface causes excessive wear of the roofing material.

Downspout extensions to the lower gutters should be installed to prevent excessive wear and tear of the roofing.

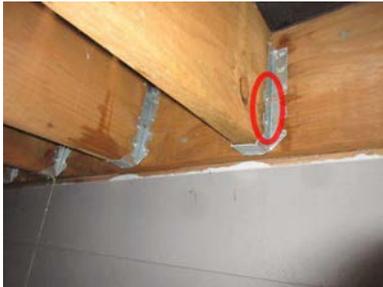
The deck support brackets are not secured with the specified fasteners recommended. The installation of 16d common nails or designed screws for the framing brackets is recommended.

The deck structure lacks lateral bracing. The installation of a diagonal brace underneath the deck is recommended.

3.8 Deck. Installed the specified fasteners in the deck support brackets.

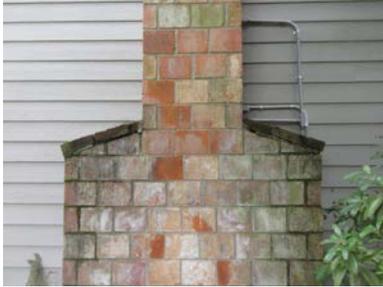
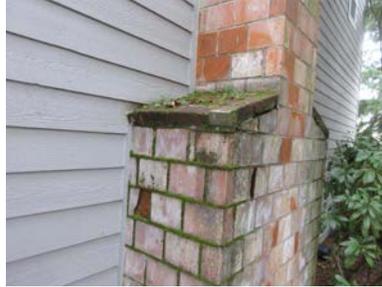
4.4 CHIMNEYS

Mortar was missing or deteriorated in the corbeled areas adjacent the chimney. This has led to accelerated deterioration of the brick masonry. Damaged areas can be repaired by filling in cutout or defective mortar joints with fresh mortar. (Tuck pointing)

The brick is spalling on the exposed portion of the chimney. Spalling occurs during the winter when the surface of the soft brick absorbs moisture and freezes. The water expands as it freezes causing the surface of the brick to flake off. Spalling can be prevented by applying a sealer to the surface of the brick. For maximum protection, the sealer should be reapplied every 2-3 years.

4.4 Chimneys. Repair missing mortar and seal the brick.

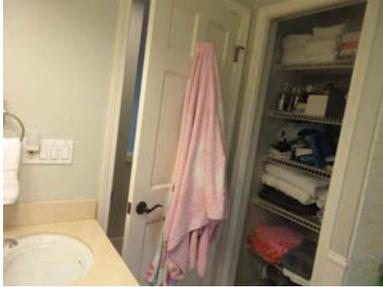
The closet door is missing in the hallway bathroom.

15.5 Closet Doors. Replace missing door in the hallway bathroom.

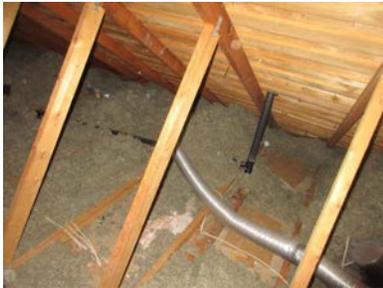
18.1 ATTIC INSULATION

There are several thermal bypasses in the attic. A thermal bypass is an opening between an insulated and uninsulated part of the house through which heated air can escape. As air is heated, it rises and pulls cool air in to the space to replace it. This condition will result in significant heat loss. Sealing up all thermal bypass routes is recommended.

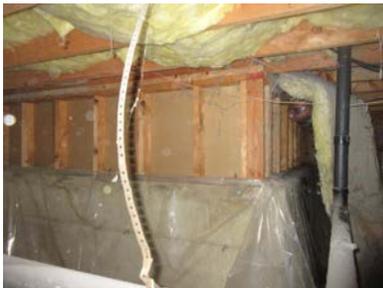
Shear panels are plywood or OSB panels that are mechanically fastened to both vertical and horizontal framing members in critical structural areas of the building. They prevent lateral movement of the structure during an earthquake. Shear panels are often visible in the crawlspace on cripple walls between the first floor and foundation. They may also be installed on interior walls that are covered with drywall. An examination of the crawlspace revealed the absence of shear panels on the cripple walls. The installation of shear panels on the cripple walls is recommended as an upgrade.

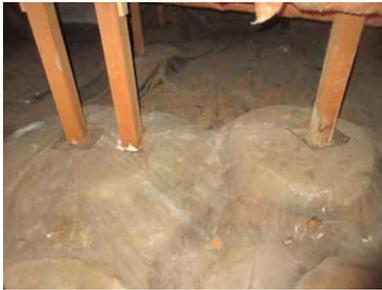
20.4 VAPOR RETARDER

The support post concrete piers are covered with the plastic vapor retarder. This allows the transmission of water vapor from the soil up and into the floor framing. The plastic vapor retarder should be removed from the pier so that it covers at least 85% of the entire surface of the soil only.

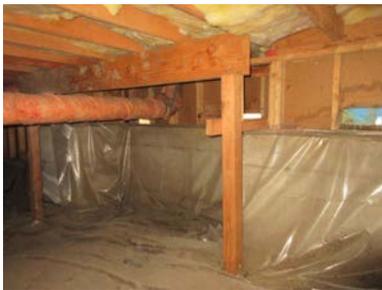
The foundation walls are covered with the plastic vapor retarder. This allows the transmission of water vapor from the soil up and into the exterior wall framing. The plastic vapor retarder should be removed from the foundation so that it covers at least 85% of the entire surface of the soil only.

The installation of a 6 mil black polyethylene plastic vapor retarder that covers at least 85% of the entire surface of the soil should be considered.

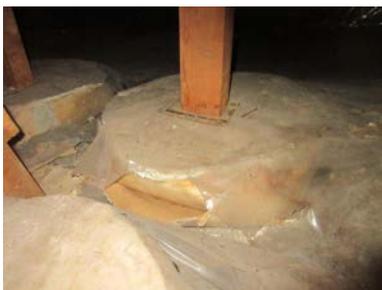
20.5 PEST CONTROL

Cellulose forms were left in place on the pier footings. This cellulose is conducive to the infestation of various wood destroying organisms. The removal of the cellulose is recommended.

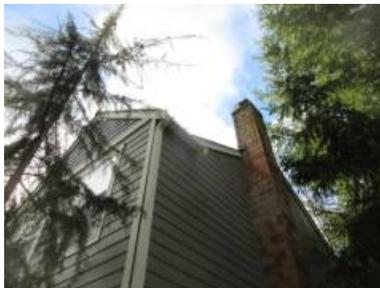
Trees are touching the building on the north and east sides. Low hanging tree branches can damage the roof, gutters, siding, doors and/or windows. Tree branches should be trimmed back where necessary.

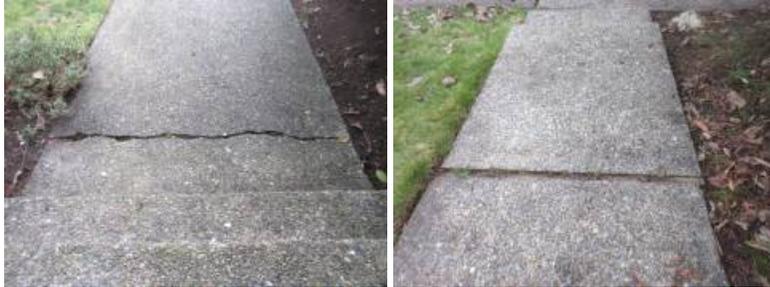
One or more of the wooden dividers separating the concrete walkway sections were infested by wood destroying organisms and have deteriorated to a point where they are becoming a trip hazard. Replacement with mortar is recommended.

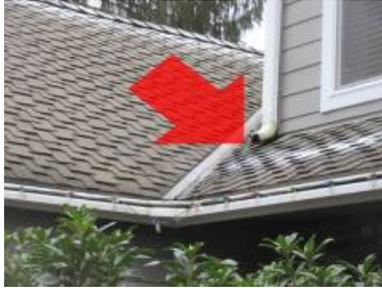
Downspouts draining directly onto the asphalt shingle surface causes excessive wear of the roofing material. Downspout extensions to the lower gutters should be installed to prevent excessive wear and tear of the roofing.

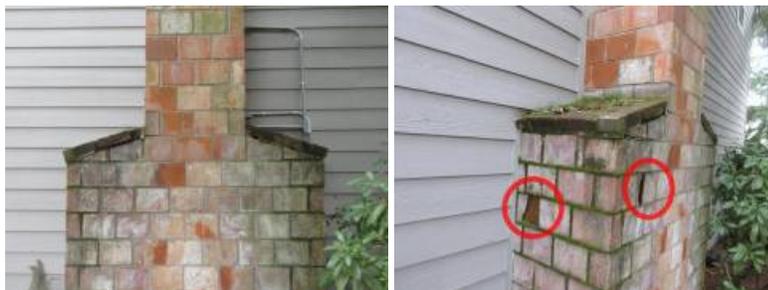
The brick is spalling on the exposed portion of the chimney. Spalling occurs during the winter when the surface of the soft brick absorbs moisture and freezes. The water expands as it freezes causing the surface of the brick to flake off. Spalling can be prevented by applying a sealer to the surface of the brick. For maximum protection, the sealer should be reapplied every 2-3 years.

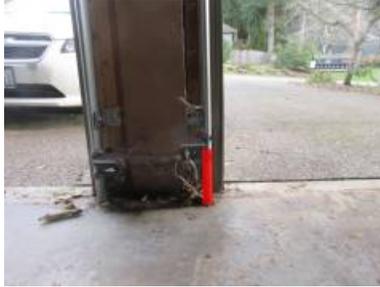
The Photo-eye beam for the south garage door was installed too high above the floor of the garage to adequately offer protection for small children and/or pets. We recommend that the photo-eye be lowered to within 4-6" of the floor.

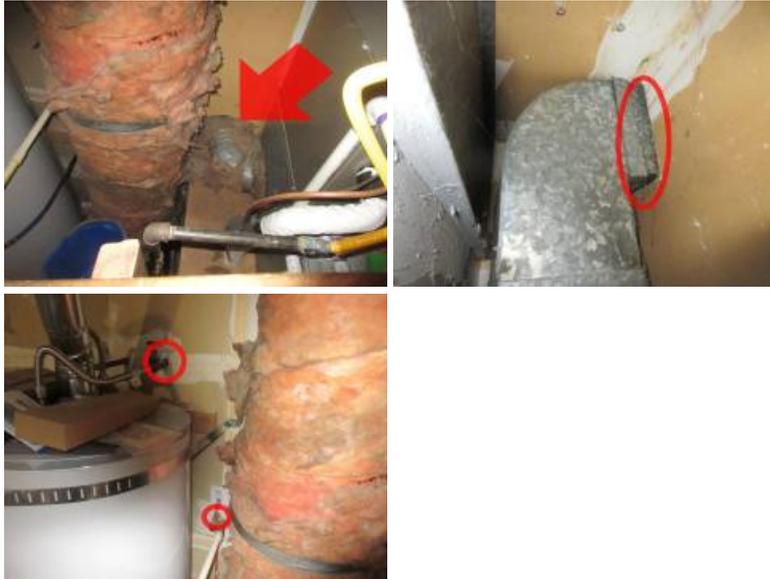
6.4 FIRE SEPARATION

There are voids in the fire resistive barrier between the living space and garage that will allow flames to penetrate. The gypsum barrier slows the spread of a fire from the garage to the structure and/or living space. Patching the voids with a fire retardant caulk is recommended.

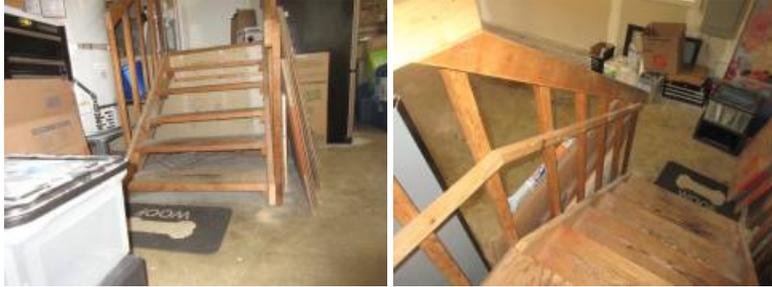
The stair railing baluster spacing is too wide. This is a hazard for small children. The baluster spacing should be reduced as a safety upgrade. Current standards require that a 4" sphere not pass through the railing.

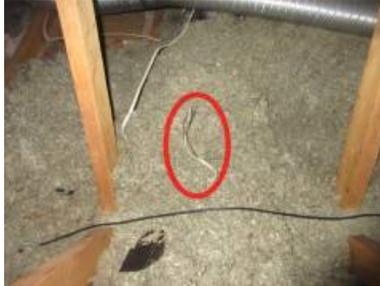
There is an abandoned electrical cable with exposed conductors in the attic. This is a potential shock hazard. The cable should be terminated in a covered junction box or removed.

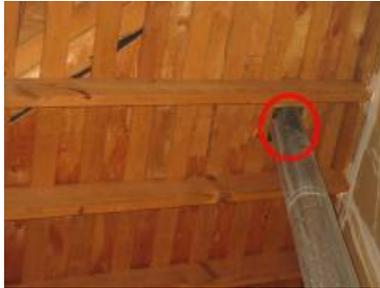
The water heater vent connector is too close to combustible material. The minimum clearance of 6" is required between the single wall vent connector and the combustible surface. The double wall type B vent requires only 1" of clearance.

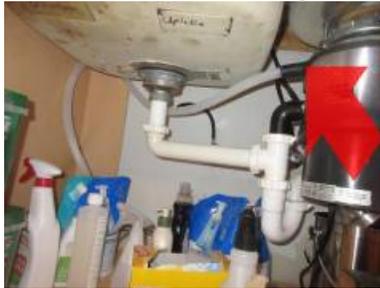
The dishwasher drain lacks an air gap. The dishwasher will function without one, but there is a risk of contamination of the inside of the dishwasher by waste water. The installation of an air gap is recommended.

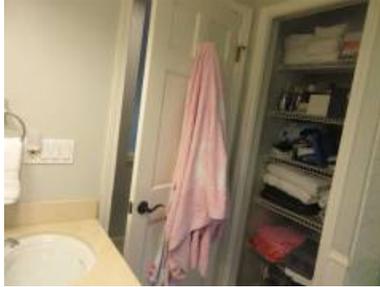
The closet door is missing in the hallway bathroom.

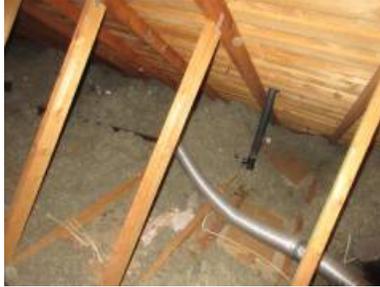
There are several thermal bypasses in the attic. A thermal bypass is an opening between an insulated and uninsulated part of the house through which heated air can escape. As air is heated, it rises and pulls cool air in to the space to replace it. This condition will result in significant heat loss. Sealing up all thermal bypass routes is recommended.

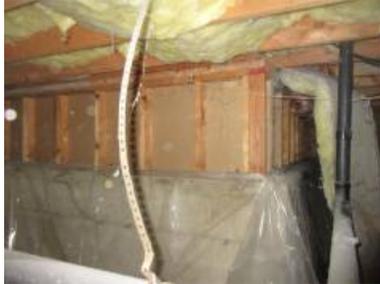
Shear panels are plywood or OSB panels that are mechanically fastened to both vertical and horizontal framing members in critical structural areas of the building. They prevent lateral movement of the structure during an earthquake. Shear panels are often visible in the crawlspace on cripple walls between the first floor and foundation. They may also be installed on interior walls that are covered with drywall. An examination of the crawlspace revealed the absence of shear panels on the cripple walls. The installation of shear panels on the cripple walls is recommended as an upgrade.

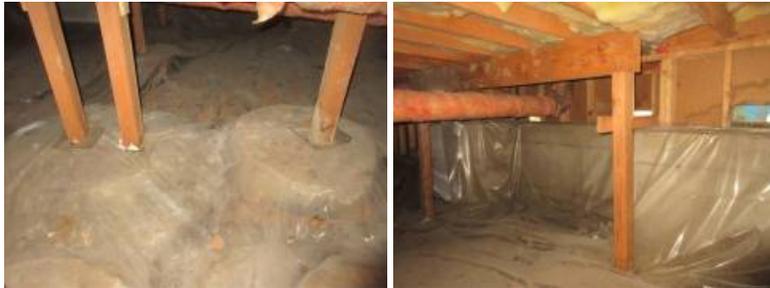
The installation of a 6 mil black polyethylene plastic vapor retarder that covers at least 85% of the entire surface of the soil should be considered.

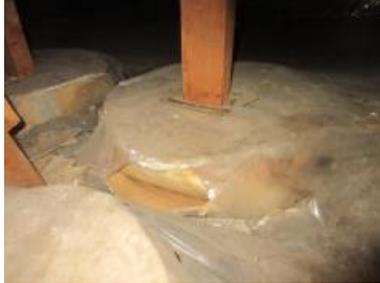
Good building practice requires that foundation walls or pier footings supporting wood frame construction, should extend at least 8" above the finish grade with at least a 6" clearance between the top of the soil and the bottom of the wood finish materials. Untreated wood should be raised 1-2" above surrounding flatwork and should have a moisture barrier such as 30 lb. asphalt impregnated felt installed between the concrete and wood. For additional information and treatment options, you should retain the services of a qualified pest control operator.
