**NOTICE TO BUYER: SELLER-PROCURED INSPECTION REPORT**

**Keith and Nancy Larson**

**14106 176<sup>th</sup> Ave NE**

At your request, a visual inspection of the above referenced property was conducted on 02/23/2021. We have inspected the major structural components, plumbing, heating and electrical systems for signs of significant non-performance, excessive or unusual wear and general state of repair.

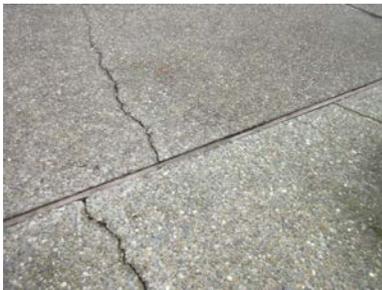
The driveway has cracked and settled differentially. This was probably caused by inadequate preparation of the soil prior to the placement of the concrete. This condition can be repaired by pressure grouting the sunken portion of the driveway or by removing and replacing it. The driveway remains functional despite this condition.

The wooden divider separating the concrete driveway sections has deteriorated to a point where it is a trip hazard. Replacement with mortar is recommended.

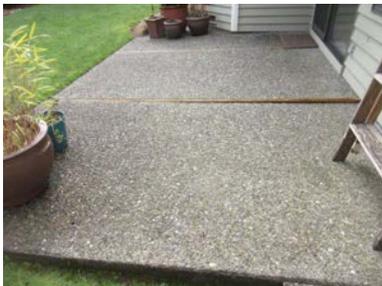
##### 2.5 PATIO

The patio has settled differentially. This was probably caused by inadequate preparation of the soil prior to the placement of the concrete. This condition can be repaired by pressure grouting the sunken portion of the patio or by removing and replacing it. The patio remains functional despite this condition. However, the raised edges of the concrete can be a trip hazard for some people. Repairs should be made as necessary.

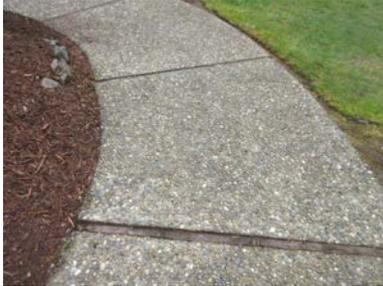
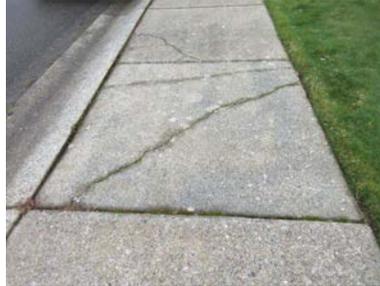
## 2.6 WALKWAY

The walkway has cracked and settled differentially. This was probably caused by inadequate preparation of the soil prior to the placement of the concrete. This condition can be repaired by pressure grouting the sunken portion of the walkway or by removing and replacing it. Grinding down the raised edges of the concrete will also mitigate the hazard. The walkway remains functional despite this condition. However, the raised edges of the concrete can be a trip hazard for some people. Repairs should be made as necessary.

One or more of the wooden dividers separating the concrete walkway sections were infested by wood destroying organisms and have deteriorated to a point where they are becoming a trip hazard. Replacement with mortar is recommended.

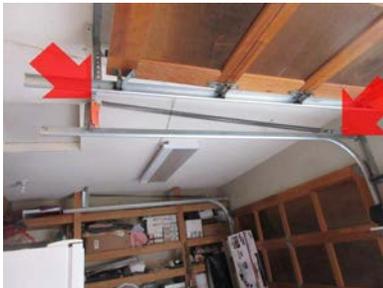
#### 6.2 OVERHEAD GARAGE DOORS

Safeties are cables run through the center of the garage door springs that prevent broken springs from becoming projectiles that can cause injury. There are no safeties installed. The installation of safeties is recommended.

**6.2 – Safeties (cables in spring of garage doors) were installed.**

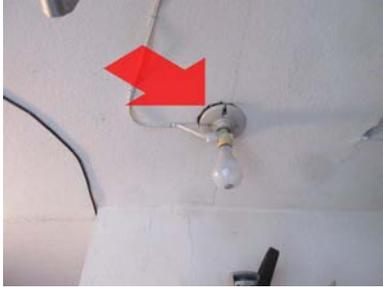
#### 6.4 FIRE SEPARATION

There are voids adjacent the luminaries in the fire resistive barrier between the living space and garage that will allow flames to penetrate. The gypsum barrier slows the spread of a fire from the garage to the structure and/or living space. Patching the voids with a fire retardant caulk is recommended.

**6.4 – Fire retardant caulking was completed.**

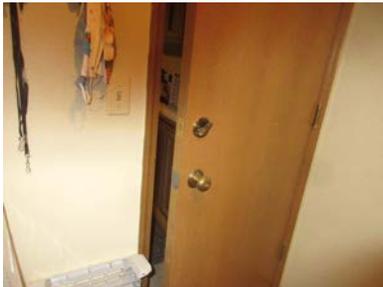
#### 6.5 PASSAGE DOOR

The self closing hinge has been disabled and therefore the door is no longer part of the fire rated assembly between the living space and garage. Resetting the self closing hinge spring is recommended.

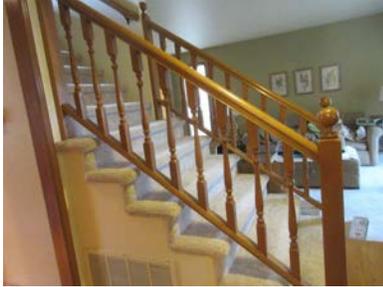
#### 14.2 STAIRS

The stair railing baluster spacing is too wide. This is a hazard for small children. The baluster spacing should be reduced as a safety upgrade. Current standards require that a 4" sphere not pass through the railing.

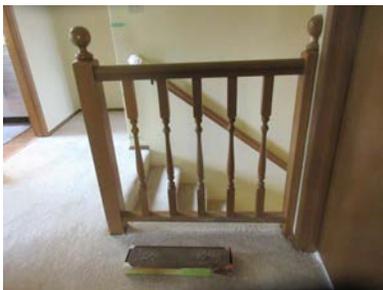
#### 14.3 GUARD RAILINGS

The spacing between the balusters is too wide. This is a hazard to small children. The balusters should be spaced close enough together so that a 4" sphere cannot pass through. Upgrading the guard railing is recommended if small children are present.

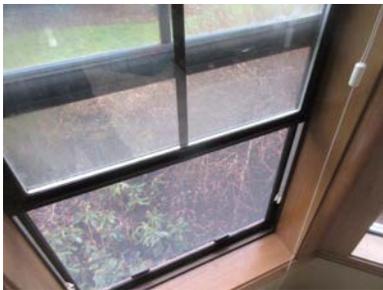
#### 14.7 WINDOWS

The lift assist mechanism for a two of the windows are in need of repair. The window should not be used until repairs are completed.

There is condensation or mineral deposits between the panes of glass in several of the insulated glass windows. This indicates failed seals. The glass assemblies should be replaced, which is the only method for correcting this deficiency.

**14. 7 – Glass panes were replaced on 19 windows with failed seals.**

**14.7 – Lift assist mechanisms for two windows will be repaired or replaced.**

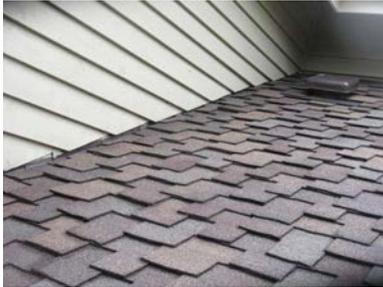
### **3.1 PRIMARY EXTERIOR WALL CLADDING**

The siding is vulnerable to damage where it has been close to or in contact with the roofing material. The siding should be modified and a minimum of a 2" clearance should be maintained between the top of the roofing and bottom of the siding.

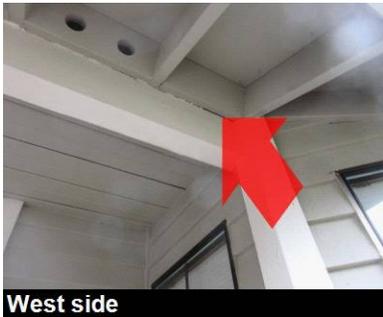
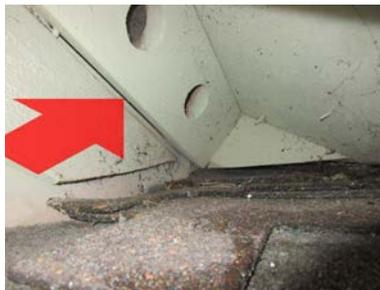
### **3.3 SOFFITS AND OVERHANGS**

There are large gaps over 1/4" in size adjacent the soffit vent blocks. These gaps allow insects and rodents to enter the attic. Covering the gaps with screening, a strip of wood and/or caulking is recommended.

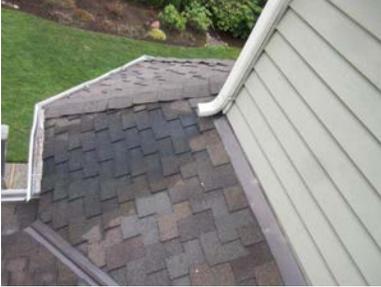
### **3.4 GUTTERS AND DOWNSPOUTS**

Downspouts draining directly onto the asphalt shingle surface causes excessive wear of the roofing material. Downspout extensions to the lower gutters should be installed to prevent excessive wear and tear of the roofing.

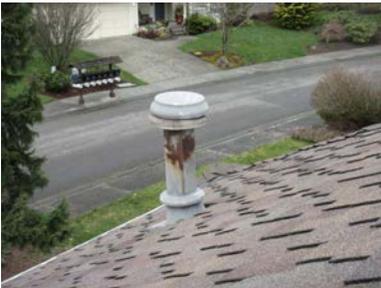
The gas appliance vent is corroded above the roof line. Cleaning and painting the vent will prolong its service life.

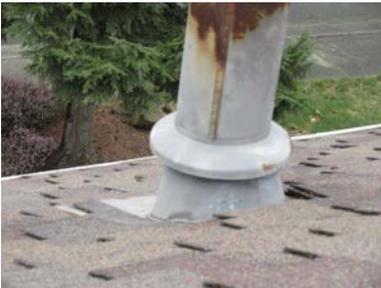
The storm collar is not sealed. This is allowing leakage to occur. Sealing the storm collar is recommended.

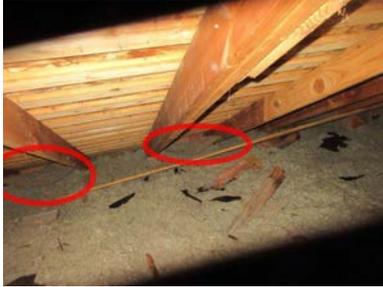
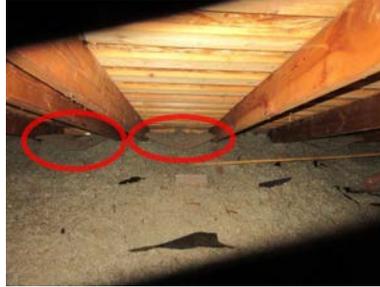
### 5.2 VENTILATION

Wind baffles locations are compromised in some areas of the attic. The proper placement of wind baffles in front of all soffit vents is recommended.

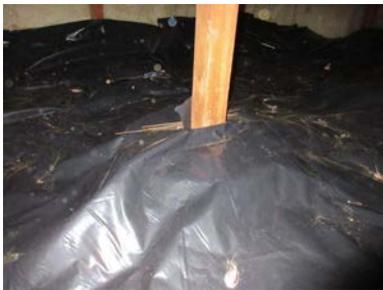
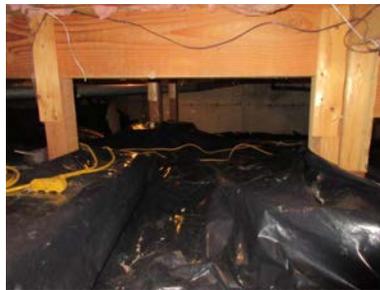
The support post concrete piers are covered with the plastic vapor retarder. This allows the transmission of water vapor from the soil up and into the floor framing. The plastic vapor retarder should be removed from the pier so that it covers at least 85% of the entire surface of the soil only.

**19.4 – Vapor barrier was removed from around support posts.**

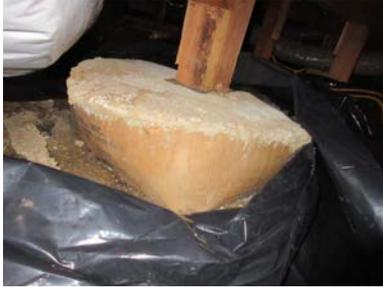
#### 19.5 PEST CONTROL

Scrap-wood and other cellulose debris was observed on the crawl floor. This wood debris creates conducive conditions for wood boring insects. The removal of all cellulose debris is recommended.

Cellulose forms were left in place on the pier footings. This cellulose is conducive to the infestation of various wood destroying organisms. The removal of the cellulose is recommended.

**19.5 – Wood debris removed from crawl floor.**

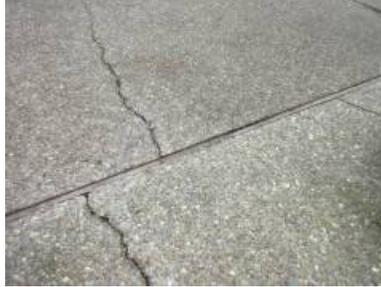
The wooden divider separating the concrete driveway sections has deteriorated to a point where it is a trip hazard. Replacement with mortar is recommended.

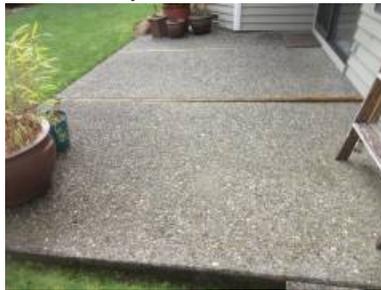
## 2.5 PATIO

The patio has settled differentially. This was probably caused by inadequate preparation of the soil prior to the placement of the concrete. This condition can be repaired by pressure grouting the sunken portion of the patio or by removing and replacing it. The patio remains functional despite this condition. However, the raised edges of the concrete can be a trip hazard for some people. Repairs should be made as necessary.

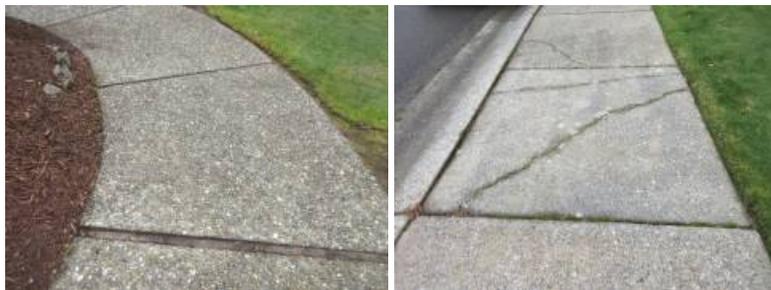
## 2.6 WALKWAY

The walkway has cracked and settled differentially. This was probably caused by inadequate preparation of the soil prior to the placement of the concrete. This condition can be repaired by pressure grouting the sunken portion of the walkway or by removing and replacing it. Grinding down the raised edges of the concrete will also mitigate the hazard. The walkway remains functional despite this condition. However, the raised edges of the concrete can be a trip hazard for some people. Repairs should be made as necessary.

Many legal and public works departments have defined a trip hazard as an irregularity in a walking surface exceeding one inch (1") in height. All walking surfaces should maintain, free of a vertical surface change of 3/4" or more, in the interest of public and personal safety.

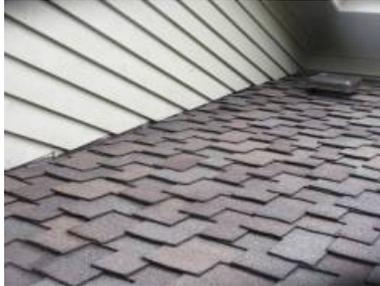
The siding is vulnerable to damage where it has been close to or in contact with the roofing material. The siding should be modified and a minimum of a 2" clearance should be maintained between the top of the roofing and bottom of the siding.

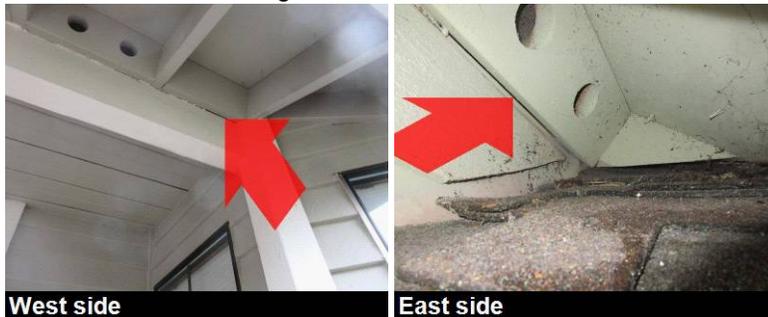
There are large gaps over 1/4" in size adjacent the soffit vent blocks. These gaps allow insects and rodents to enter the attic. Covering the gaps with screening, a strip of wood and/or caulking is recommended.

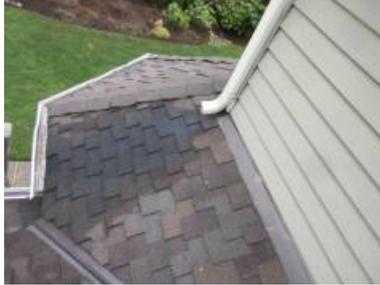
Downspouts draining directly onto the asphalt shingle surface causes excessive wear of the roofing material. Downspout extensions to the lower gutters should be installed to prevent excessive wear and tear of the roofing.

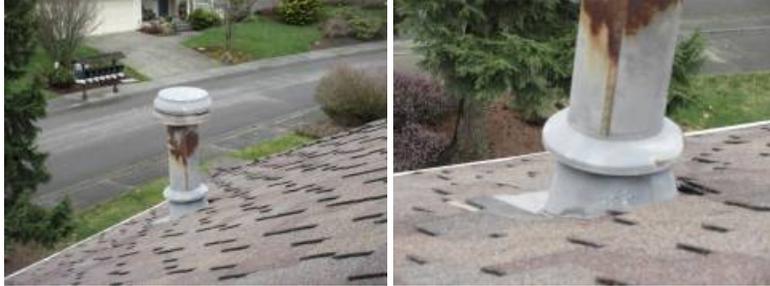
The storm collar is not sealed. This is allowing leakage to occur. Sealing the storm collar is recommended.

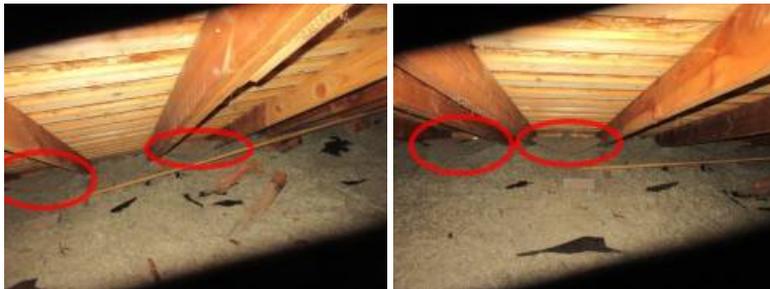
Wind baffles locations are compromised in some areas of the attic. The proper placement of wind baffles in front of all soffit vents is recommended.

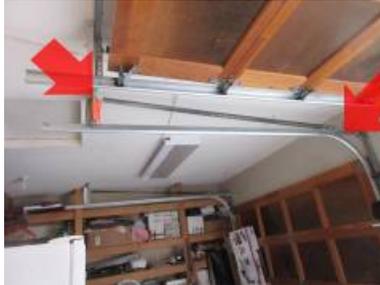
Safeties are cables run through the center of the garage door springs that prevent broken springs from becoming projectiles that can cause injury. There are no safeties installed. The installation of safeties is recommended.

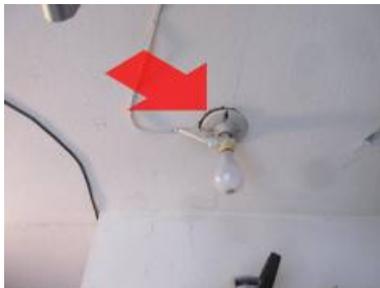
There are voids adjacent the luminaries in the fire resistive barrier between the living space and garage that will allow flames to penetrate. The gypsum barrier slows the spread of a fire from the garage to the structure and/or living space. Patching the voids with a fire retardant caulk is recommended.

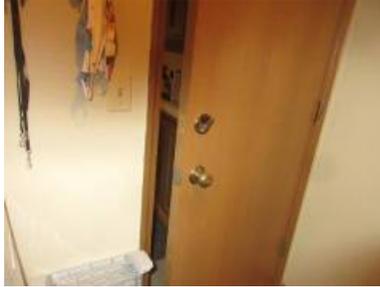
## 6.5 PASSAGE DOOR

The self closing hinge has been disabled and therefore the door is no longer part of the fire rated assembly between the living space and garage. Resetting the self closing hinge spring is recommended.

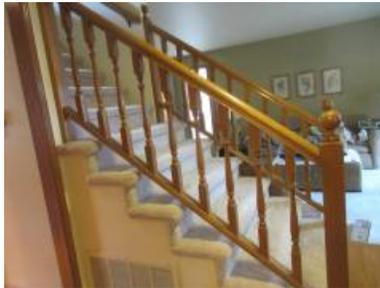
The stair railing baluster spacing is too wide. This is a hazard for small children. The baluster spacing should be reduced as a safety upgrade. Current standards require that a 4" sphere not pass through the railing.

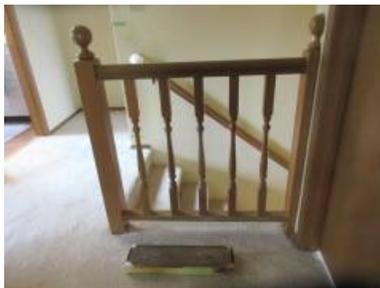
### 14.3 GUARD RAILINGS

The spacing between the balusters is too wide. This is a hazard to small children. The balusters should be spaced close enough together so that a 4" sphere cannot pass through. Upgrading the guard railing is recommended if small children are present.

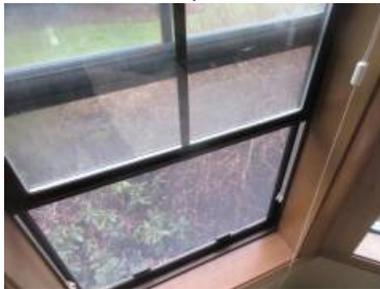
There is condensation or mineral deposits between the panes of glass in several of the insulated glass windows. This indicates failed seals. The glass assemblies should be replaced, which is the only method for correcting this deficiency.

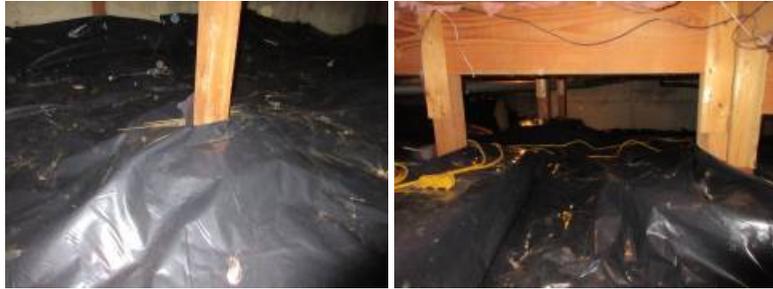
The support post concrete piers are covered with the plastic vapor retarder. This allows the transmission of water vapor from the soil up and into the floor framing. The plastic vapor retarder should be removed from the pier so that it covers at least 85% of the entire surface of the soil only.

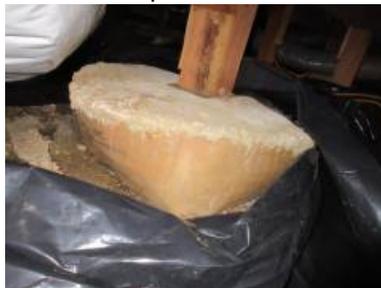
Good building practice requires that foundation walls or pier footings supporting wood frame construction, should extend at least 8" above the finish grade with at least a 6" clearance between the top of the soil and the bottom of the wood finish materials. Untreated wood should be raised 1-2" above surrounding flatwork and should have a moisture barrier such as 30 lb. asphalt impregnated felt installed between the concrete and wood. For additional information and treatment options, you should retain the services of a qualified pest control operator.
