**NOTICE TO BUYER: SELLER-PROCURED INSPECTION REPORT**

Jim and Maryann Purkey  
17042 NE 133rd St  
Redmond, WA 98052

April 21, 2021

**Mr. & Mrs. Jim & Maryann Purkey  
17042 NE133rd St.  
Redmond, WA.**

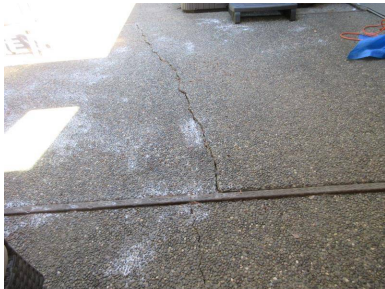
The patio has settled differentially. This was probably caused by inadequate preparation of the soil prior to the placement of the concrete. This condition can be repaired by pressure grouting the sunken portion of the patio or by removing and replacing it. The patio remains functional despite this condition. However, the raised edges of the concrete can be a trip hazard for some people. Repairs should be made as necessary.

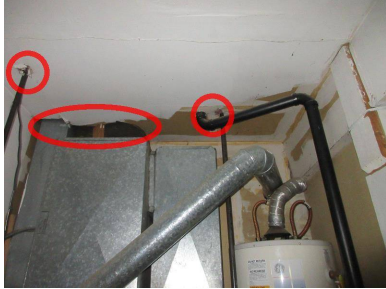
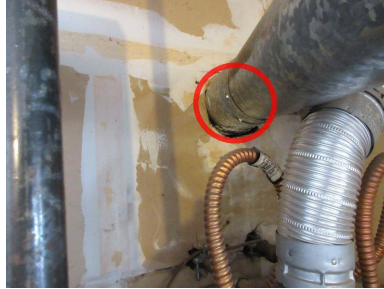
There are voids in the fire resistive barrier between the living space and garage that will allow flames to penetrate. The gypsum barrier slows the spread of a fire from the garage to the structure and/or living space. Patching the voids with a fire retardant caulk is recommended.

The installation of a furnace vent thimble is recommended to prevent flames to spread to the structure.

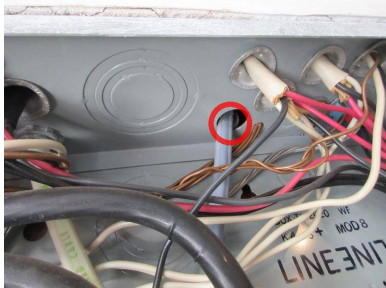
There is an electrical cable emanating from the service panel that is not clamped. The sharp edge of the panel box could cut through the wire insulation and cause a short circuit or fire. Clamping the cable to the panel box using an approved cable clamp is recommended.

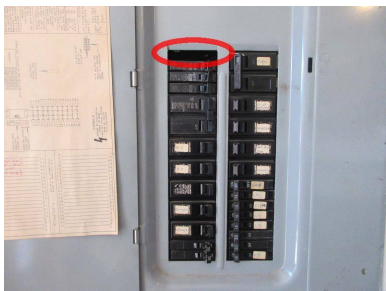
Twist-outs are missing from the service panel cover. This exposes live conductors and is a shock hazard. The installation of snap-in replacement blanks is recommended.

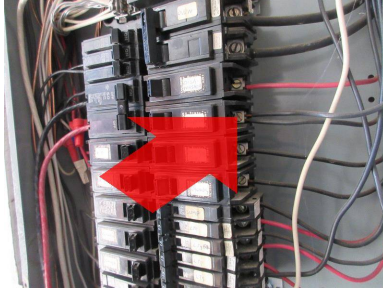
#### 7.9 OVER CURRENT PROTECTION

One of the circuits is double tapped. Double tapping means that two conductors share a single terminal. Double tapped terminals can loosen and overheat and therefore are not permitted unless the terminal is specifically listed for multiple wires. This defect is easily repaired by connecting the two wires to a "pig tail", securing them with a wire cap, and then inserting the pig tail conductor under the terminal.

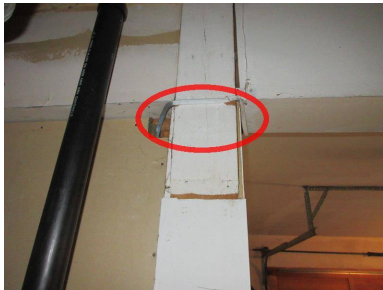
#### 7.10 WIRING

There is Romex cable in the garage that is run over the surface of the wall. This cable is vulnerable to damage. The cable should be relocated or protected in conduit.

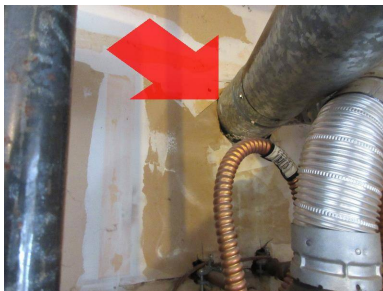
The furnace vent connector is too close to a combustible material. This is a hazard. A minimum clearance of 6" is required between the single wall vent connector and the combustible material. The double wall type B vent requires only 1" of clearance. Repairs are recommended.

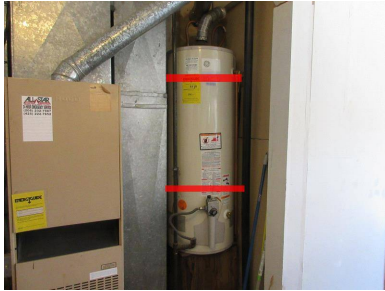
The water heater is not secured to the wall. A seismic restraint should be installed to secure the water heater and prevent it from falling over during an earthquake. This prevents the gas and water lines from rupturing.

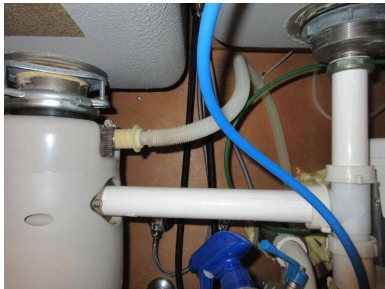
The dishwasher drain lacks an air gap. The dishwasher will function without one, but there is a risk of contamination of the inside of the dishwasher by waste water. The installation of an air gap is recommended.

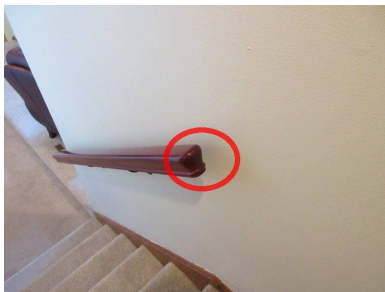
The railing ends in the stairwell does not return to the wall. This is a safety hazard. The installation of a continuous handrail should be considered as a safety upgrade.

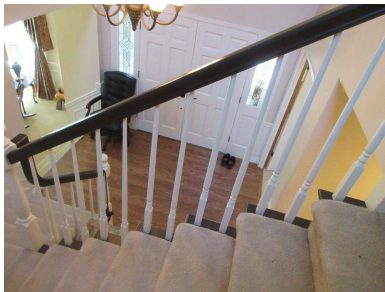
The stair railing baluster spacing is too wide. This is a hazard for small children. The baluster spacing should be reduced as a safety upgrade. Current standards require that a 4" sphere not pass through the railing.

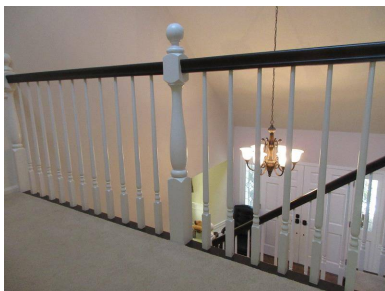
#### ***14.3 GUARD RAILINGS***

The spacing between the balusters is too wide. This is a hazard to small children. The balusters should be spaced close enough together so that a 4" sphere cannot pass through. Upgrading the guard railing is recommended if small children are present.

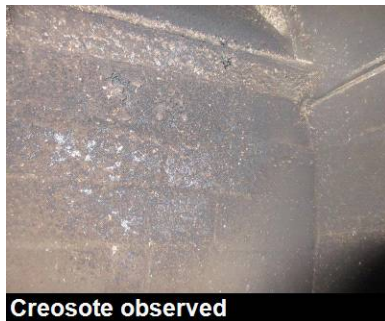
An examination of the inside of the family room chimney revealed a noticeable accumulation of creosote. Smoldering fires and the burning of green or wet wood are the primary contributors to creosote build-up. Creosote in a chimney flue is dangerous because it is the fuel for a chimney fire. Chimney fires produce intense heat and sparks. The intense heat can crack the flue tile, brick and mortar of a masonry chimney. After holes or cracks have developed, chimney fires can cause the wood framing or roof of the house to catch on fire. To avoid chimney fires, flues should be cleaned and inspected at least once a year with moderate use. More frequent cleaning may be required depending on amount of use and burning practice.

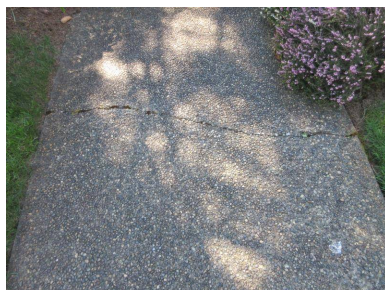
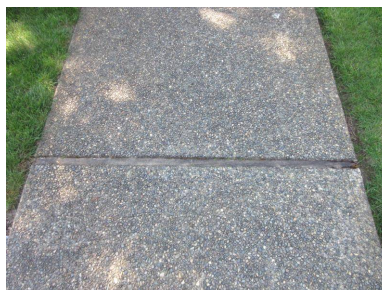
When the wooden dividers separating the concrete walkway sections have deteriorated to a point where they become a trip hazard. Replacement with mortar is recommended.

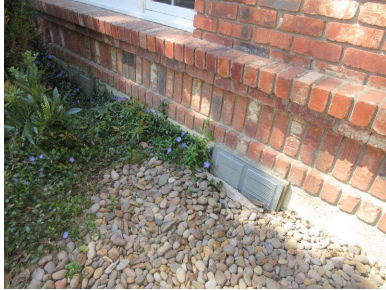
### 3.2 SECONDARY EXTERIOR WALL CLADDING

The brick is a veneer installed over the wood wall structure. It is not a structural component of the wall. Weep holes are missing at the bottom of the masonry wall. This allows moisture to become trapped behind the brick. Weep holes are recommended to mitigate moisture damage.

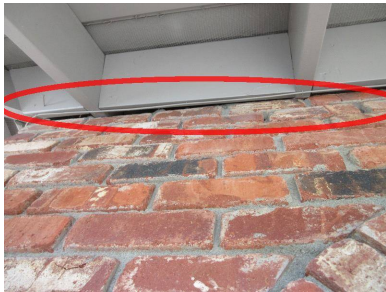
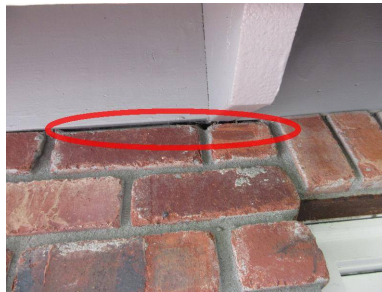
### 3.4 SOFFITS AND OVERHANGS

There are large gaps over 1/4" in size adjacent the soffit vent blocks and the brick cladding. These gaps allow insects and rodents to enter the attic. Covering the gaps with screening, a strip of wood and/or caulking is recommended.

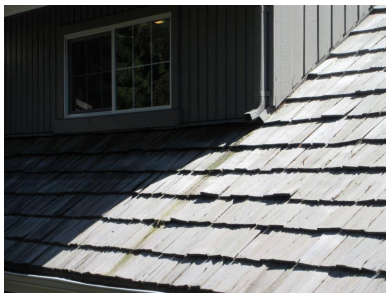
### 3.5 GUTTERS AND DOWNSPOUTS

Downspouts draining directly onto the wood shingle surface causes excessive wear of the roofing material. Downspout extensions to the lower gutters should be installed to prevent excessive wear and tear of the roofing.

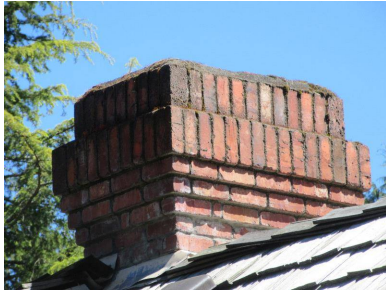
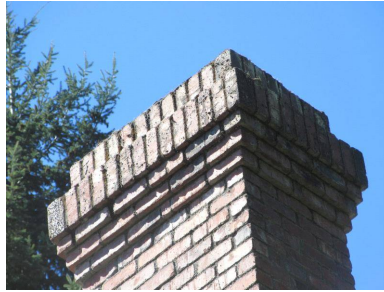
Moss/vegetation was observed in several areas around the upper portions of the chimneys. This will lead to accelerated deterioration of the brick masonry mortar. We recommend removal of all organic growth. Damaged areas can be repaired by filling in cutout or defective mortar joints with fresh mortar. (Tuck pointing)

The chimney crowns are cracked. The mortar chimney crowns prevent water from entering and damaging the

masonry. Repairing or replacing the chimney crowns will extend the service life of the chimneys.

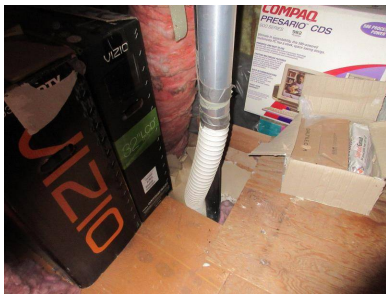
Flexible plastic duct is used to direct air from the vent fan to the exterior. This type of material is unreliable. Replacing the plastic duct with 4" smooth-wall sheet metal duct is recommended.

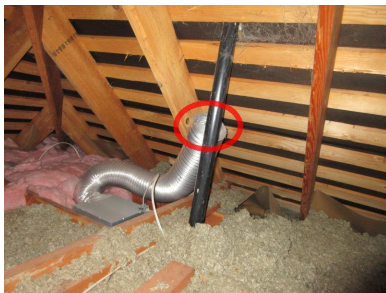
The master bedroom bathroom vent fan discharges in the attic rather than outside. This is an undesirable condition that causes excessive moisture in the attic and can result in mold or fungus growth. A 4" smooth-wall sheet metal duct should be installed to direct the moisture laden air discharged from the fan out of the attic.

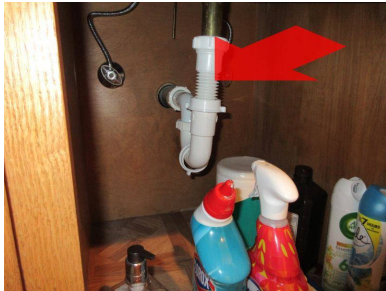
Improper, non-conforming material has been used for the drain pipe fitting. This material will not function reliably. Replacement with industry standard fittings is recommended.

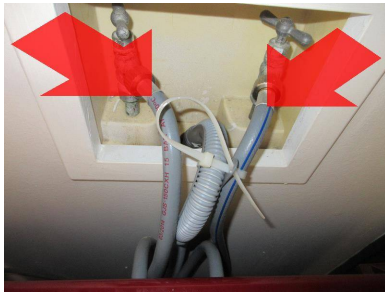
Upgrading the washer connections to high pressure (steel braided) lines is recommended.

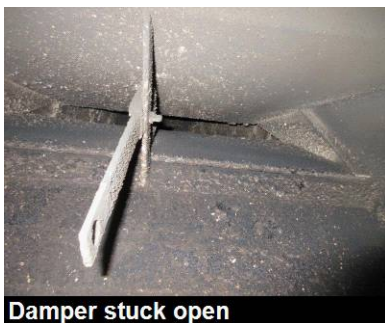
The family room fireplace damper is stuck in the open position. This allows heat to escape up the chimney and could result in odors emanating from the fireplace. Repairing the damper is recommended.

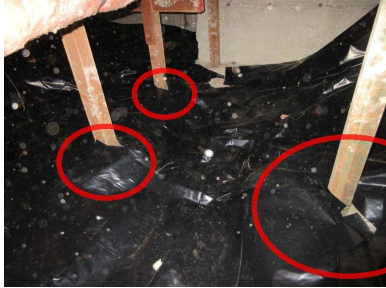
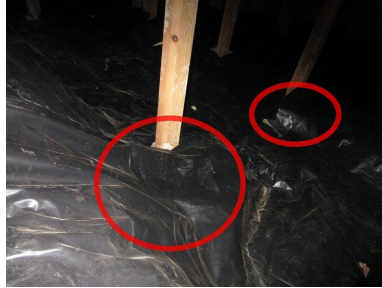
The support post concrete piers are covered with the plastic vapor retarder. This allows the transmission of water vapor from the soil up and into the floor framing. The plastic vapor retarder should be removed from the pier so that it covers at least 85% of the entire surface of the soil only.

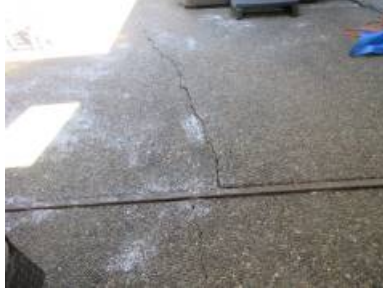
The patio has settled differentially. This was probably caused by inadequate preparation of the soil prior to the placement of the concrete. This condition can be repaired by pressure grouting the sunken portion of the patio or by removing and replacing it. The patio remains functional despite this condition. However, the raised edges of the concrete can be a trip hazard for some people. Repairs should be made as necessary.

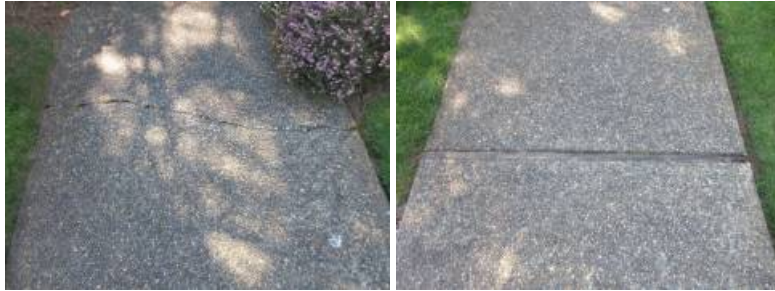
## 2.6 WALKWAY

Many legal and public works departments have defined a trip hazard as an irregularity in a walking surface exceeding one inch (1") in height. All walking surfaces should maintain, free of a vertical surface change of 3/4" or more, in the interest of public and personal safety.

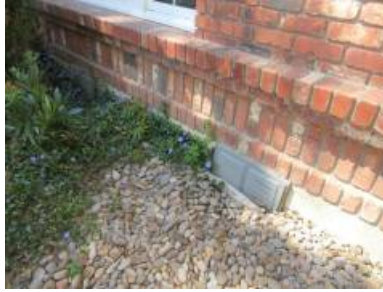
recommended to mitigate moisture damage.

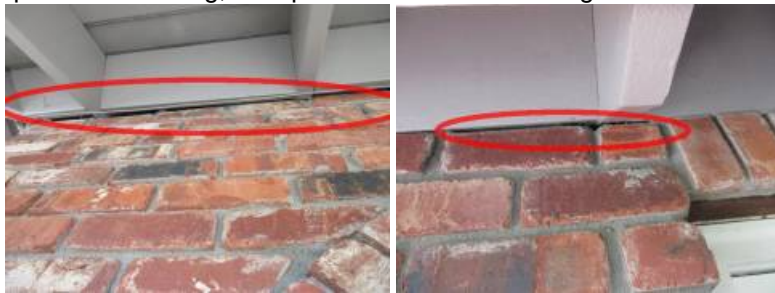
There are large gaps over 1/4" in size adjacent the soffit vent blocks and the brick cladding. These gaps allow insects and rodents to enter the attic. Covering the gaps with screening, a strip of wood and/or caulking is recommended.

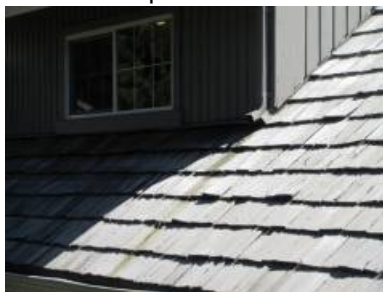
### 3.5 GUTTERS AND DOWNSPOUTS

Downspouts draining directly onto the wood shingle surface causes excessive wear of the roofing material. Downspout extensions to the lower gutters should be installed to prevent excessive wear and tear of the roofing.

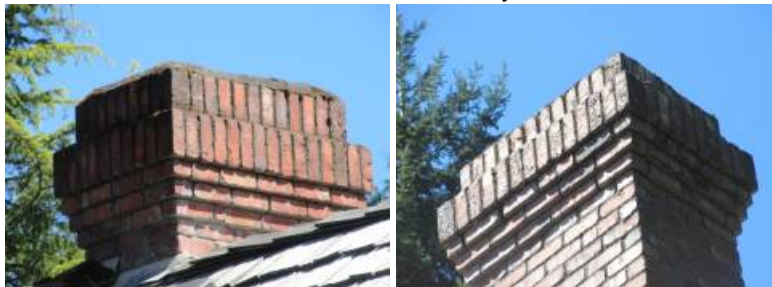
The chimney crowns are cracked. The mortar chimney crowns prevent water from entering and damaging the masonry. Repairing or replacing the chimney crowns will extend the service life of the chimneys.

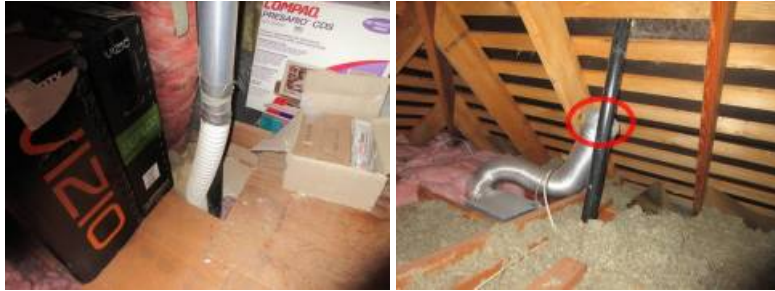
The master bedroom bathroom vent fan discharges in the attic rather than outside. This is an undesirable condition that causes excessive moisture in the attic and can result in mold or fungus growth. A 4" smooth-wall sheet metal duct should be installed to direct the moisture laden air discharged from the fan out of the attic.

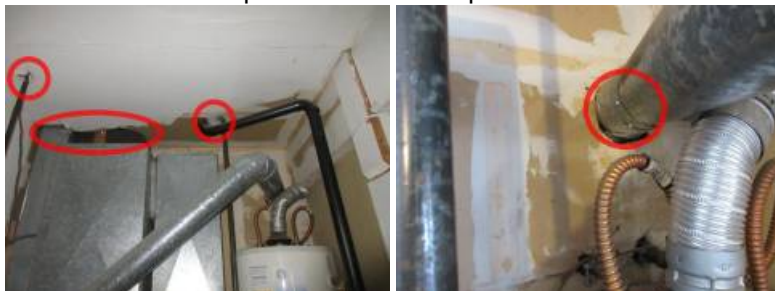
The installation of a furnace vent thimble is recommended to prevent flames to spread to the structure.

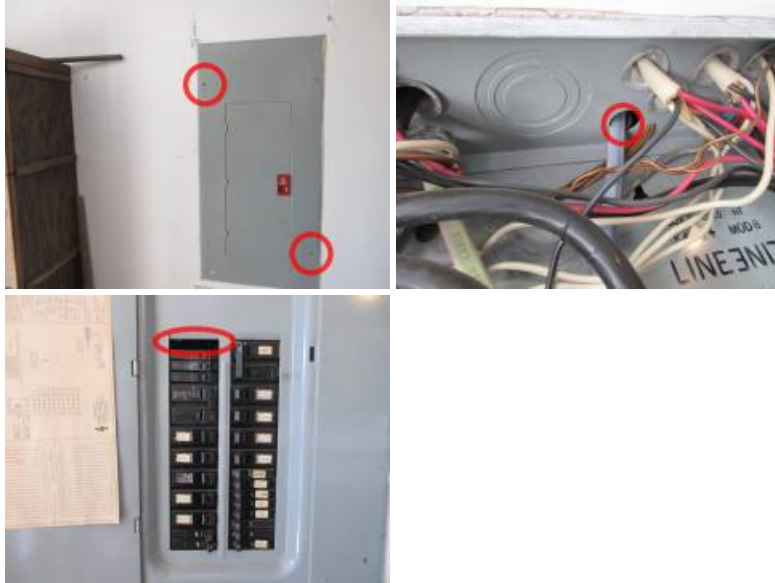
Twist-outs are missing from the service panel cover. This exposes live conductors and is a shock hazard. The installation of snap-in replacement blanks is recommended.

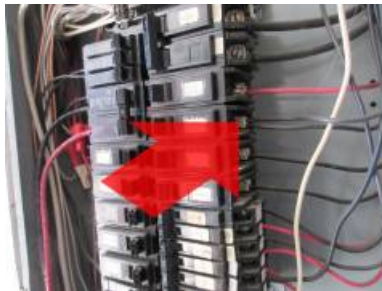
### 7.9 OVER CURRENT PROTECTION

One of the circuits is double tapped. Double tapping means that two conductors share a single terminal. Double tapped terminals can loosen and overheat and therefore are not permitted unless the terminal is specifically listed for multiple wires. This defect is easily repaired by connecting the two wires to a "pig tail", securing them with a wire cap, and then inserting the pig tail conductor under the terminal.

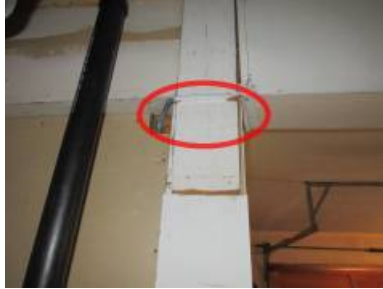
### 7.10 WIRING

There is Romex cable in the garage that is run over the surface of the wall. This cable is vulnerable to damage. The cable should be relocated or protected in conduit.

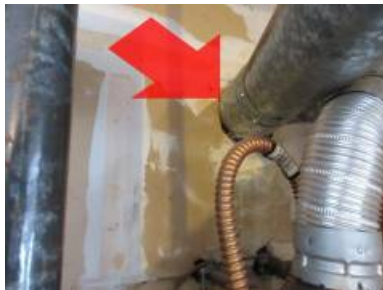
The furnace vent connector is too close to a combustible material. This is a hazard. A minimum clearance of 6" is required between the single wall vent connector and the combustible material. The double wall type B vent requires only 1" of clearance. Repairs are recommended.

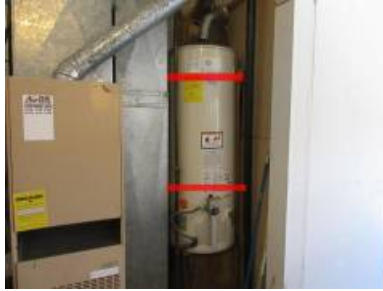
The water heater is not secured to the wall. A seismic restraint should be installed to secure the water heater and prevent it from falling over during an earthquake. This prevents the gas and water lines from rupturing.

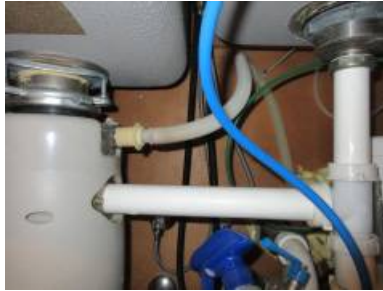
The cap protruding on the exterior wall opposite the dishwasher is not drilled. This air gap protects the dishwasher from contamination caused by a backflow of waste water when in use. Drilling a 1/4" hole in the end of the cap will restore its function when connected to the dishwasher waste line.

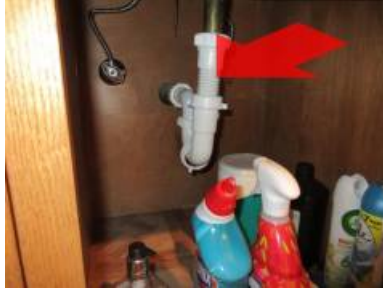
Improper, non-conforming material has been used for the drain pipe fitting. This material will not function reliably. Replacement with industry standard fittings is recommended.

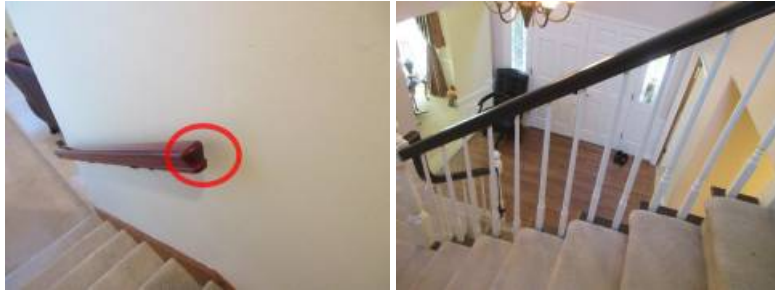
The stair railing baluster spacing is too wide. This is a hazard for small children. The baluster spacing should be reduced as a safety upgrade. Current standards require that a 4" sphere not pass through the railing.

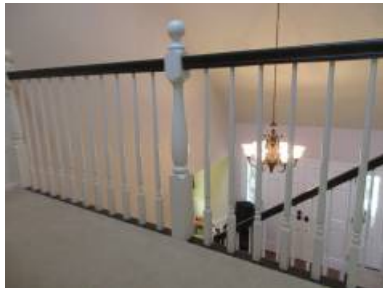
#### 14.3 GUARD RAILINGS

The spacing between the balusters is too wide. This is a hazard to small children. The balusters should be spaced close enough together so that a 4" sphere cannot pass through. Upgrading the guard railing is recommended if small children are present.

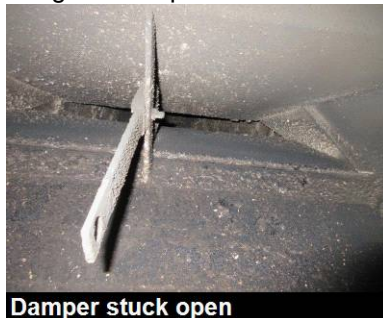
The family room fireplace damper is stuck in the open position. This allows heat to escape up the chimney and could result in odors emanating from the fireplace. Repairing the damper is recommended.

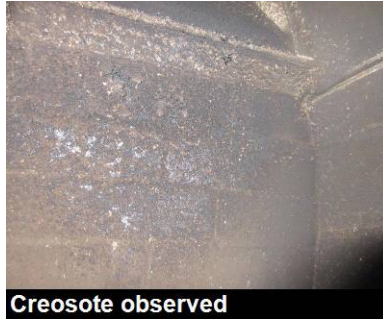
#### **15.3 CHIMNEYS**

An examination of the inside of the family room chimney revealed a noticeable accumulation of creosote. Smoldering fires and the burning of green or wet wood are the primary contributors to creosote build-up. Creosote in a chimney flue is dangerous because it is the fuel for a chimney fire. Chimney fires produce intense heat and sparks. The intense heat can crack the flue tile, brick and mortar of a masonry chimney. After holes or cracks have developed, chimney fires can cause the wood framing or roof of the house to catch on fire. To avoid chimney fires, flues should be cleaned and inspected at least once a year with moderate use. More frequent cleaning may be required depending on amount of use and burning practice.

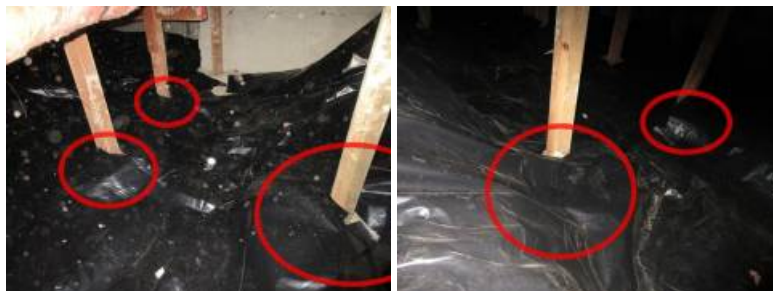
The support post concrete piers are covered with the plastic vapor retarder. This allows the transmission of water vapor from the soil up and into the floor framing. The plastic vapor retarder should be removed from the pier so that it covers at least 85% of the entire surface of the soil only.
