NOTICE TO BUYER: SELLER-PROCURED INSPECTION REPORT

April 22, 2021

**Re: 12903 176th Pl. NE
Redmond, WA.**

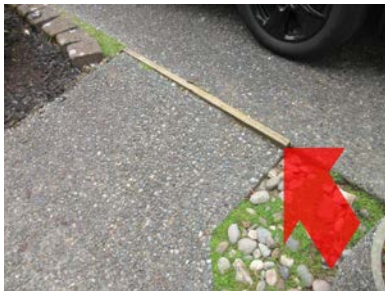
The wooden timbers separating the concrete walkway sections have deteriorated to a point where the raised edges and gaps are a trip hazard. Repairs are recommended. Replacement with masonry and mortar could be considered as an option.

2.6 Removed and fixed wooden timber on the right side of the driveway, this is the walkway to the backyard .

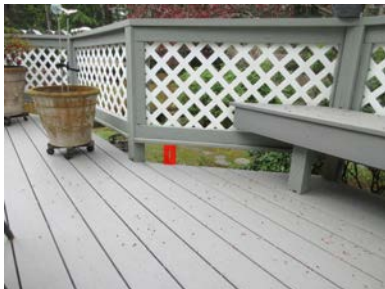
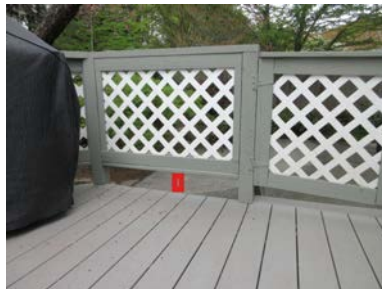
3.8 DECK RAILINGS

The spacing under the railings is too wide. This is a hazard to small children. The railing should be spaced close enough to the deck surface so that a 4" sphere cannot pass through. Upgrading the deck railing is recommended if small children are present.

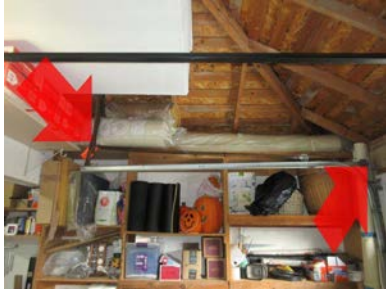
Safeties are cables run through the center of the garage door springs that prevent broken springs from becoming projectiles that can cause injury. There are no safeties installed. The installation of safeties is recommended.

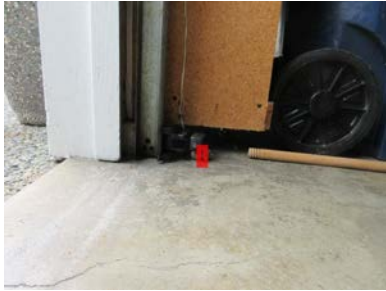
6.3 GARAGE DOOR OPENER

The Photo-eye beam was installed too low to the floor of the garage to adequately offer protection for small children and/or pets. We recommend that the photo-eye be raised to within 4-6" of the floor.

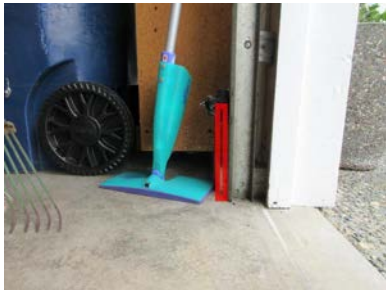
The Photo-eye beam was installed too high above the floor of the garage to adequately offer protection for small children and/or pets. We recommend that the photo-eye be lowered to within 4-6" of the floor.

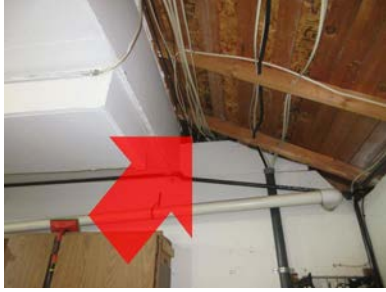
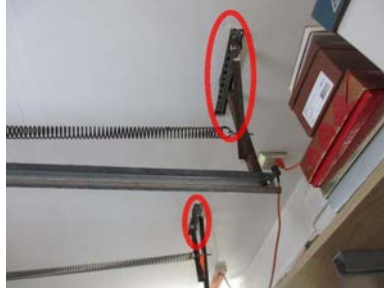
6.4 FIRE SEPARATION

There are voids in the fire resistive barrier between the living space and garage that will allow flames to penetrate. The gypsum barrier slows the spread of a fire from the garage to the structure and/or living space. Patching the voids with a fire retardant caulk is recommended.

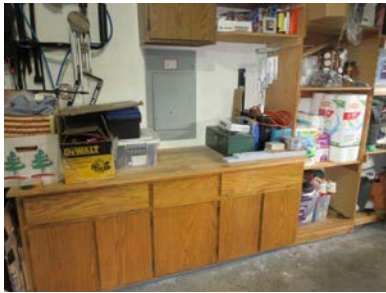
Access to the electrical panel is blocked by shelving. Cabinets should be removed or modified so that there is a 30" wide by 36" deep by 7' tall clearance in front of the panel.

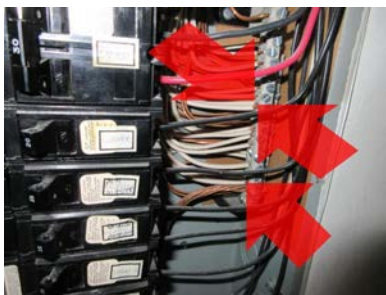
7.8 SERVICE PANEL

Several of the neutral wires are double tapped on the buss bar. Double tapping means that two conductors share a single terminal. Double tapped terminals can loosen and overheat and therefore are not permitted unless the terminal is specifically listed for multiple wires. This defect is easily repaired by connecting the two wires to a "pig tail", securing them with a wire cap, and then inserting the pig tail conductor under the terminal.

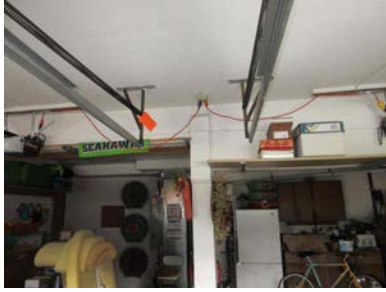
7.10 WIRING

An extension cord is used as a temporary power source for the garage door openers. An extension cord is not suitable as a permanent wiring method. The installation of a receptacle within cords length of the motors is recommended.

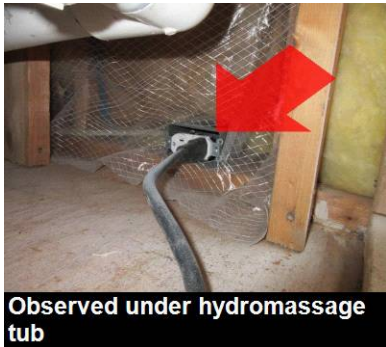
The cover plate is missing from a receptacle in the guest bedroom bathroom. This is a shock and fire hazard. The installation of a cover plate is recommended.

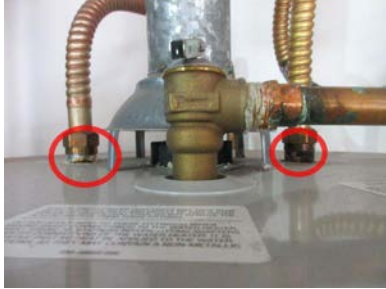
The nipples sticking out of the top of the water heater are corroded and may start to leak. The nipples should be monitored for leakage and replaced as necessary. Installing brass nipples will eliminate the corrosion that occurs when two dissimilar metals are joined together in the presence of water.

11.5 Water heater: Tony had a discussion with the "Fast" service rep who was at the house replacing the Water expansion tank, he explained the fittings are all factory pieces and they are not in danger of leaking. The water heater will be 9 years in November. There is a new Expansion tank, new gas shut off and thermostat.

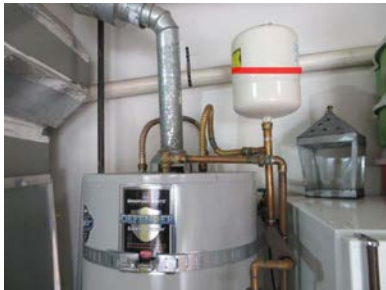
11.6 EXPANSION TANK

The expansion tank is not adequately secured to the wall. This could result in damage to the water pipe and leakage during an earth quake. A seismic restraint should be installed to secure the expansion tank.

11.6 Expansion Tank, Sesmic Restraint has been attached to the tank

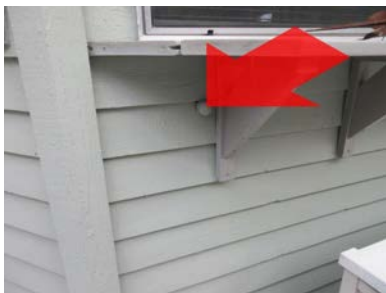
An air gap called a Johnson Tee is installed in the kitchen wall. This air gap protects the dishwasher from contamination caused by a backflow of waste water. The cap protruding on the exterior wall opposite the dishwasher is not drilled. This renders the air gap non-functional. Drilling a 1/4" hole in the end of the cap will restore its function. The remaining visible portions of the Johnson Tee were properly installed and functioning as intended.

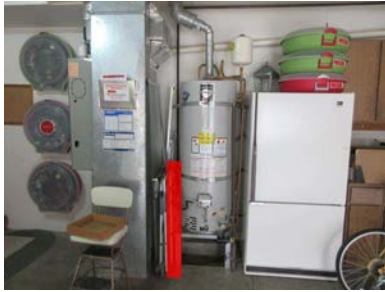
The gas pipes in front of the furnace and water heater are not protected by a bumper stop. A vertical steel pipe, bolted to the floor, is typically installed in front of the water heater to prevent a car bumper from damaging the gas lines.

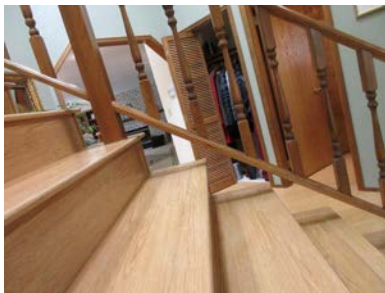
The stair railing baluster spacing is too wide. This is a hazard for small children. The baluster spacing should be reduced as a safety upgrade. Current standards require that a 4" sphere not pass through the railing.

The stair railing spacing at the stair treads is too wide. This is a hazard for small children. The railing spacing should be reduced as a safety upgrade. Current standards require that a 4" sphere not pass through or under the railing.

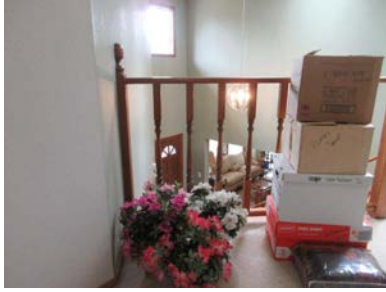
16.3 GUARD RAILINGS

The spacing between the balusters is too wide. This is a hazard to small children. The balusters should be spaced close enough together so that a 4" sphere cannot pass through. Upgrading the guard railing is

recommended if small children are present.

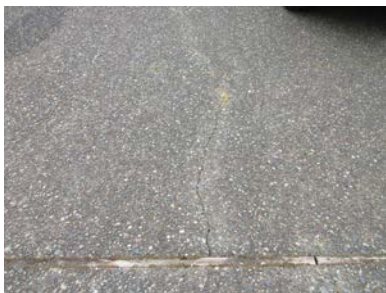
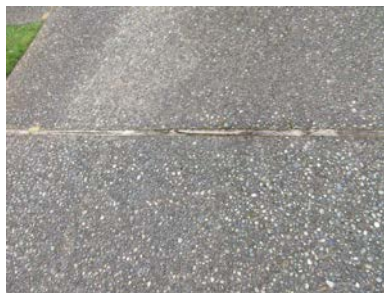
Cracks were observed in the concrete surface of the driveway. Minor cracks can be sealed to minimize moisture entry and further settlement of the concrete. Minor cracks are common and do not affect the serviceability of the concrete.

One or more of the wooden dividers separating the concrete driveway sections were infested by wood destroying organisms and have deteriorated to a point where they are becoming a trip hazard. Replacement with mortar is recommended.

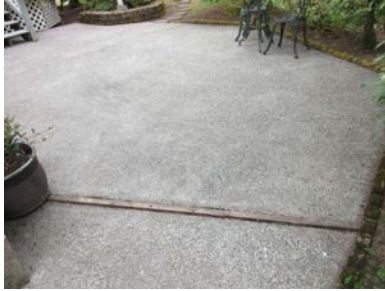
2.5 PATIO

The wooden dividers separating the concrete patio sections will eventually deteriorate to a condition where the gaps would be a trip hazard. Replacement with mortar is recommended.

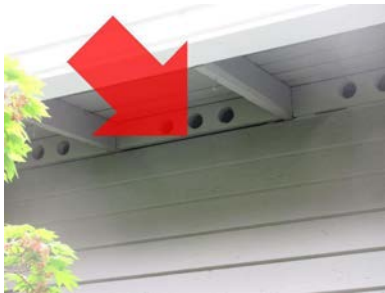
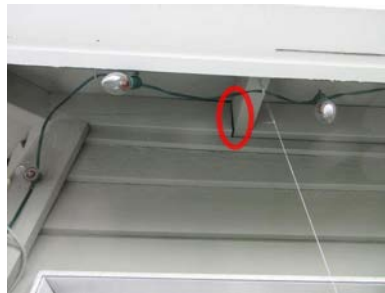
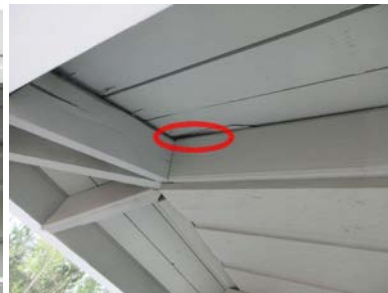
There are large gaps over 1/4" in size adjacent the soffit vent blocks. These gaps allow insects and rodents to enter the attic. Covering the gaps with screening, a strip of wood and/or caulking is recommended.

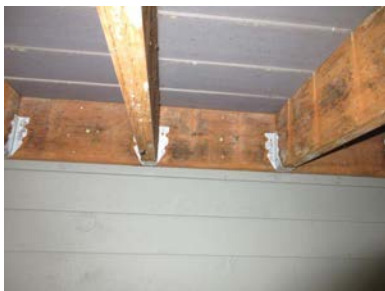
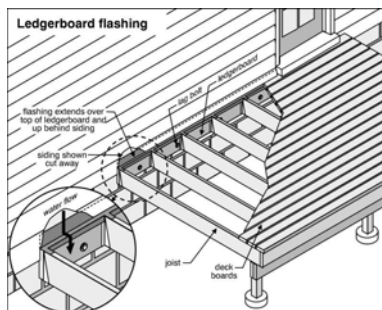
There is no flashing at the intersection between the deck and house. This will allow water to enter behind the siding. The installation of flashing in this area is recommended.

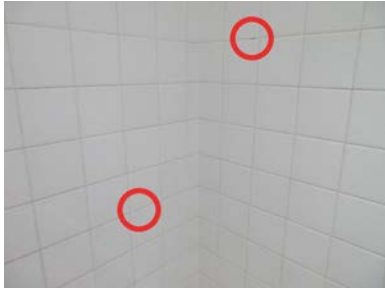
Grout is missing from between some of the wall tiles. This can allow water to enter through the tile and can damage the walls. Regrouting the wall tile is recommended.

13.13 Repaired grout in wall tiles in upstairs bathroom

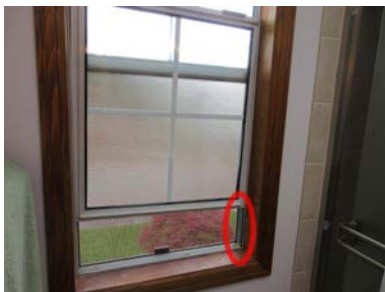
The lift assist mechanism for the window in the master bedroom bathroom is in need of repair. The window should not be used until repairs are completed.

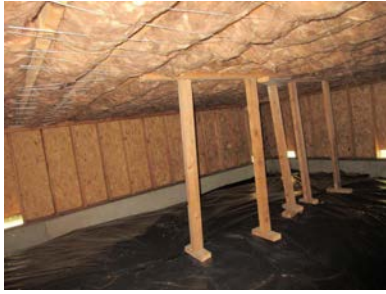
The visible portions of the posts and beams are properly installed and are performing their intended function. However several posts have been propped up under the south extension floor and are improperly braced and

supported. Replacement if needed should be done under current industry standards.

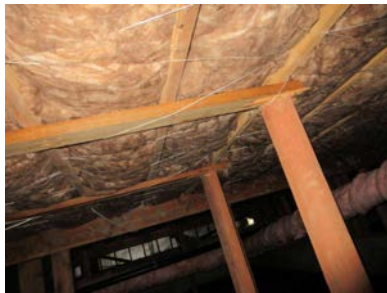
Two posts have been propped up under the kitchen floor and is improperly supported. Replacement if needed should be done under current industry standards.

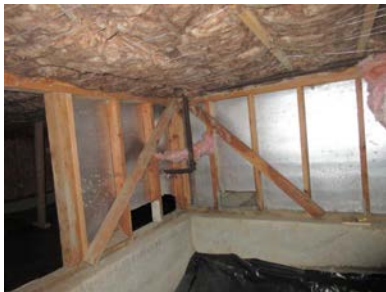
20.6 SHEAR PANELS

Shear panels are plywood or OSB panels that are mechanically fastened to both vertical and horizontal framing members in critical structural areas of the building. They prevent lateral movement of the structure during an earthquake. Shear panels are often visible in the crawlspace on cripple walls between the first floor and foundation. They may also be installed on interior walls that are covered with drywall. An examination of the crawlspace revealed the absence of shear panels on the cripple walls. The installation of shear panels on the cripple walls is recommended as an upgrade.

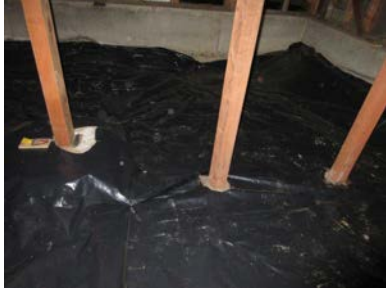
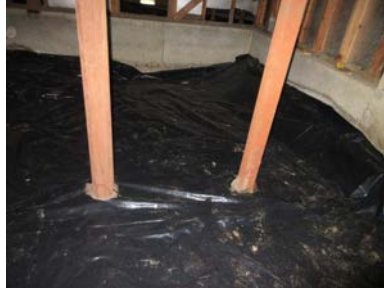
The support post concrete piers are covered with the plastic vapor retarder. This allows the transmission of water vapor from the soil up and into the floor framing. The plastic vapor retarder should be removed from the pier so that it covers at least 85% of the entire surface of the soil only.

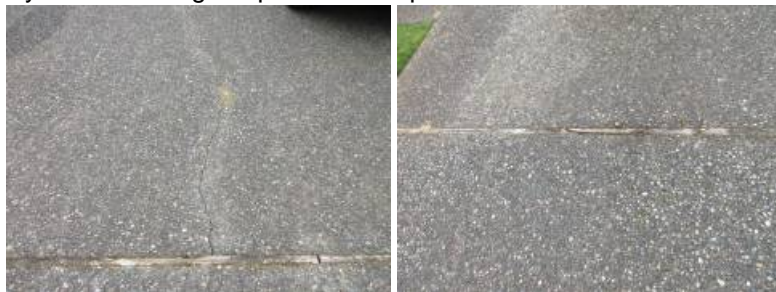
One or more of the wooden dividers separating the concrete driveway sections were infested by wood destroying organisms and have deteriorated to a point where they are becoming a trip hazard. Replacement with mortar is recommended.

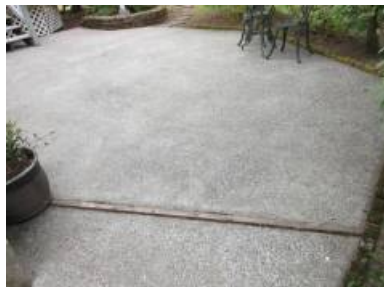
2.5 PATIO

The wooden dividers separating the concrete patio sections will eventually deteriorate to a condition where the gaps would be a trip hazard. Replacement with mortar is recommended.

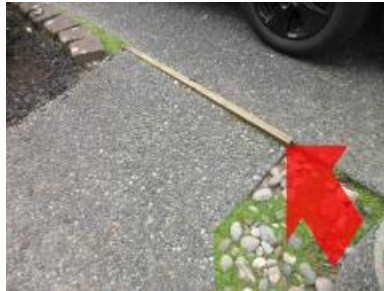
2.6 WALKWAY

Many legal and public works departments have defined a trip hazard as an irregularity in a walking surface exceeding one inch (1") in height. All walking surfaces should maintain, free of a vertical surface change of 3/4" or more, in the interest of public and personal safety.

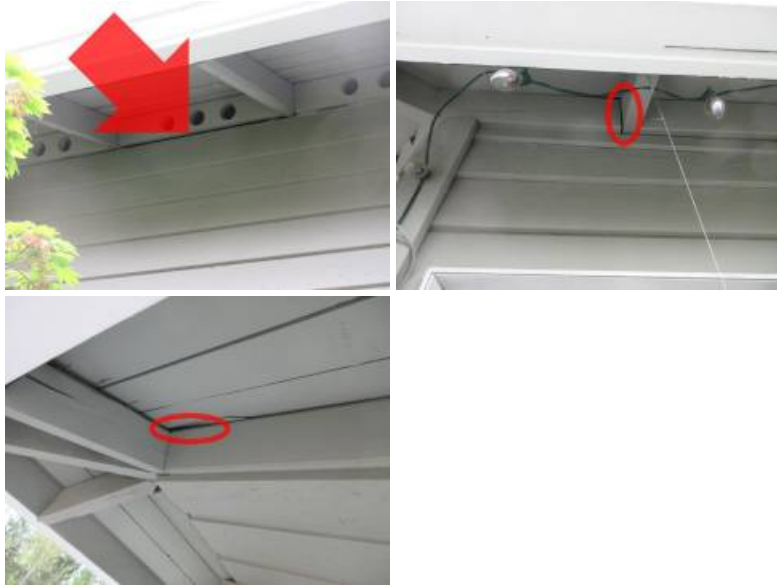
There are large gaps over 1/4" in size adjacent the soffit vent blocks. These gaps allow insects and rodents to enter the attic. Covering the gaps with screening, a strip of wood and/or caulking is recommended.

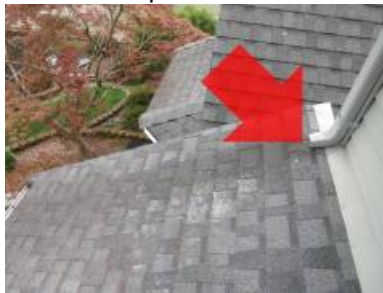
3.5 GUTTERS AND DOWNSPOUTS

Downspouts draining directly onto the asphalt shingle surface causes excessive wear of the roofing material. Downspout extensions to the lower gutters should be installed to prevent excessive wear and tear of the roofing.

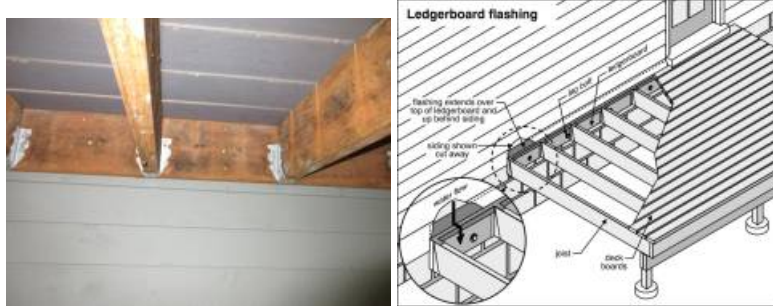
There is no flashing at the intersection between the deck and house. This will allow water to enter behind the siding. The installation of flashing in this area is recommended.

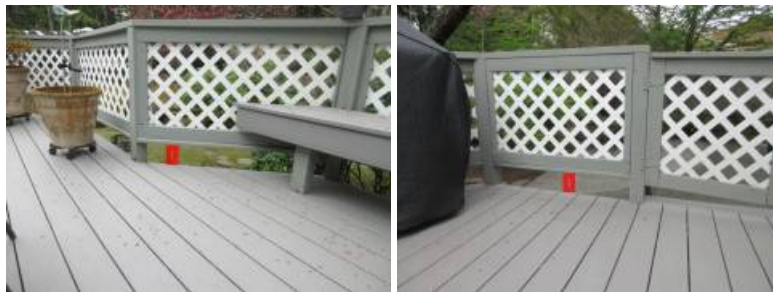
3.8 DECK RAILINGS

The spacing under the railings is too wide. This is a hazard to small children. The railing should be spaced close enough to the deck surface so that a 4" sphere cannot pass through. Upgrading the deck railing is recommended if small children are present.

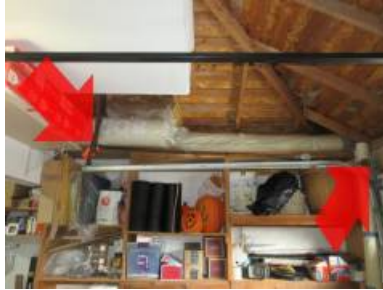
Safeties are cables run through the center of the garage door springs that prevent broken springs from becoming projectiles that can cause injury. There are no safeties installed. The installation of safeties is recommended.

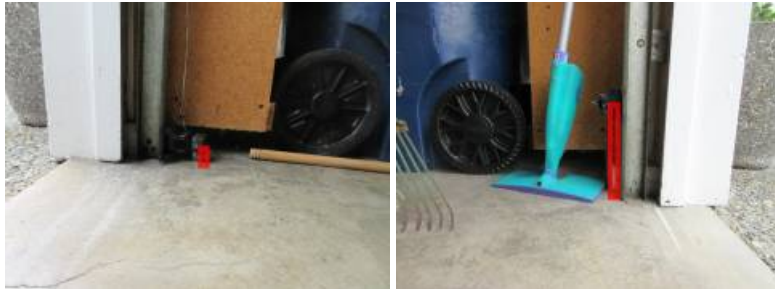
The Photo-eye beam was installed too high above the floor of the garage to adequately offer protection for small children and/or pets. We recommend that the photo-eye be lowered to within 4-6" of the floor.

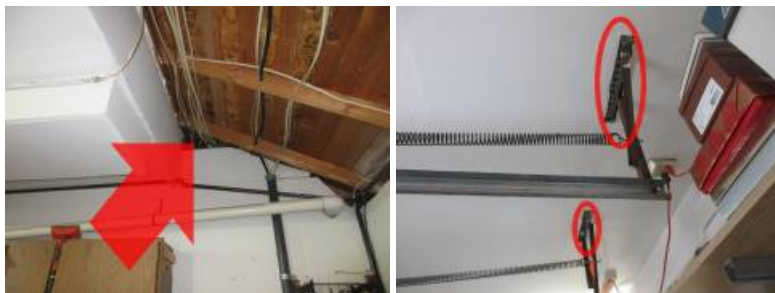
6.4 FIRE SEPARATION

There are voids in the fire resistive barrier between the living space and garage that will allow flames to penetrate. The gypsum barrier slows the spread of a fire from the garage to the structure and/or living space. Patching the voids with a fire retardant caulk is recommended.

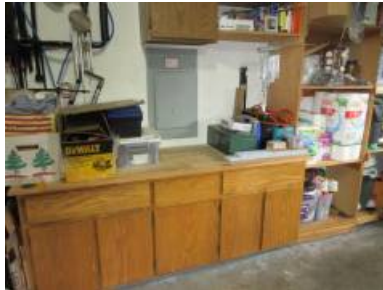
Access to the electrical panel is blocked by shelving. Cabinets should be removed or modified so that there is a 30" wide by 36" deep by 7' tall clearance in front of the panel.

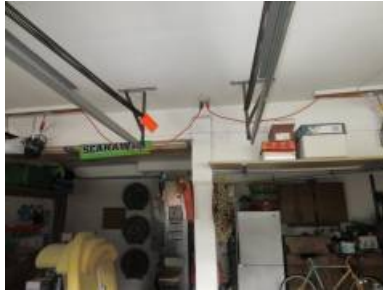
An extension cord is used as a temporary power source for the garage door openers. An extension cord is not suitable as a permanent wiring method. The installation of a receptacle within cords length of the motors is recommended.

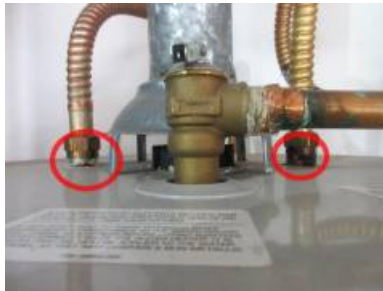
The nipples sticking out of the top of the water heater are corroded and may start to leak. The nipples should be monitored for leakage and replaced as necessary. Installing brass nipples will eliminate the corrosion that occurs when two dissimilar metals are joined together in the presence of water.

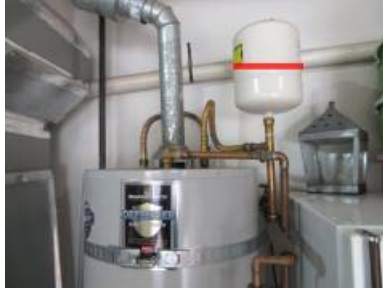
11.6 EXPANSION TANK

The expansion tank is not adequately secured to the wall. This could result in damage to the water pipe and leakage during an earth quake. A seismic restraint should be installed to secure the expansion tank.

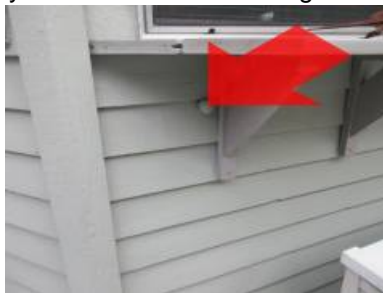
An air gap called a Johnson Tee is installed in the kitchen wall. This air gap protects the dishwasher from contamination caused by a backflow of waste water. The cap protruding on the exterior wall opposite the dishwasher is not drilled. This renders the air gap non-functional. Drilling a 1/4" hole in the end of the cap will restore its function. The remaining visible portions of the Johnson Tee were properly installed and functioning as intended.

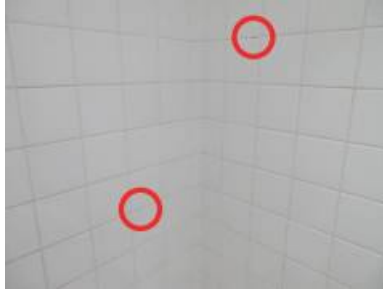
Where the tile is applied directly over the gypsum board, it is critical that the tile grout be maintained to prevent water intrusion behind the tile. Missing or cracked grout should be repaired. Inside corners, and penetrations in the tile should be kept sealed with a high quality caulk.

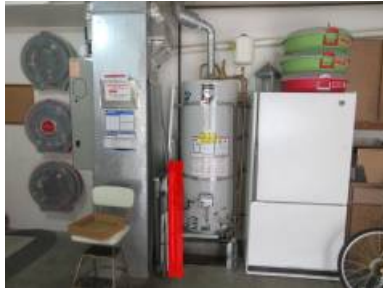
The gas pipes in front of the furnace and water heater are not protected by a bumper stop. A vertical steel pipe, bolted to the floor, is typically installed in front of the water heater to prevent a car bumper from damaging the gas lines.

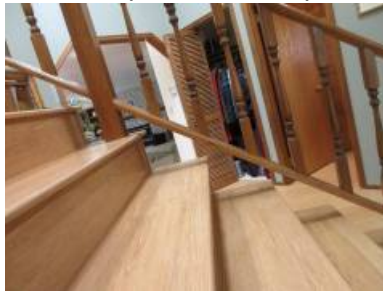
The stair railing spacing at the stair treads is too wide. This is a hazard for small children. The railing spacing should be reduced as a safety upgrade. Current standards require that a 4" sphere not pass through or under the railing.

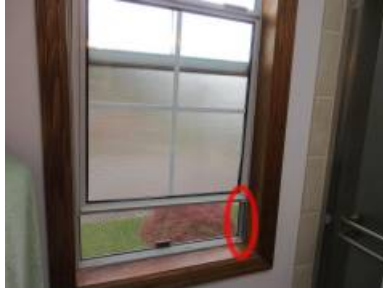
The lift assist mechanism for the window in the master bedroom bathroom is in need of repair. The window should not be used until repairs are completed.
