**NOTICE TO BUYER: SELLER-PROCURED INSPECTION REPORT**

Ron and Debbie Porterfield
13901 177th PL NE
Redmond, WA 98052

At your request, a visual inspection of the above referenced property was conducted on 07/13/2021. We have inspected the major structural components, plumbing, heating and electrical systems for signs of significant non-performance, excessive or unusual wear and general state of repair.

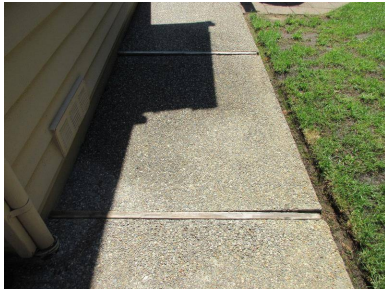
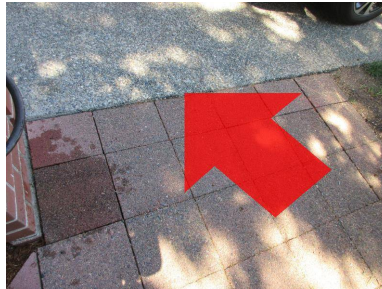
The walkway has cracked and settled differentially. This was probably caused by inadequate preparation of the soil prior to the placement of the concrete. This condition can be repaired by pressure grouting the sunken portion of the walkway or by removing and replacing it. Grinding down the raised edges of the concrete will also mitigate the hazard. The walkway remains functional despite this condition. However, the raised edges of the concrete can be a trip hazard for some people. Repairs should be made as necessary.

When the wooden dividers separating the concrete walkway sections have deteriorated to a point where they become a trip hazard. Replacement with mortar is recommended.

2.6	Walkway	Seller will contact a contractor to evaluate the situation.
2.6 cont.	Walkway	Seller will look at dividers and replace if necessary
3.8	Deck railings	The railings were built to code with the house and will not be adjusted.

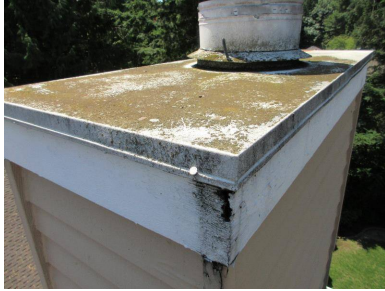
4.4 CHIMNEYS

The chase cover for the south fireplace is leaking. This has resulted in visible rust/corrosion on the damper within the fireplace and rot damage of the exterior trim boards was observed. Chase cover replacement is recommended. The new chase cover should be sloped for drainage. Rot damaged material should be repaired/replaced.

4.4	Chimneys	Seller will replace chase cover and fix all rot damage.
6.2	Overhead garage door	Seller will install center safety cable.
6.3	Garage door opener	Seller will install photo- eye sensor.

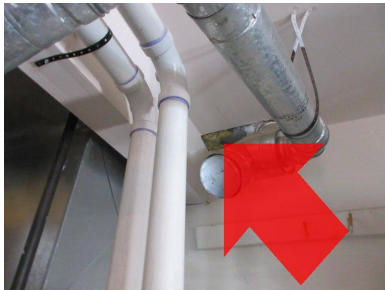
6.4 FIRE SEPARATION

There are voids in the fire resistive barrier between the living space and garage that will allow flames to penetrate. The gypsum barrier slows the spread of a fire from the garage to the structure and/or living space. Patching the voids with a fire retardant caulk is recommended.

6.4	Fire separation	Seller will fill void with Gypsum board.
6.7	Garage stairs	Seller will adjust slats to maximum or 4" gap
6.8	Garage receptacles	Seller will replace current outlet with GFCI

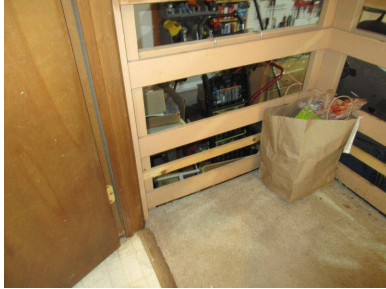
6.7 STAIRS

The guard railing baluster spacing is too wide. This is a hazard for small children. The baluster spacing should be reduced as a safety upgrade. Current standards require that a 4" sphere not pass through the railing.

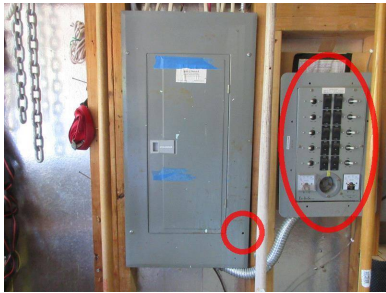
7.8 SERVICE PANEL

Screws that secure the panel cover to the panel box are missing. This is a potential hazard. Missing screws should be replaced with the original style blunt end screws.

7.8	Service Panel	Seller will buy and install missing screw to match others
15.8	Smoke detectors	Seller has bought and will install.
3.6	Paint- Chimney	Seller will repair and paint.

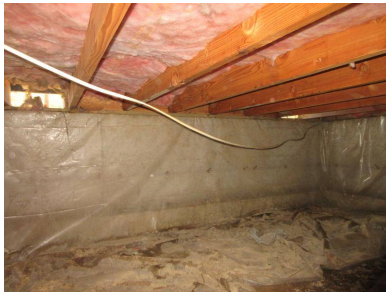
7.10 WIRING

A loose electrical cable was observed in the crawlspace. Loose cables are vulnerable to damage. All loose cables should be secured at 4' intervals using approved cable staples.

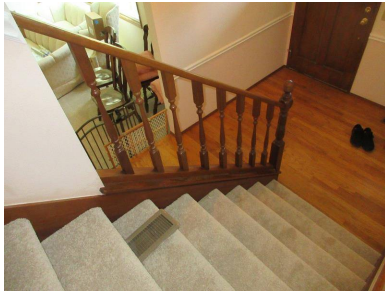
15.2 STAIRS

The stair railing baluster spacing is too wide. This is a hazard for small children. The baluster spacing should be reduced as a safety upgrade. Current standards require that a 4" sphere not pass through the railing.

15.2	Stairs - main hall	Balusters installed with house. Replacement / addition can be evaluated.
15.3	Guard rails -upper hall	Balusters installed with house. Replacement / addition can be evaluated.

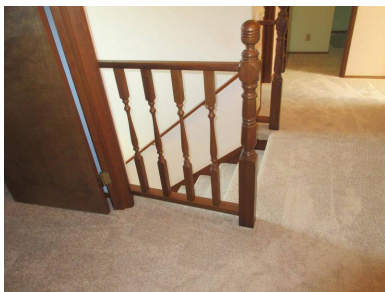
15.3 GUARD RAILINGS

The spacing between the balusters is too wide. This is a hazard to small children. The balusters should be spaced close enough together so that a 4" sphere cannot pass through. Upgrading the guard railing is recommended if small children are present.

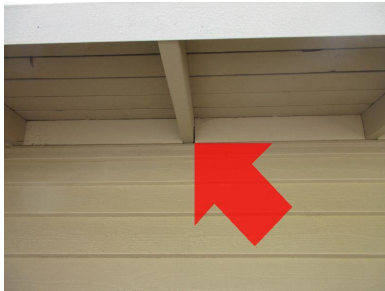
3.4 SOFFITS AND OVERHANGS

There are large gaps over 1/4" in size adjacent the soffit vent blocks. These gaps allow insects and rodents to enter the attic. Covering the gaps with screening, a strip of wood and/or caulking is recommended.

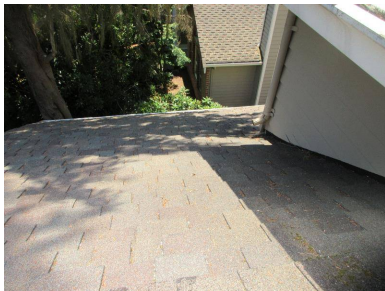
3.5 GUTTERS AND DOWNSPOUTS

Downspouts draining directly onto the asphalt shingle surface causes excessive wear of the roofing material. Downspout extensions to the lower gutters should be installed to prevent excessive wear and tear of the roofing.

The 2" round downspouts are too small and are more vulnerable to clogging than the larger rectangular ones. Consideration should be given to upgrading the downspouts.

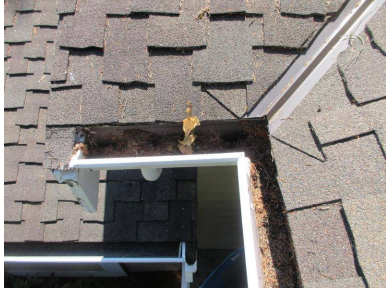
There is a build-up of organic debris inside the gutters. Proper maintenance of gutters and downspouts is essential and should be performed routinely in order to prevent clogging. Maintenance consists primarily of keeping leaves and other organic debris out of the system. Failure to clean the gutters will result in water splash on the building when they overflow. Gutters can be damaged under the weight of the water and organic matter inside the gutter. Gutters should be cleaned as necessary to maintain a free flow of water into the downspouts.

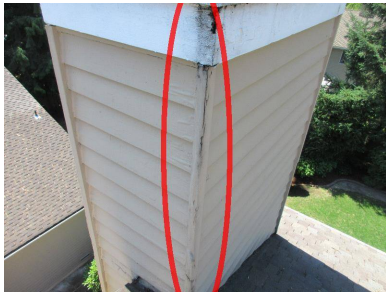
3.6 PAINT

Localized areas of peeling paint were noted on the south chimney. Paint protects the wood from cupping, checking, warping and rot. These areas should be scraped, primed and repainted.

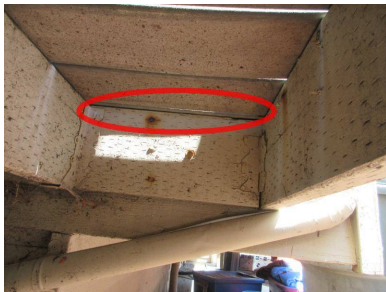
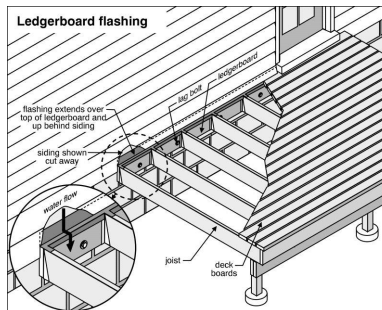
3.7 DECK

There is no flashing at the intersection between the deck and house. This will allow water to enter behind the siding. The installation of flashing in this area is recommended.

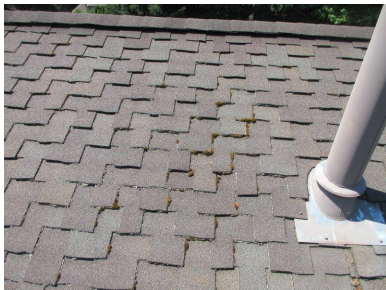
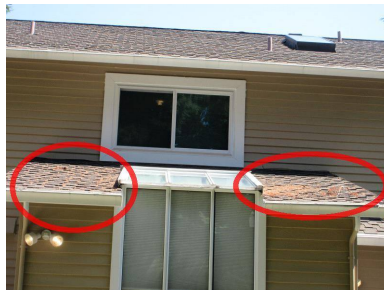
4.7 MAINTENANCE AND REPAIRS

The roof is in need of routine maintenance. The surface should be blown off or washed with a high volume low pressure garden hose to remove moss and organic debris. Performing this maintenance will improve the appearance and increase the life expectancy of the roof.

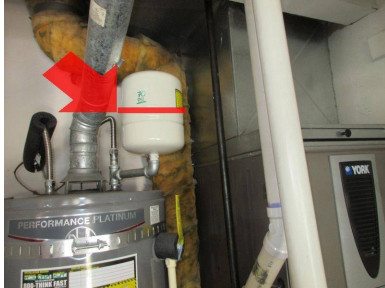
10.6 EXPANSION TANK

The expansion tank is not adequately secured to the wall. This could result in damage to the water pipe and leakage during an earth quake. A seismic restraint should be installed to secure the expansion tank.

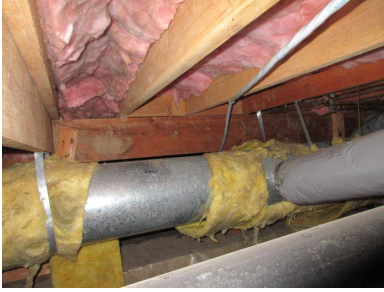
18.4 DUCT INSULATION

Some of the duct insulation is missing or has fallen off the ducts. This increases the amount of heat loss. The installation of new duct insulation is recommended in areas where insulation is missing.

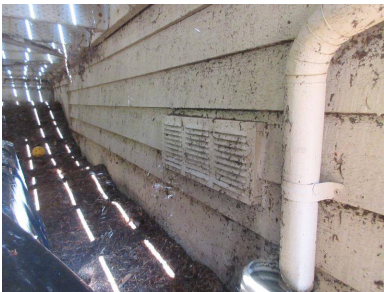
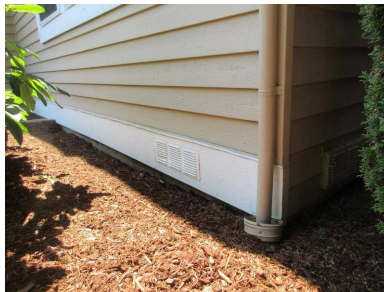
20.3 VENTILATION

The vents are covered with louvered vent covers. This type of vent cover blocks the flow of air and the screen behind the cover becomes easily clogged with dust and dirt. Better ventilation can be achieved by installing 1/4" wire mesh over the vents.

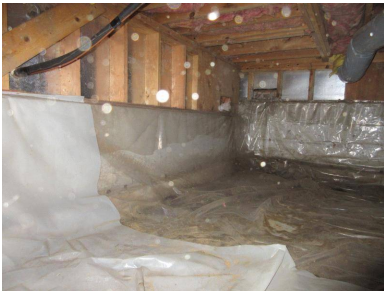
20.4 VAPOR RETARDER

The foundation walls are covered with the plastic vapor retarder. This allows the transmission of water vapor from the soil up and into the exterior wall framing. The plastic vapor retarder should be removed from the foundation.

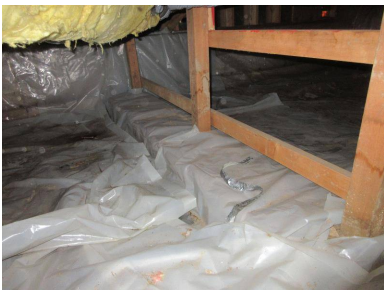
The support post concrete piers are covered with the plastic vapor retarder. This allows the transmission of water vapor from the soil up and into the floor framing. The plastic vapor retarder should be removed from the piers.

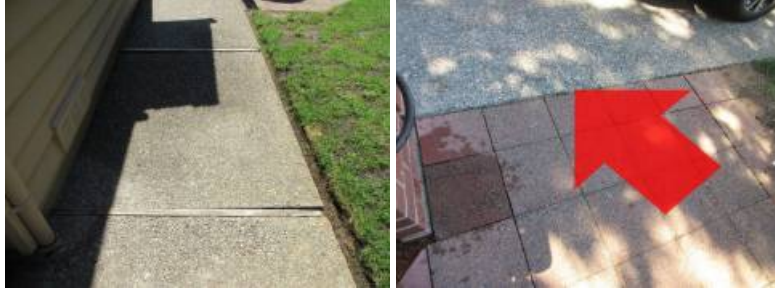
When the wooden dividers separating the concrete walkway sections have deteriorated to a point where they become a trip hazard. Replacement with mortar is recommended.

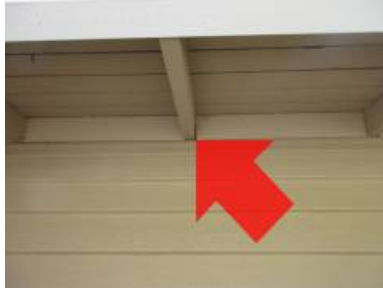
There are large gaps over 1/4" in size adjacent the soffit vent blocks. These gaps allow insects and rodents to enter the attic. Covering the gaps with screening, a strip of wood and/or caulking is recommended.

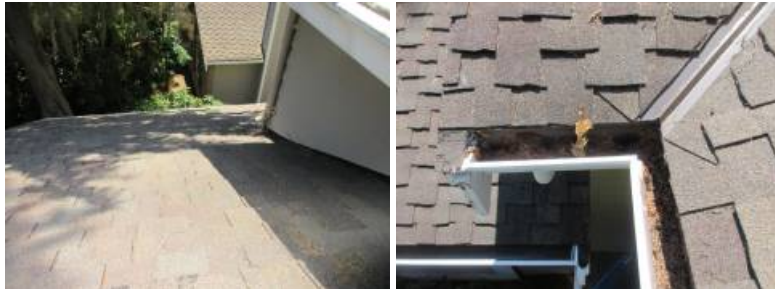
There is a build-up of organic debris inside the gutters. Proper maintenance of gutters and downspouts is essential and should be performed routinely in order to prevent clogging. Maintenance consists primarily of keeping leaves and other organic debris out of the system. Failure to clean the gutters will result in water splash on the building when they overflow. Gutters can be damaged under the weight of the water and organic matter inside the gutter. Gutters should be cleaned as necessary to maintain a free flow of water into the downspouts.

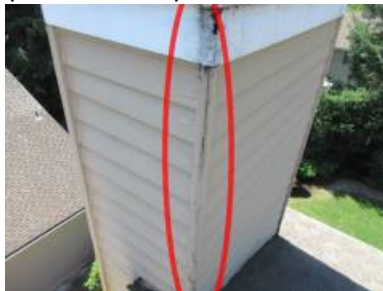
3.6 PAINT

Localized areas of peeling paint were noted on the south chimney. Paint protects the wood from cupping, checking, warping and rot. These areas should be scraped, primed and repainted.

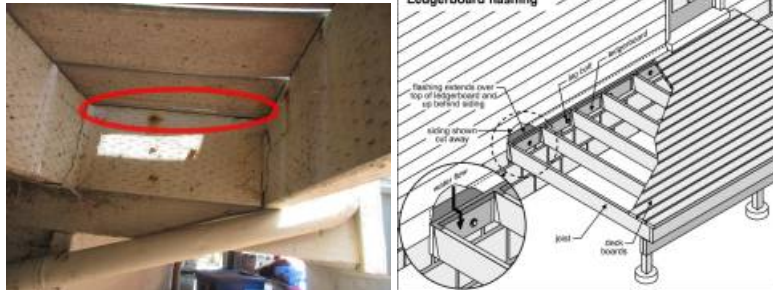
There is no flashing at the intersection between the deck and house. This will allow water to enter behind the siding. The installation of flashing in this area is recommended.

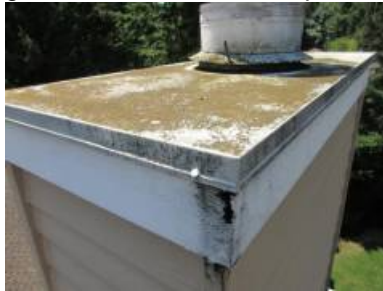
The chase cover for the south fireplace is leaking. This has resulted in visible rust/corrosion on the damper within the fireplace and rot damage of the exterior trim boards was observed. Chase cover replacement is recommended. The new chase cover should be sloped for drainage. Rot damaged material should be repaired/replaced.

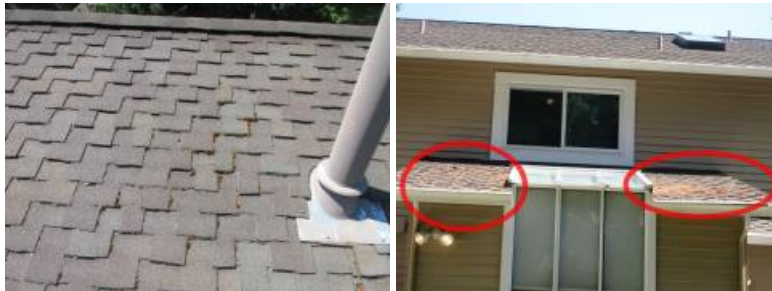
4.7 MAINTENANCE AND REPAIRS

The roof is in need of routine maintenance. The surface should be blown off or washed with a high volume low pressure garden hose to remove moss and organic debris. Performing this maintenance will improve the appearance and increase the life expectancy of the roof.

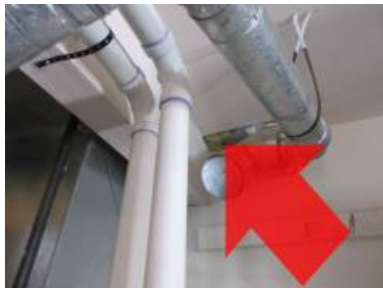
There are voids in the fire resistive barrier between the living space and garage that will allow flames to penetrate. The gypsum barrier slows the spread of a fire from the garage to the structure and/or living space. Patching the voids with a fire retardant caulk is recommended.

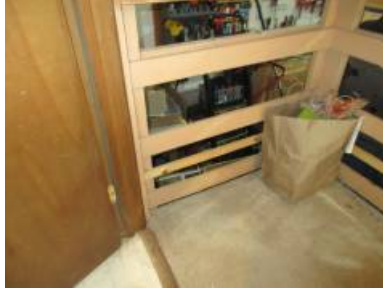
The guard railing baluster spacing is too wide. This is a hazard for small children. The baluster spacing should be reduced as a safety upgrade. Current standards require that a 4" sphere not pass through the railing.

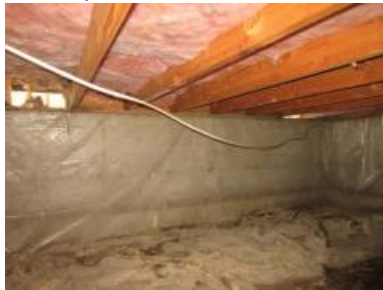
A loose electrical cable was observed in the crawlspace. Loose cables are vulnerable to damage. All loose cables should be secured at 4' intervals using approved cable staples.

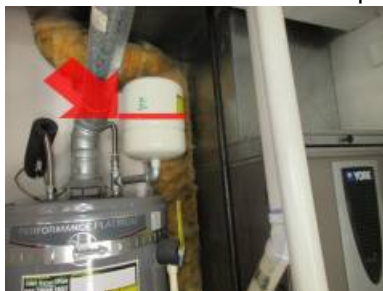
The expansion tank is not adequately secured to the wall. This could result in damage to the water pipe and leakage during an earth quake. A seismic restraint should be installed to secure the expansion tank.

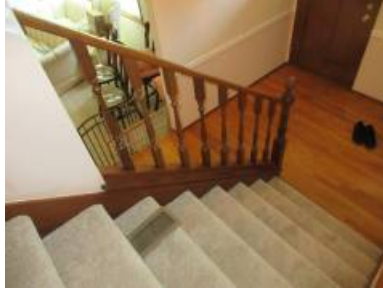
The stair railing baluster spacing is too wide. This is a hazard for small children. The baluster spacing should be reduced as a safety upgrade. Current standards require that a 4" sphere not pass through the railing.

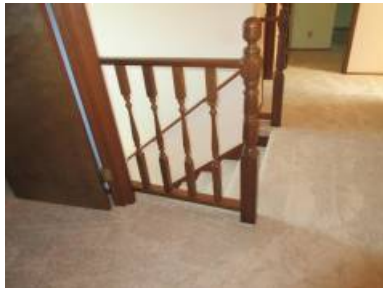
15.3 GUARD RAILINGS

The spacing between the balusters is too wide. This is a hazard to small children. The balusters should be spaced close enough together so that a 4" sphere cannot pass through. Upgrading the guard railing is recommended if small children are present.

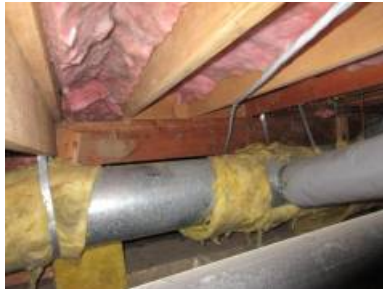
Some of the duct insulation is missing or has fallen off the ducts. This increases the amount of heat loss. The installation of new duct insulation is recommended in areas where insulation is missing.

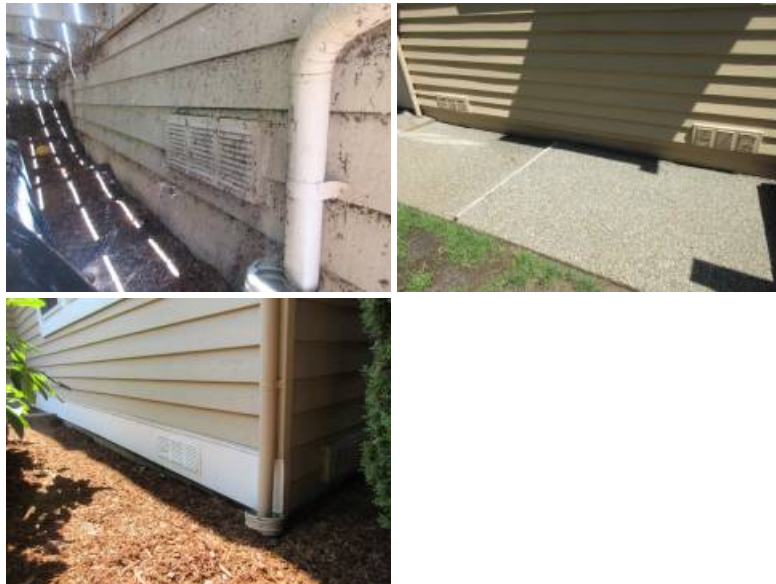
The vents are covered with louvered vent covers. This type of vent cover blocks the flow of air and the screen behind the cover becomes easily clogged with dust and dirt. Better ventilation can be achieved by installing 1/4" wire mesh over the vents.

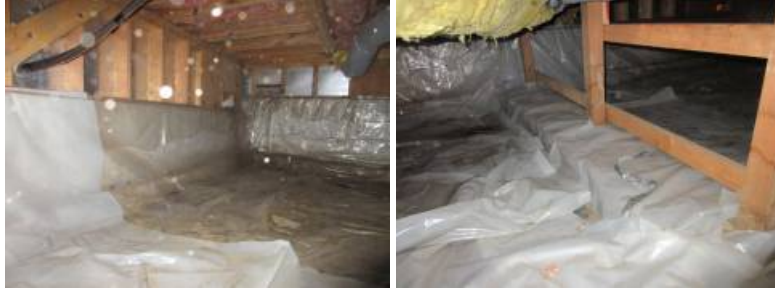
The support post concrete piers are covered with the plastic vapor retarder. This allows the transmission of water vapor from the soil up and into the floor framing. The plastic vapor retarder should be removed from the piers.
