**NOTICE TO BUYER: SELLER-PROCURED INSPECTION REPORT**

**Durgaprasad & Lakshminadhuri Gorti**  
**17424 NE 139<sup>th</sup> PI**  
**Redmond, WA 98052**

At your request, a visual inspection of the above referenced property was conducted on 08/11/2021. We have inspected the major structural components, plumbing, heating and electrical systems for signs of significant non-performance, excessive or unusual wear and general state of repair.

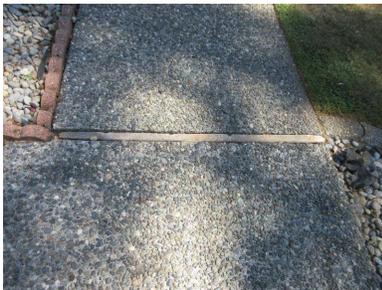
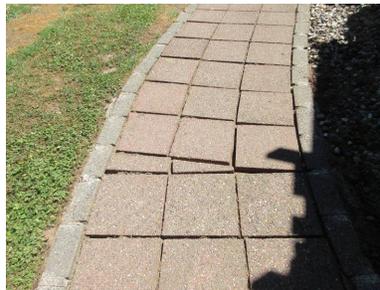
One or more of the wooden dividers separating the concrete walkway sections were infested by wood destroying organisms and have deteriorated to a point where they are becoming a trip hazard. Replacement with mortar is recommended.

The walking surface was not even and trip hazards were present. We recommend all walking surfaces be maintained free of trip hazards.

The minor settlement of the patio blocks and the gaps separating the patio stones are a trip hazard. We recommend all walking surfaces be maintained free of trip hazards.

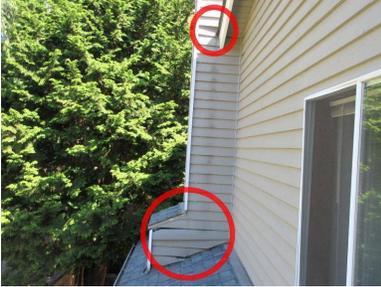
The siding at the west chimney chase wall is damaged. The siding has had chronic contact with moisture. Damaged material should be repaired and protected from chronic contact with moisture. Refer to discussion under Roofing/Flashing.

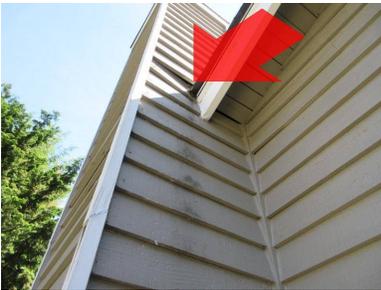
There is no kick out flashing at the roof edge to wall intersection above the gutter at the west chimney. This will allow water to enter the wall behind the siding. The installation of a kick-out flashing is recommended.

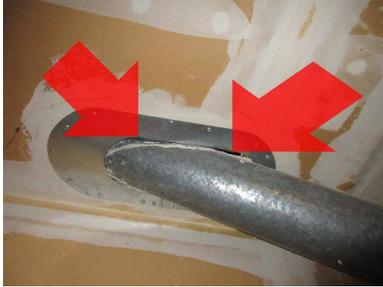
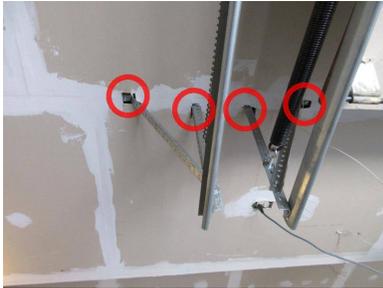
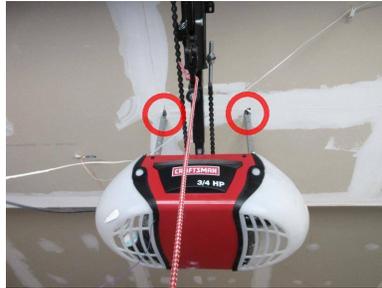
There are voids in the fire resistive barrier between the living space and garage that will allow flames to penetrate. The gypsum barrier slows the spread of a fire from the garage to the structure and/or living space. Patching the voids with a fire retardant caulk is recommended to prevent flames to spread to the structure.

The gaps adjacent the furnace vent thimble is a breach in the fire resistive barrier in the garage. This is a safety concern. The installation of a properly fitted furnace vent thimble is recommended to prevent flames to spread to the structure.

**6.4 Fire Separation**

Fire retardant caulking applied to the voids

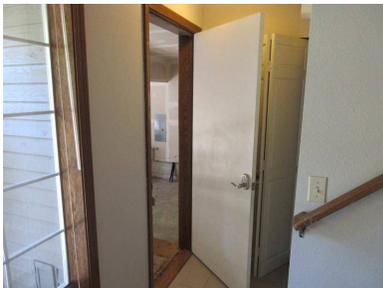
#### 6.5 PASSAGE DOOR

The self closing hinge has been disabled and therefore the west door is no longer part of the fire rated assembly between the living space and garage. The installation of a self closing hinge is recommended as a safety upgrade.

**6.4 Passage Door**

New Hinges installed and self closing verified

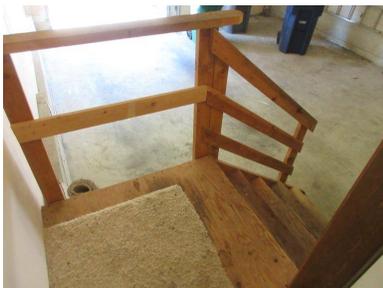
#### 6.6 STAIRS

The stair railing baluster spacing is too wide. This is a hazard for small children. The baluster spacing should be reduced as a safety upgrade. Current standards require that a 4" sphere not pass through the railing.

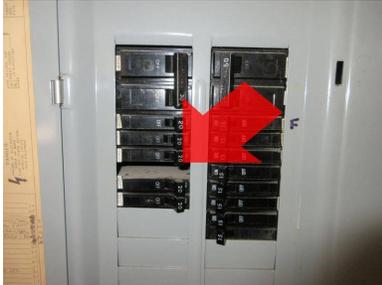
Twist-outs are missing from the service panel cover. This exposes live conductors and is a shock hazard. The installation of snap-in replacement blanks is recommended.

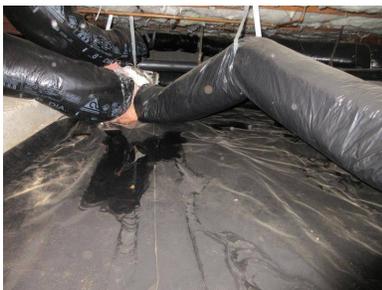
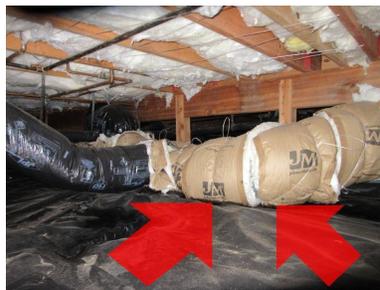
Heating ducts are in direct contact with water in the crawlspace under the kitchen and dining rooms. This will cause the ducts to corrode. They should be reattached and secured in accordance with the manufacturer's specifications. Proper clearances should be established under the air ducts.

Numerous air register covers are missing. The holes in the floor are hazardous. The air registers covers should be installed.

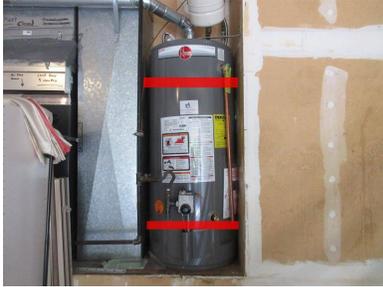
### 9.12 SEISMIC RESTRAINT

The seismic restraint for the water heater was minimal. Proper strapping is recommended to adequately secure the tank and provide potable water in the event of an earthquake.

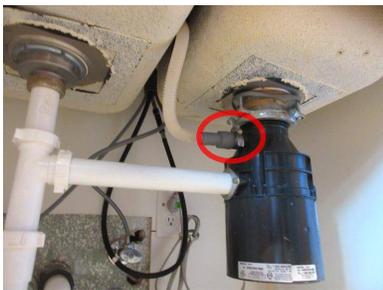
**10.8 AIR GAP**

The dishwasher drain lacks an air gap. The dishwasher will function without one, but there is a risk of contamination of the inside of the dishwasher by waste water. The installation of an air gap is recommended.

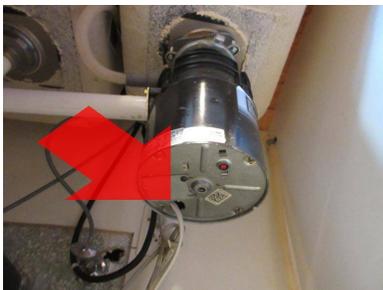
The cord is not clamped where it enters the disposal. This could damage the wires or cause a ground fault. The cord should be clamped in accordance with industry standards.

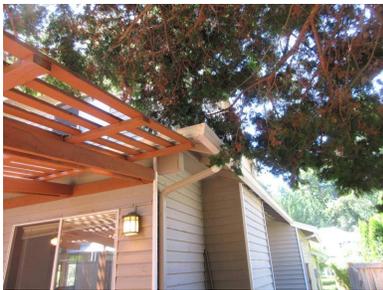
Trees are touching the building on the west side. Low hanging tree branches can damage the roof, gutters, siding, doors and/or windows. Tree branches should be trimmed back where necessary.

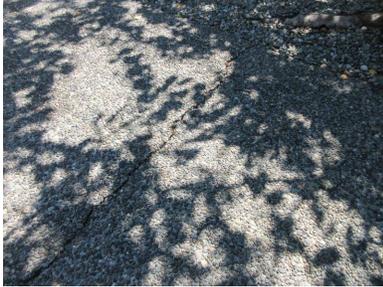
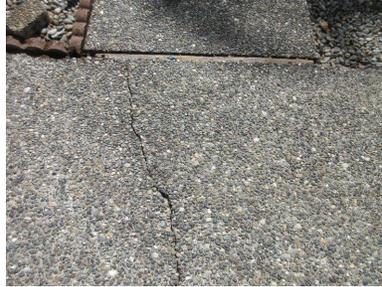
### *2.4 DRIVEWAY*

One or more of the wooden dividers separating the concrete driveway sections were infested by wood destroying organisms and have deteriorated to a point where they are becoming a trip hazard. Replacement with mortar is recommended.

Cracks were observed in the concrete surface of the driveway. Minor cracks can be sealed to minimize moisture entry and further settlement of the concrete. Minor cracks are common and do not affect the serviceability of the concrete.

Minor cracks also were observed in the concrete surface of the driveway. Minor cracks can be sealed to minimize moisture entry and further settlement of the concrete. Minor cracks are common and do not affect the serviceability of the concrete.

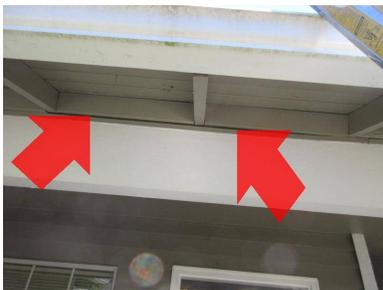
### 3.3 SOFFITS AND OVERHANGS

There are large gaps over 1/4" in size adjacent the soffit vent blocks. These gaps allow insects and rodents to enter the structure. Covering the gaps with screening, a strip of wood and/or caulking is recommended.

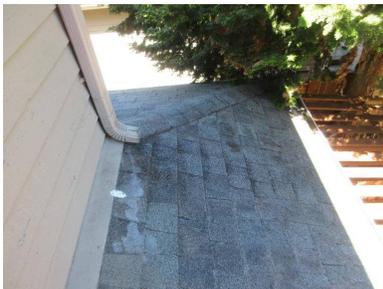
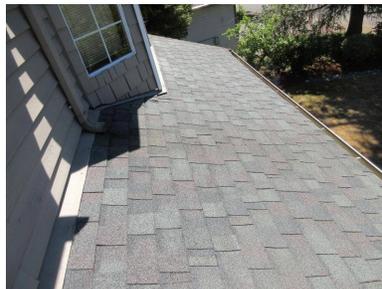
### 3.4 GUTTERS AND DOWNSPOUTS

Downspouts draining directly onto the asphalt shingle surface causes excessive wear of the roofing material. Downspout extensions to the lower gutters should be installed to prevent excessive wear and tear of the roofing.

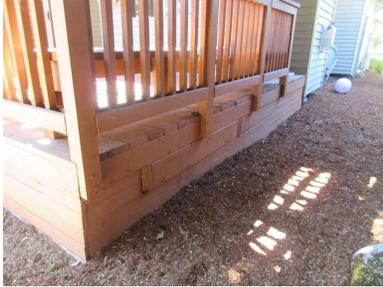
### 3.6 DECK

There is no access to the crawl space area under the enclosed outdoor deck. The installation of an access opening is recommended for inspection and servicing of this area. Defects or deficiencies may exist in inaccessible areas.

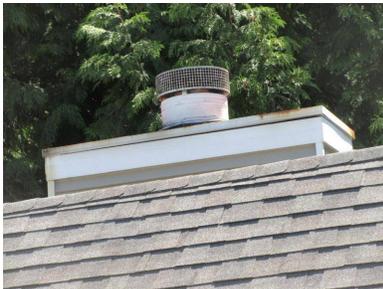
### 4.4 CHIMNEYS

The chase cover for the fireplace is concave and holds water. This has resulted in corrosion of the sheet metal. When rust holes form the cover will begin to leak. Chase cover replacement is recommended. The new chase cover should be sloped for drainage.

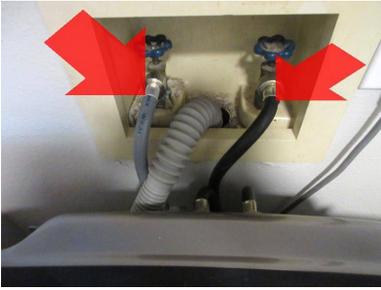
High pressure (steel braided) washer line connections is recommended.

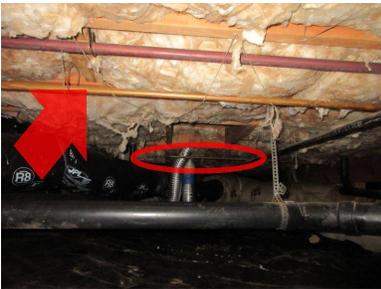
There are water pipes in the crawlspace that are not adequately insulated and could freeze. The installation of foam pipe insulation on all exposed water pipes is recommended.

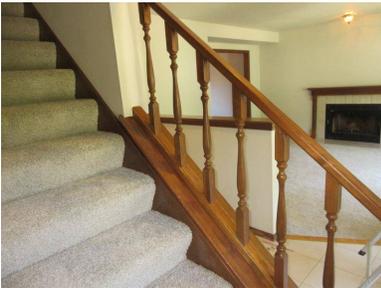
The stair railing baluster spacing is too wide. This is a hazard for small children. The baluster spacing should be reduced as a safety upgrade. Current standards require that a 4" sphere not pass through the railing.

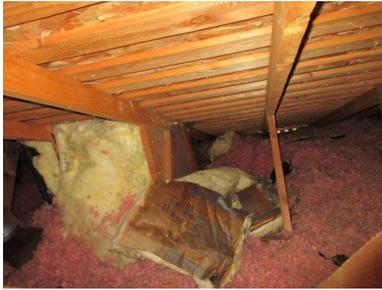
At least one of the insulation batts were not properly secured and have falling down. The fallen batts should be reinstalled and secured.

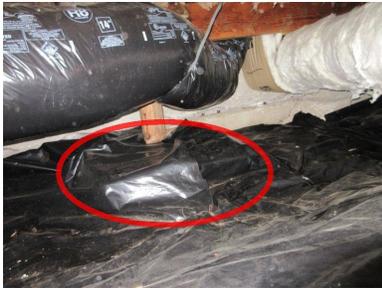
The support post concrete piers are covered with the plastic vapor retarder. This allows the transmission of water vapor from the soil up and into the floor framing. The plastic vapor retarder should be removed from the pier so that it covers at least 85% of the entire surface of the soil only.

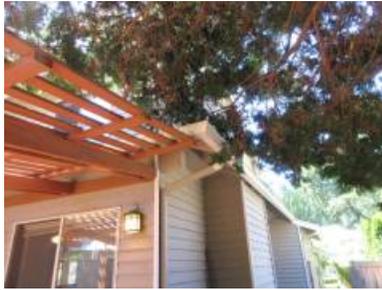
Trees are touching the building on the west side. Low hanging tree branches can damage the roof, gutters, siding, doors and/or windows. Tree branches should be trimmed back where necessary.

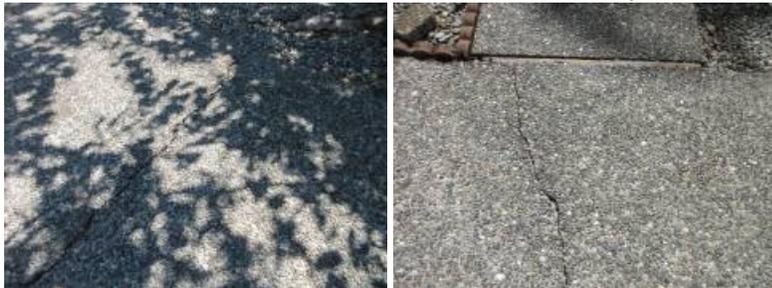
Cracks were observed in the concrete surface of the driveway. Minor cracks can be sealed to minimize moisture entry and further settlement of the concrete. Minor cracks are common and do not affect the serviceability of the concrete.

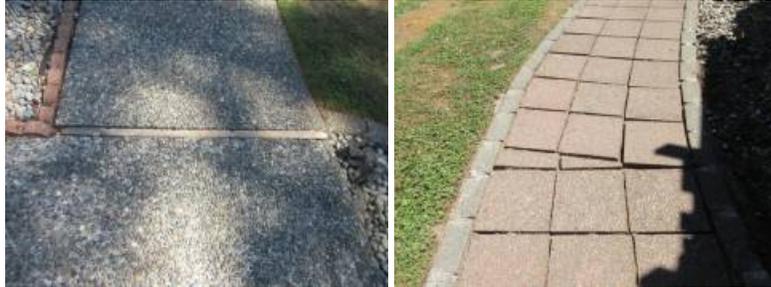
Many legal and public works departments have defined a trip hazard as an irregularity in a walking surface exceeding one inch (1") in height. All walking surfaces should maintain, free of a vertical surface change of 3/4" or more, in the interest of public and personal safety.

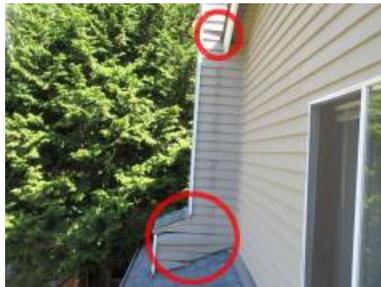
The siding at the west chimney chase wall is damaged. The siding has had chronic contact with moisture. Damaged material should be repaired and protected from chronic contact with moisture. Refer to discussion under Roofing/Flashing.

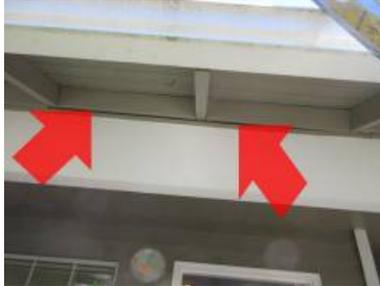
There are large gaps over 1/4" in size adjacent the soffit vent blocks. These gaps allow insects and rodents to enter the structure. Covering the gaps with screening, a strip of wood and/or caulking is recommended.

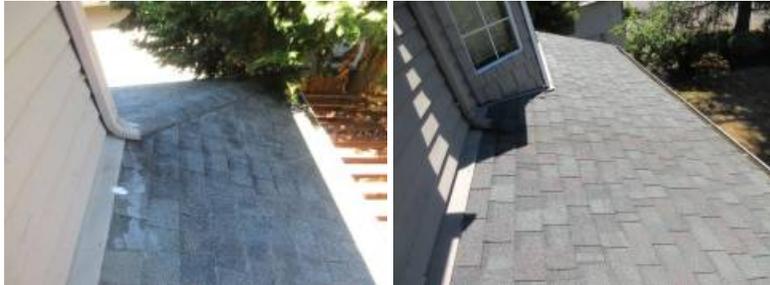
Downspouts draining directly onto the asphalt shingle surface causes excessive wear of the roofing material. Downspout extensions to the lower gutters should be installed to prevent excessive wear and tear of the roofing.

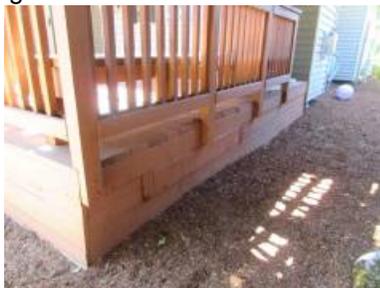
There is no access to the crawl space area under the enclosed outdoor deck. The installation of an access opening is recommended for inspection and servicing of this area. Defects or deficiencies may exist in inaccessible areas.

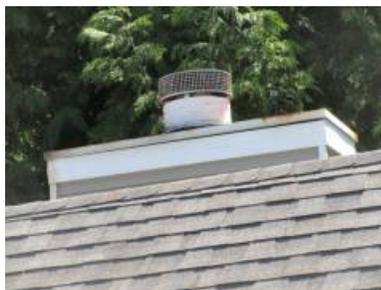
The chase cover for the fireplace is concave and holds water. This has resulted in corrosion of the sheet metal. When rust holes form the cover will begin to leak. Chase cover replacement is recommended. The new chase cover should be sloped for drainage.

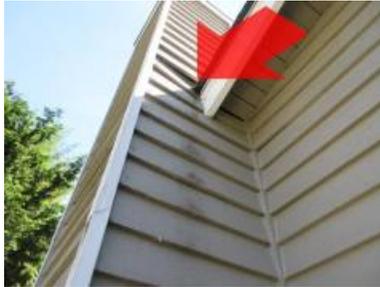
There is no kick out flashing at the roof edge to wall intersection above the gutter at the west chimney. This will allow water to enter the wall behind the siding. The installation of a kick-out flashing is recommended.

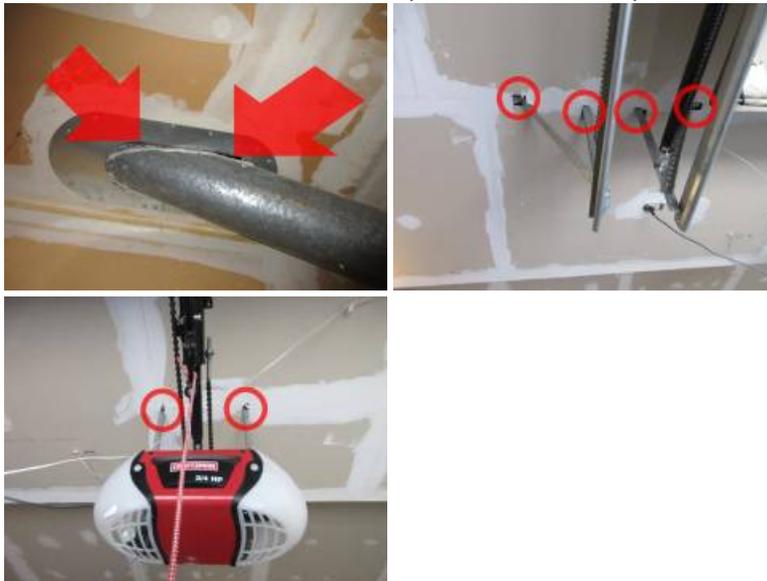
The installation of a properly fitted furnace vent thimble is recommended to prevent flames to spread to the structure.

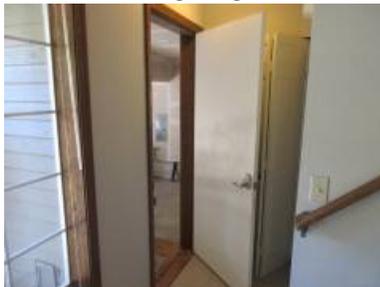
The self closing hinge has been disabled and therefore the west door is no longer part of the fire rated assembly between the living space and garage. The installation of a self closing hinge is recommended as a safety upgrade.

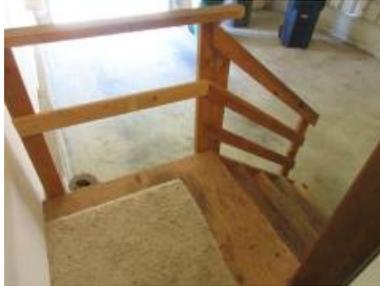
The stair railing baluster spacing is too wide. This is a hazard for small children. The baluster spacing should be reduced as a safety upgrade. Current standards require that a 4" sphere not pass through the railing.

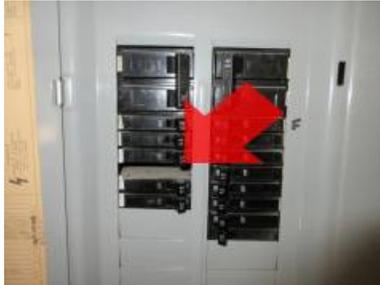
Twist-outs are missing from the service panel cover. This exposes live conductors and is a shock hazard. The installation of snap-in replacement blanks is recommended.

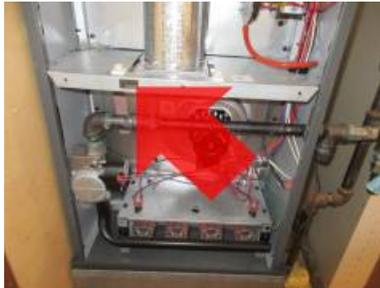
The door switch prevents the gas furnace blower from circulating CO in case the blower panel is off. Sometimes we forget to put the panel back on, or it could fall off during operation. If you bypass the door switch, **blower operation will continue**. In that situation, this is a potential hazard.

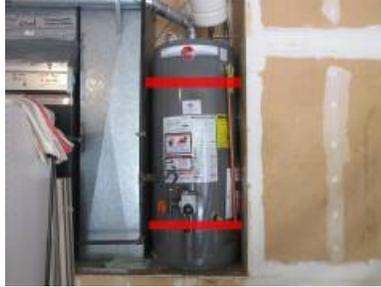
The seismic restraint for the water heater was minimal. Proper strapping is recommended to adequately secure the tank and provide potable water in the event of an earthquake.

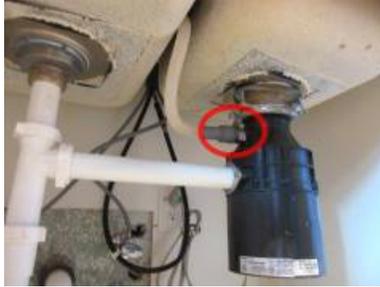
The dishwasher drain lacks an air gap. The dishwasher will function without one, but there is a risk of contamination of the inside of the dishwasher by waste water. The installation of an air gap is recommended.

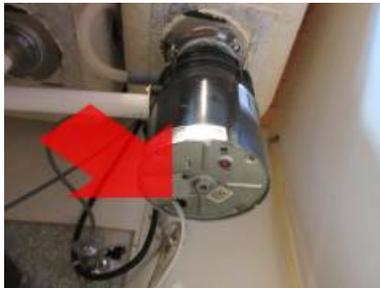
The cord is not clamped where it enters the disposal. This could damage the wires or cause a ground fault. The cord should be clamped in accordance with industry standards.

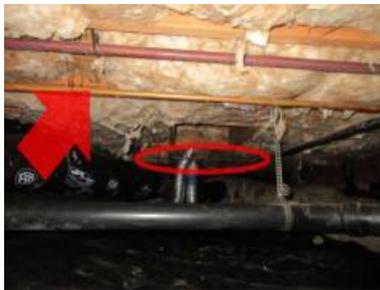
There are water pipes in the crawlspace that are not adequately insulated and could freeze. The installation of foam pipe insulation on all exposed water pipes is recommended.

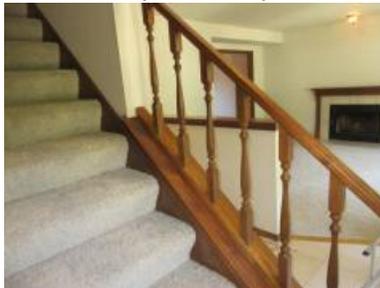
The stair railing baluster spacing is too wide. This is a hazard for small children. The baluster spacing should be reduced as a safety upgrade. Current standards require that a 4" sphere not pass through the railing.

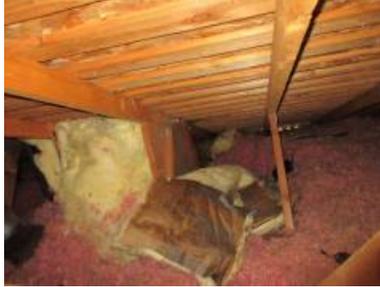
At least one of the insulation batts were not properly secured and have falling down. The fallen batts should be reinstalled and secured.

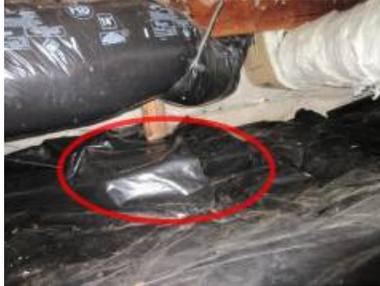
The support post concrete piers are covered with the plastic vapor retarder. This allows the transmission of water vapor from the soil up and into the floor framing. The plastic vapor retarder should be removed from the pier so that it covers at least 85% of the entire surface of the soil only.
