# NOTICE TO BUYER: SELLER-PROCURED INSPECTION REPORT

**Michael Salamone and Wenting Cai**  
**17302 NE 131st St**  
**Redmond, WA 98052**

**Per the seller, the following items listed on the pre-sale inspection summary dated February 15, 2022, are being corrected by the seller as part of preparation for sale in good faith.**

At your request, a visual inspection of the above referenced property was conducted on 02/15/2022. We have inspected the major structural components, plumbing, heating and electrical systems for signs of significant non-performance, excessive or unusual wear and general state of repair.

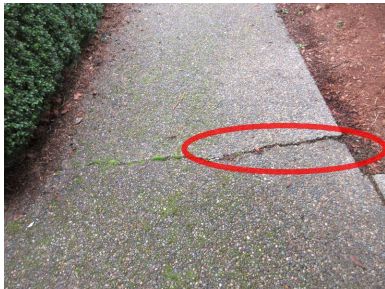
### 2.6 WALKWAY

The walkway has cracked and settled differentially. This was probably caused by inadequate preparation of the soil prior to the placement of the concrete. This condition can be repaired by pressure grouting the sunken portion of the walkway or by removing and replacing it. Grinding down the raised edges of the concrete will also mitigate the hazard. The walkway remains functional despite this condition. However, the raised edges of the concrete can be a trip hazard for some people. Repairs should be made as necessary.

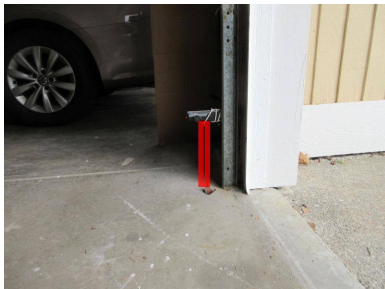
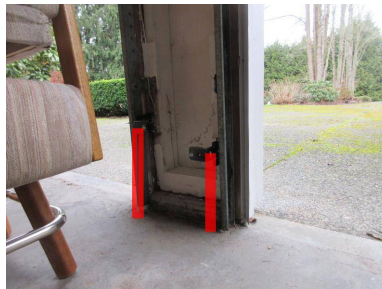
The Photo-eye beam was installed to high above the floor of the garage to adequately offer protection for small children and/or pets. We recommend that the photo-eye be lowered to within 4-6" of the floor.

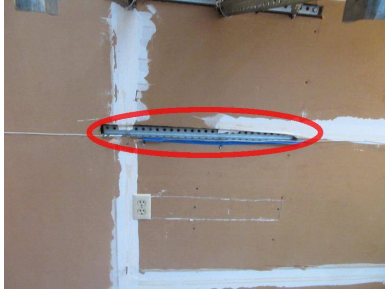
#### 6.4 FIRE SEPARATION

There are voids adjacent the garage door brackets in the fire resistive barrier between the living space and garage that will allow flames to penetrate. The gypsum barrier slows the spread of a fire from the garage to the structure and/or living space. Patching the voids with a fire retardant caulk is recommended.

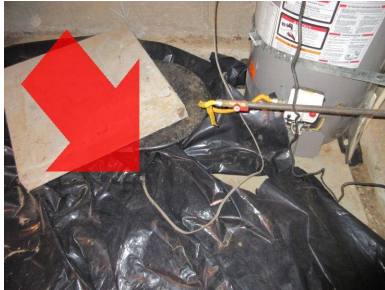
#### 7.10 WIRING

There is an abandoned electrical cable with exposed conductors in the crawl adjacent the water heater. This is a shock hazard. The cable should be terminated in a covered junction box or removed.

7.10 Wiring – cable was removed

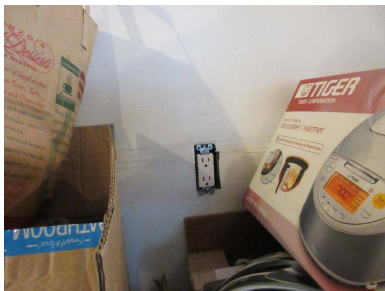
#### 7.12 RECEPTACLES

The receptacle adjacent the dining room slider on the north exterior wall at the exterior is loose. This is a potential shock and a fire hazard. All loose receptacles should be repaired as necessary.

The cover plates are missing from several receptacles. This is a shock and fire hazard. The installation of a cover plates is recommended.

7.12 Receptacles – cover plates were installed

7.12 Receptacles – the receptacle adjacent the slider on the north exterior wall will be repaired or replaced

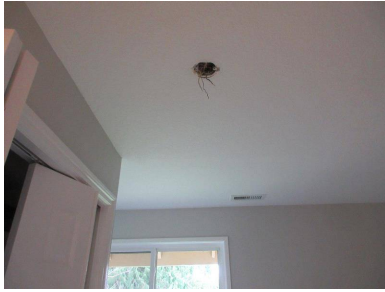
#### 7.15 LUMINARIES

The luminaire in one of the bedrooms is missing. A luminaire should be installed to provide proper lighting in this area.

There are several luminaries in the master bedroom closet that are not working. Testing the luminaries with a voltage tester revealed that there is current to the luminaries. Light bulbs should be replaced in non-functional luminaries and then they should be tested for proper operation.

7.15 Luminaires were installed in front bedroom and master bedroom closets

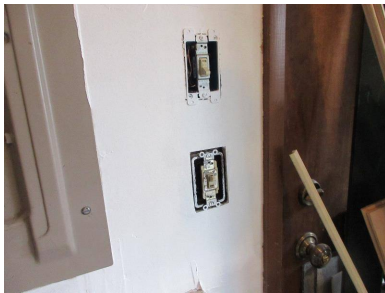
#### **7.16 SWITCHES**

The cover plate is missing from the wall switch in the garage. This is a shock and fire hazard. The installation of a cover plate is recommended.

7.16 Switches – cover plates were installed in garage

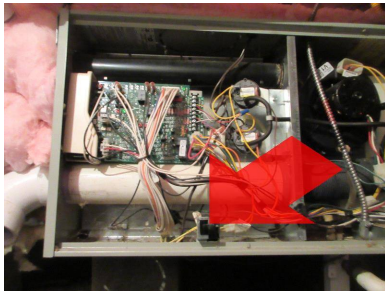
##### **8.10 BLOWER**

The blower door cut-out switch has been disabled. This is a potential hazard. The cut-out switch should be not be restricted.

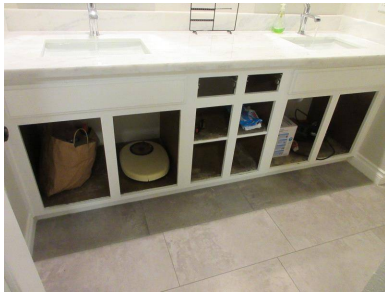
The bathroom cabinet doors are missing and in need of replacement. The cabinet is otherwise in serviceable condition.

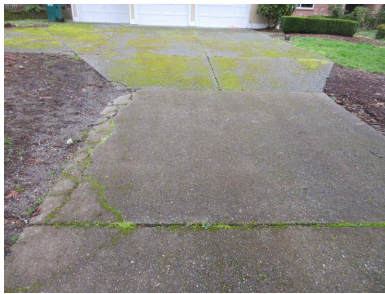
The driveway has cracked and settled differentially. This was probably caused by inadequate preparation of the soil prior to the placement of the concrete. This condition can be repaired by pressure grouting the sunken portion of the driveway or by removing and replacing it. The driveway remains functional despite this condition.

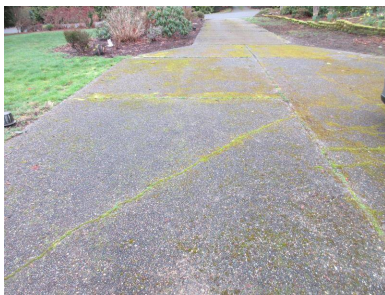
Cracks were observed in the concrete surface of the driveway. Minor cracks can be sealed to minimize moisture entry and further settlement of the concrete. Minor cracks are common and do not affect the serviceability of the concrete.

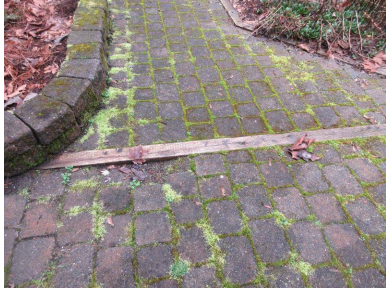
#### **2.5 PATIO**

The wooden dividers separating the masonry patio sections will eventually deteriorate to a condition where the gaps would be a trip hazard. Replacement with mortar is recommended.

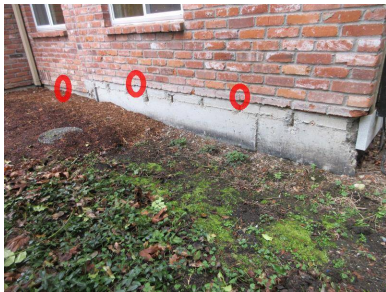
### 3.2 SECONDARY EXTERIOR WALL CLADDING

The brick is a veneer installed over the wood wall structure. It is not a structural component of the wall. Weep holes are missing at the bottom of the masonry wall. This allows moisture to become trapped behind the brick. Weep holes are recommended to mitigate moisture damage.

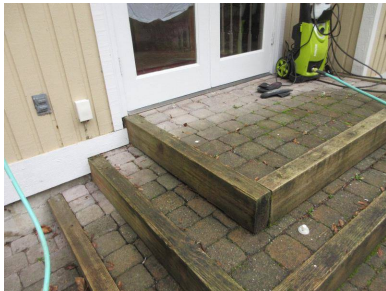
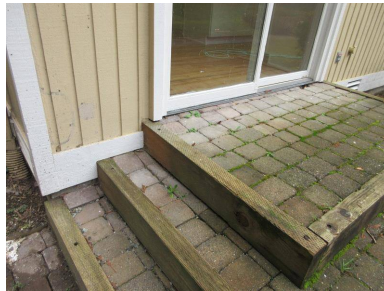
### 3.3 PEST CONTROL

Untreated wood in direct contact with concrete was observed along the patio stoops. Untreated wood should be raised 1-2" above the concrete. Treating the wood with a preservative sometimes will prevent wood destroy organism damage.

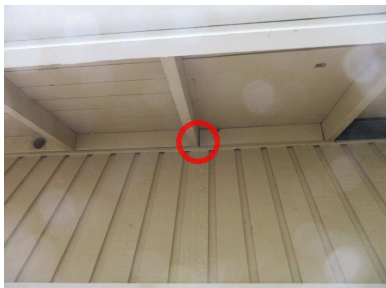
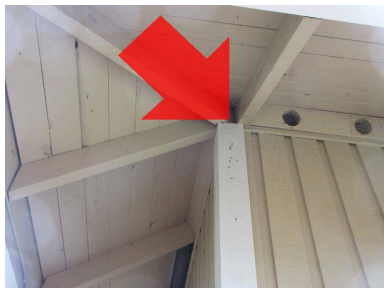
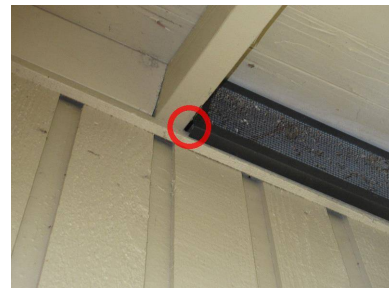
### 3.4 SOFFITS AND OVERHANGS

There are large gaps over 1/4" in size adjacent the soffit vent blocks. These gaps allow insects and rodents to enter the attic. Covering the gaps with screening, a strip of wood and/or caulking is recommended.

3.4 Soffits and Overhangs – Willard’s Pest Control has inspected the home and disputes some of the findings in the inspection report. However, they did go ahead and seal some of the areas called out on the report as well as another area they found. Notes from Willard’s inspection will be provided.

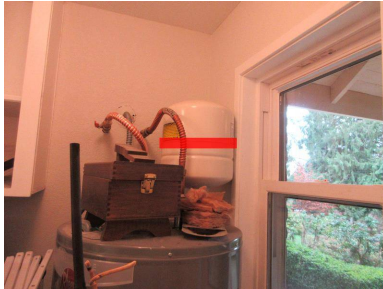
The expansion tank is not adequately secured to the wall. As code requirements start to call for engineered expansion tank supports we recommend the installation of seismic restraints to secure the expansion tank instead of allowing it to simply depend on piping connections that could result in damage to the water pipe and leakage during an earthquake.

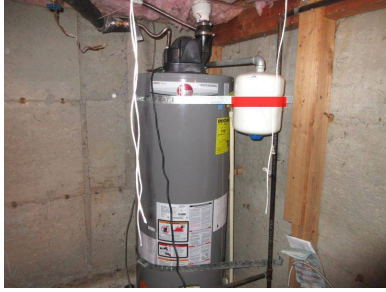
The expansion tank is not adequately secured to the wall. As code requirements start to call for engineered expansion tank supports we recommend the installation of seismic restraints to secure the expansion tank instead of allowing it to simply depend on piping connections that could result in damage to the water pipe and leakage during an earthquake.

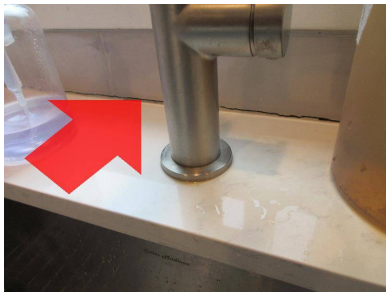
### 11.1 COUNTERTOPS

The backsplash is not caulked. Cracking of the grout allows water to enter the gap between the back splash and counter and is difficult to clean. Caulking should be installed at this location.

11.1 Countertops – Cracked grout will be repaired and caulking will be installed

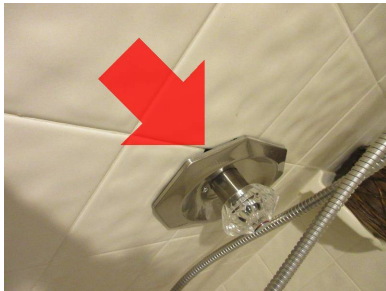
The caulking around the shower faucet escutcheon is missing. The wall surround should be caulked to prevent moisture penetration into the surrounding materials and subsequent damage.

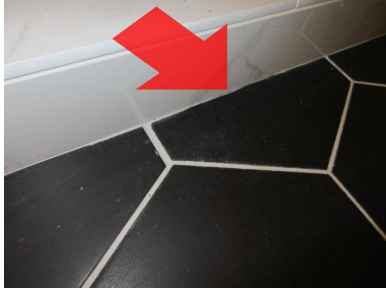
#### 12.29 FLOORING MATERIAL

The grout is cracked at the intersection between the tub/shower and floor. This can lead to water damage to the flooring and substrate. Caulking this area with a flexible grout is recommended.

12.29 Flooring Material – grout will be repaired and caulking with flexible grout will be installed

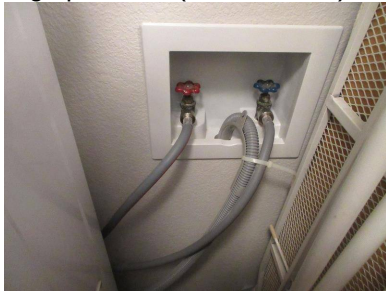
### 13.5 APPLIANCES

High pressure (steel braided) washer line connections is recommended.

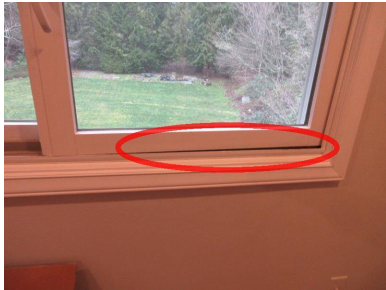
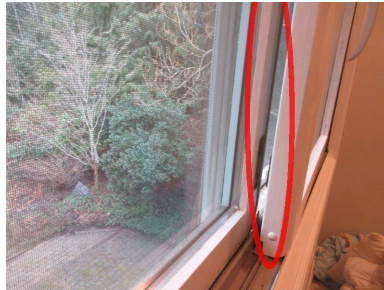
### 15.8 WINDOWS

One of the bedroom windows does not operate smoothly which makes it difficult to close completely. We recommend repairs as necessary to restore the windows proper operation.

15.8 Windows – malfunctioning window will be repaired

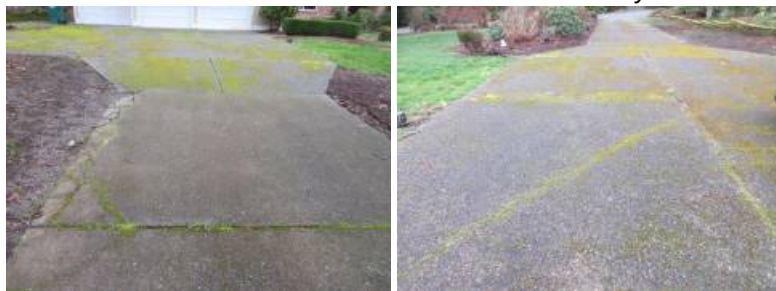
Cracks were observed in the concrete surface of the driveway. Minor cracks can be sealed to minimize moisture entry and further settlement of the concrete. Minor cracks are common and do not affect the serviceability of the concrete.

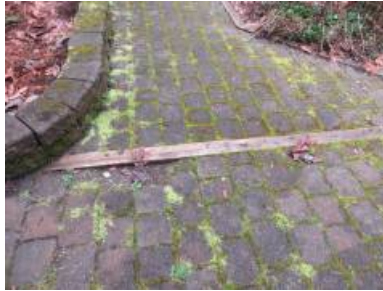
## 2.5 PATIO

The wooden dividers separating the masonry patio sections will eventually deteriorate to a condition where the gaps would be a trip hazard. Replacement with mortar is recommended.

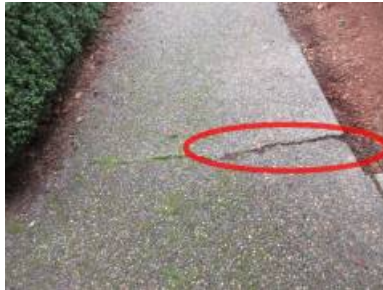
## 2.6 WALKWAY

The walkway has cracked and settled differentially. This was probably caused by inadequate preparation of the soil prior to the placement of the concrete. This condition can be repaired by pressure grouting the sunken portion of the walkway or by removing and replacing it. Grinding down the raised edges of the concrete will also mitigate the hazard. The walkway remains functional despite this condition. However, the raised edges of the concrete can be a trip hazard for some people. Repairs should be made as necessary.

Many legal and public works departments have defined a trip hazard as an irregularity in a walking surface exceeding one inch (1") in height. All walking surfaces should maintain, free of a vertical surface change of 3/4" or more, in the interest of public and personal safety.

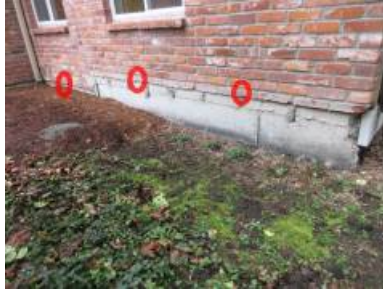
The brick is a veneer installed over the wood wall structure. It is not a structural component of the wall. Weep holes are missing at the bottom of the masonry wall. This allows moisture to become trapped behind the brick. Weep holes are recommended to mitigate moisture damage.

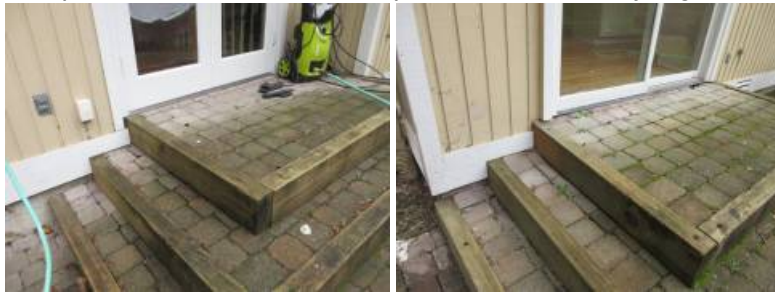
### 3.3 PEST CONTROL

Untreated wood in direct contact with concrete was observed along the patio stoops. Untreated wood should be raised 1-2" above the concrete. Treating the wood with a preservative sometimes will prevent wood destroy organism damage.

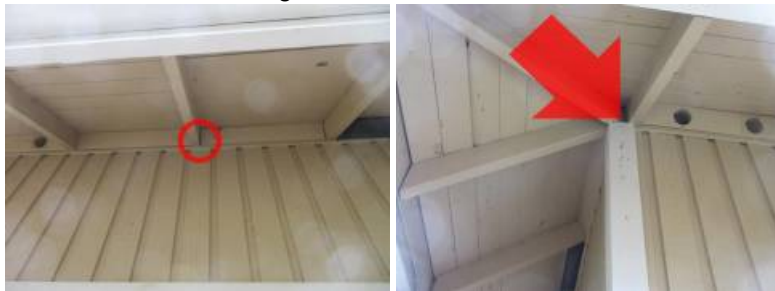
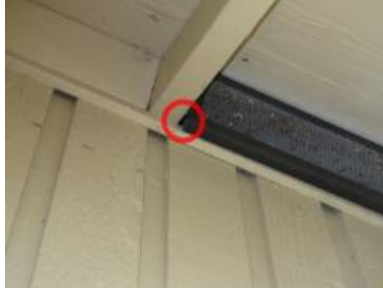
### 3.4 SOFFITS AND OVERHANGS

There are large gaps over 1/4" in size adjacent the soffit vent blocks. These gaps allow insects and rodents to enter the attic. Covering the gaps with screening, a strip of wood and/or caulking is recommended.

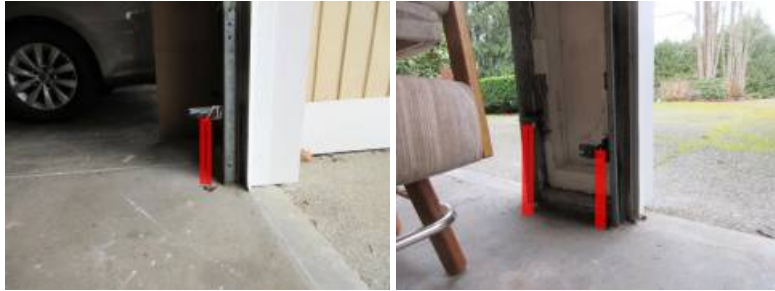
The Photo-eye beam was installed too high above the floor of the garage to adequately offer protection for small children and/or pets. We recommend that the photo-eye be lowered to within 4-6" of the floor.

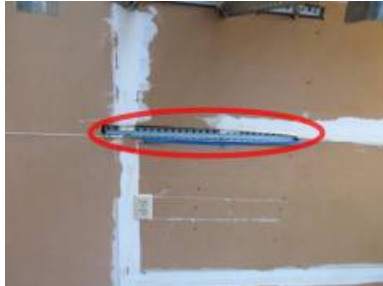
#### 6.4 FIRE SEPARATION

There are voids adjacent the garage door brackets in the fire resistive barrier between the living space and garage that will allow flames to penetrate. The gypsum barrier slows the spread of a fire from the garage to the structure and/or living space. Patching the voids with a fire retardant caulk is recommended.

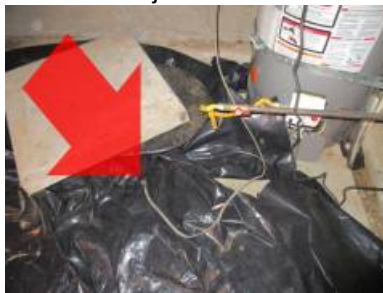
There is an abandoned electrical cable with exposed conductors in the crawl adjacent the water heater. This is a shock hazard. The cable should be terminated in a covered junction box or removed.

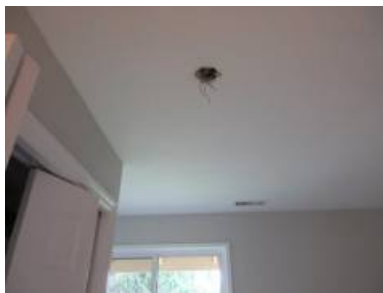
There are several luminaries in the master bedroom closet that are not working. Testing the luminaries with a voltage tester revealed that there is current to the luminaries. Light bulbs should be replaced in non-functional luminaries and then they should be tested for proper operation.

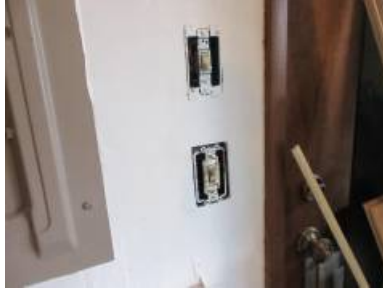
### 7.16 SWITCHES

The cover plate is missing from the wall switch in the garage. This is a shock and fire hazard. The installation of a cover plate is recommended.

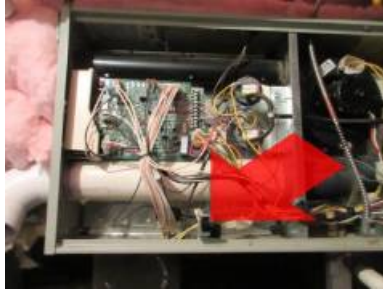
The blower door cut-out switch has been disabled. This is a potential hazard. The cut-out switch should be not be restricted.

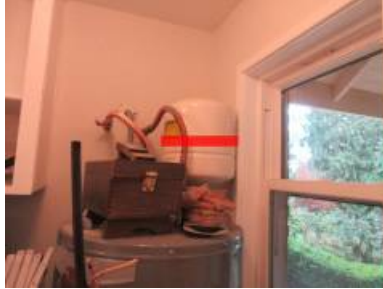
The expansion tank is not adequately secured to the wall. As code requirements start to call for engineered expansion tank supports we recommend the installation of seismic restraints to secure the expansion tank instead of allowing it to simply depend on piping connections that could result in damage to the water pipe and leakage during an earthquake.

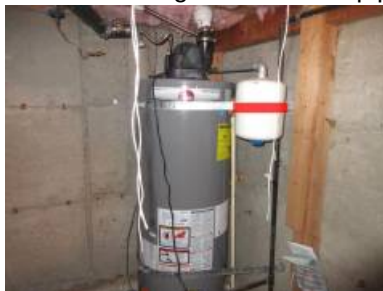
The expansion tank is not adequately secured to the wall. As code requirements start to call for engineered expansion tank supports we recommend the installation of seismic restraints to secure the expansion tank instead of allowing it to simply depend on piping connections that could result in damage to the water pipe and leakage during an earthquake.

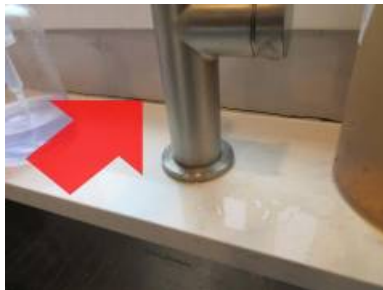
The backsplash is not caulked. Cracking of the grout allows water to enter the gap between the back splash and counter and is difficult to clean. Caulking should be installed at this location.

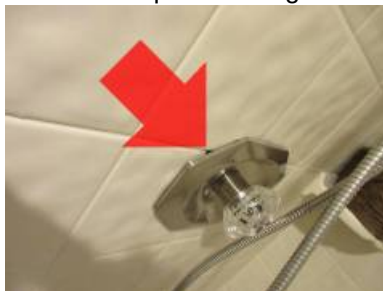
The caulking around the shower faucet escutcheon is missing. The wall surround should be caulked to prevent moisture penetration into the surrounding materials and subsequent damage.

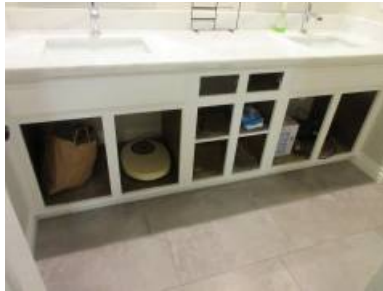
The bathroom cabinet doors are missing and in need of replacement. The cabinet is otherwise in serviceable condition.

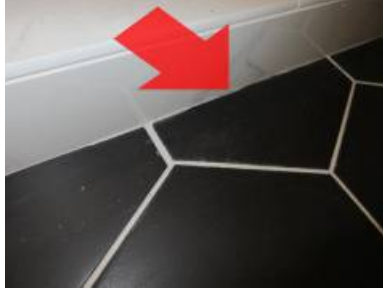
The grout is cracked at the intersection between the tub/shower and floor. This can lead to water damage to the flooring and substrate. Caulking this area with a flexible grout is recommended.

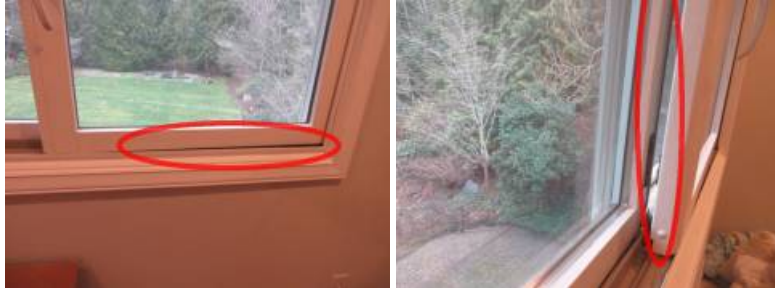
One of the bedroom windows does not operate smoothly which makes it difficult to close completely. We recommend repairs as necessary to restore the windows proper operation.
