NOTICE TO BUYER: SELLER-PROCURED INSPECTION REPORT

**Mr. & Mrs. Ekkehard & Gabi Priss
13833 174th Pl. NE
Redmond, WA.**

At your request, a visual inspection of the above referenced property was conducted on 02/08/2023. We have inspected the major structural components, plumbing, heating and electrical systems for signs of significant non-performance, excessive or unusual wear and general state of repair.

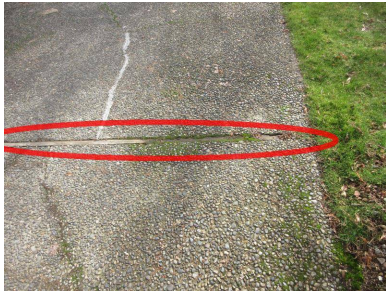
One or more of the wooden dividers separating the concrete driveway sections were infested by wood destroying organisms and have deteriorated to a point where they are becoming a trip hazard. Replacement with mortar is recommended.

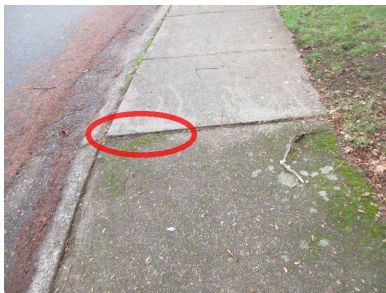
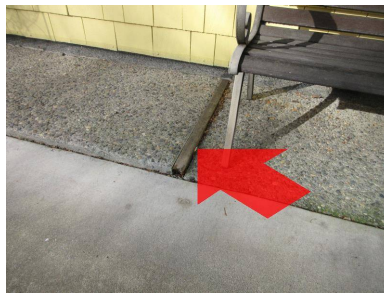
2.6 WALKWAY

The walkway has cracked and settled differentially. This was probably caused by inadequate preparation of the soil prior to the placement of the concrete. This condition can be repaired by pressure grouting the sunken portion of the walkway or by removing and replacing it. Grinding down the raised edges of the concrete will also mitigate the hazard. The walkway remains functional despite this condition. However, the raised edges of the concrete can be a trip hazard for some people. Repairs should be made as necessary.

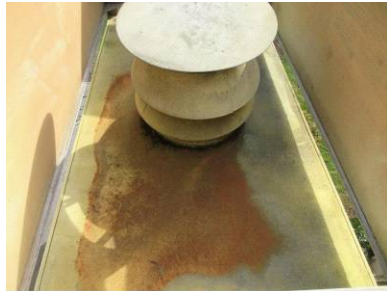
West chimney

The chase covers for the fireplaces are concave and hold water. This has resulted in corrosion of the sheet metal. When rust holes form the cover will begin to leak. Leakage was observed from within the attic. Chase cover replacement is recommended. The new chase cover should be sloped for drainage.

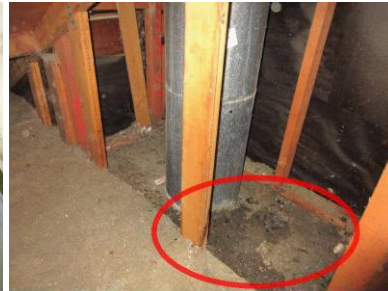
Observed from within the attic.

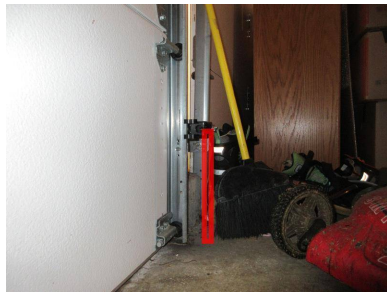
The Photo-eye beam was installed too high above the floor of the garage to adequately offer protection for small children and/or pets. We recommend that the photo-eye be lowered to within 4-6" of the floor.

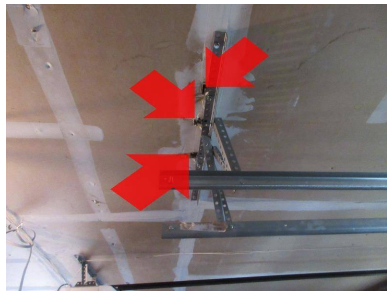
6.4 FIRE SEPARATION

There are voids in the fire resistive barrier between the living space and garage that will allow flames to penetrate. The gypsum barrier slows the spread of a fire from the garage to the structure and/or living space. Patching the voids with a fire retardant caulk is recommended.

6.4 Fire Separation – Patched

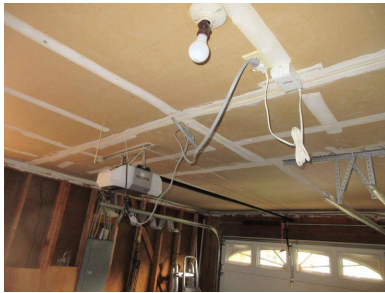
An extension cord is used as a temporary power source for the garage door opener. An extension cord is not suitable as a permanent wiring method. The installation of a receptacle within cords length of the motor is recommended.

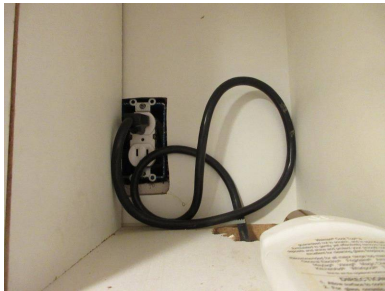
7.11 RECEPTACLES

The polarity is reversed in receptacles in the main floor powder room. Reversed polarity means that the hot and neutral wires are reversed at the back of the receptacle. This defect is a shock hazard and can damage some electronic equipment. All receptacles exhibiting reversed polarity should be rewired.

The cover plate is missing from a receptacle in the kitchen cabinet over the range. This is a shock and fire hazard. The installation of a cover plate is recommended.

There are several loose receptacles throughout the home. This is a potential shock and a fire hazard. All loose receptacles should be repaired as necessary.

7.11 Receptables – All listed issues repaired

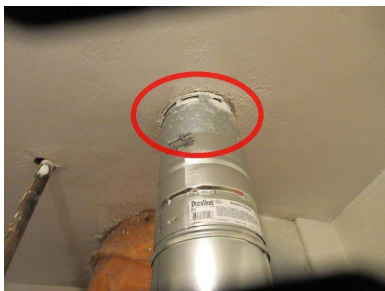
The furnace vent connector is too close to a combustible material. This is a hazard. A minimum clearance of 6" is required between the single wall vent connector and the combustible material. The double wall type B vent requires only 1" of clearance. Repairs are recommended.

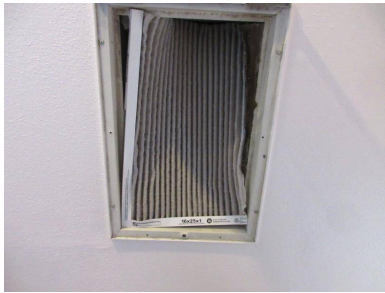
8.11 AIR FILTER

The air filter is ill-fitting and clogged with dust. This reduces air flow and furnace efficiency. Removal and replacement of the air filter is recommended. Pleated style air filters are recommended as they offer better filtration of dust than the coarser hogs hair or fiberglass filters.

8.11 Air Filter – New air filters installed

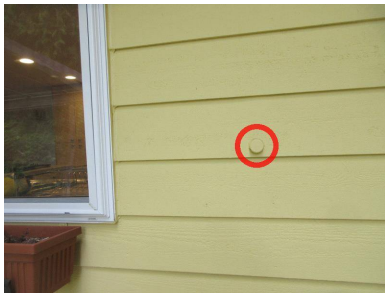
An air gap called a Johnson Tee is installed in the kitchen wall. This air gap protects the dishwasher from contamination caused by a backflow of waste water. The cap protruding on the exterior wall opposite the dishwasher is not drilled. This renders the air gap non-functional. Drilling a 1/4" hole in the end of the cap will restore its function. The remaining visible portions of the Johnson Tee were properly installed and functioning as intended.

10.11 Air Gap – will be addressed

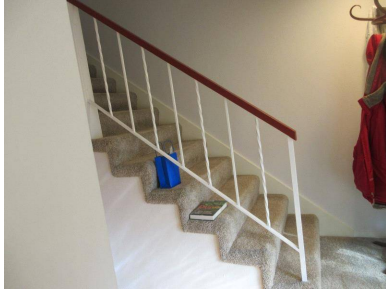
The stair railing baluster spacing is too wide. This is a hazard for small children. The baluster spacing should be reduced as a safety upgrade. Current standards require that a 4-3/8" sphere not pass through the railing.

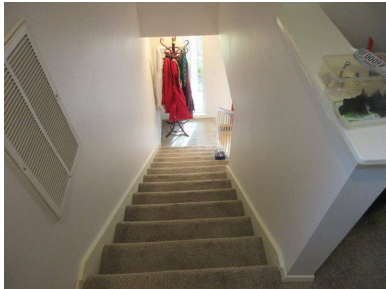
The stair railing spacing at the stair treads is too wide. This is a hazard for small children. The railing spacing should be reduced as a safety upgrade. Current standards require that a 6" sphere not pass through or under the railing.

There is no handrail in the upper stairwell. This is a safety hazard. The installation of a graspable handrail that conforms to present industry standards is recommended.

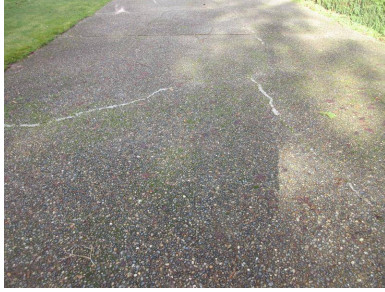
Cracks were observed in the concrete surface of the driveway. Minor cracks can be sealed to minimize moisture entry and further settlement of the concrete. Minor cracks are common and do not affect the

serviceability of the concrete.

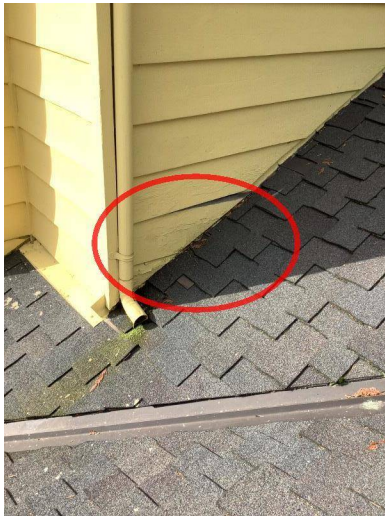
3.1 PRIMARY EXTERIOR WALL CLADDING

The siding above the roof is damaged where it has been in contact with the roofing material. The loose siding should be repaired and a minimum of a 2" clearance should be maintained between the top of the roofing and bottom of the siding.

3.1 Primary Exterior Wall Cladding – Repaired

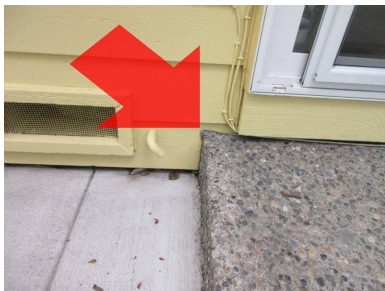
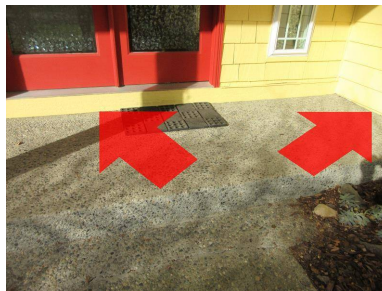
3.3 PEST CONTROL

Untreated wood in direct contact with concrete was observed along the front porch and patio stoop. Untreated wood should be raised 1-2" above the concrete. Treating the wood with a preservative sometimes will prevent wood destroy organism damage.

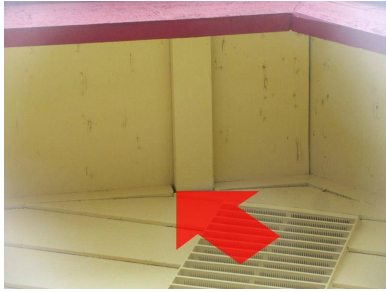
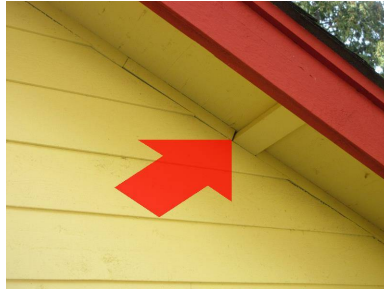
3.4 SOFFITS AND OVERHANGS

There are openings adjacent the ends of the outlook boards under the overhang through which insects and rodents can enter into the attic. These openings should be covered with wood, wire mesh or filled with aerosol foam.

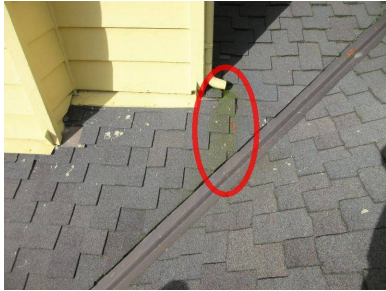
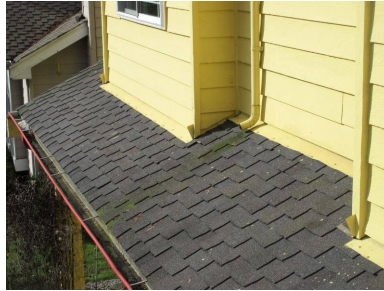
3.5 GUTTERS AND DOWNSPOUTS

Downspouts draining directly onto the asphalt shingle surface causes excessive wear of the roofing material. Downspout extensions to the lower gutters should be installed to prevent excessive wear and tear of the roofing.

The 2" round downspouts are too small and are more vulnerable to clogging than the larger rectangular ones. Consideration should be given to upgrading the downspouts.

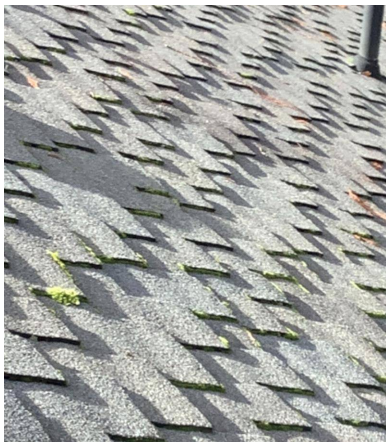
4.7 MAINTENANCE AND REPAIRS

The roof is in need of routine maintenance. The surface should be treated for moss, lichen, and algae growth, then brushed and washed off with a high volume low pressure hose to remove moss and organic debris. Performing this maintenance will improve the appearance and increase the life expectancy of the roof.

4.7 Maintenance And Repairs – Roof treatment to be considered

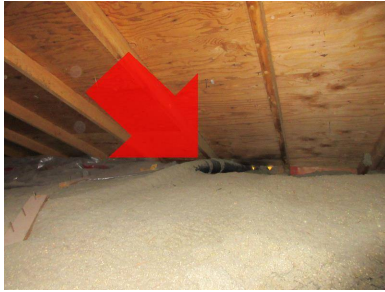
Replacing the plastic duct with 4" smooth-wall sheet metal duct is recommended.

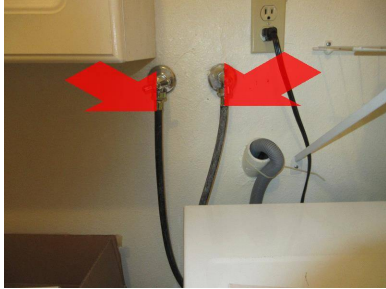
Upgrading the washer connections to high pressure (steel braided) lines is recommended.

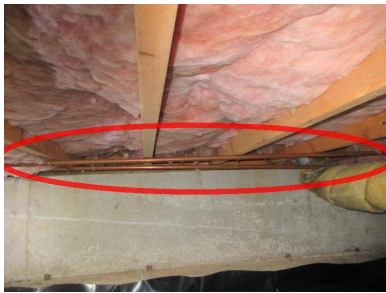
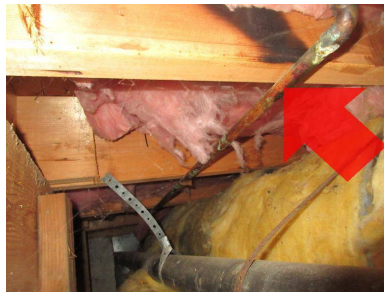
There are water pipes in the crawlspace that are not adequately insulated and could freeze. The installation of foam pipe insulation on all exposed water pipes is recommended.

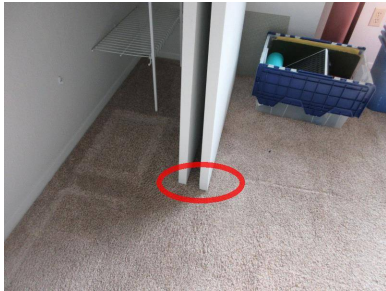
The floor guides are missing from the bypass closet doors in the bedroom. Missing floor guides could result in damage to the doors. The installation of floor guides is recommended.

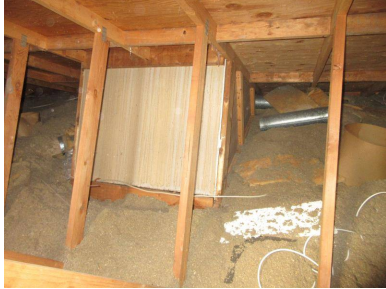
17.2 SKYLIGHT

The skylight shaft is not insulated. This condition will result in significant heat loss. The installation of additional attic insulation around the skylight shafts is recommended.

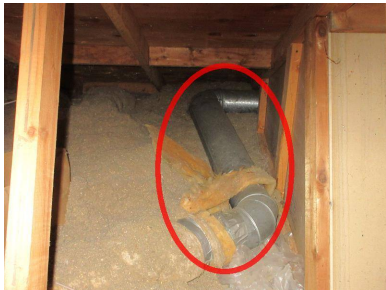
17.5 DUCT INSULATION

Some of the duct insulation is missing or has fallen off the ducts in the attic. This increases the amount of heat loss. The installation of new duct insulation is recommended in areas where insulation is missing.

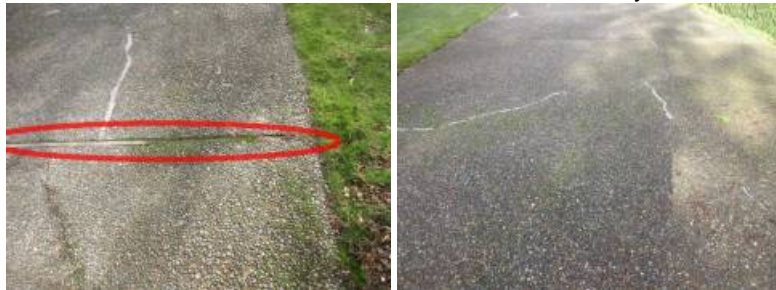
Cracks were observed in the concrete surface of the driveway. Minor cracks can be sealed to minimize moisture entry and further settlement of the concrete. Minor cracks are common and do not affect the serviceability of the concrete.

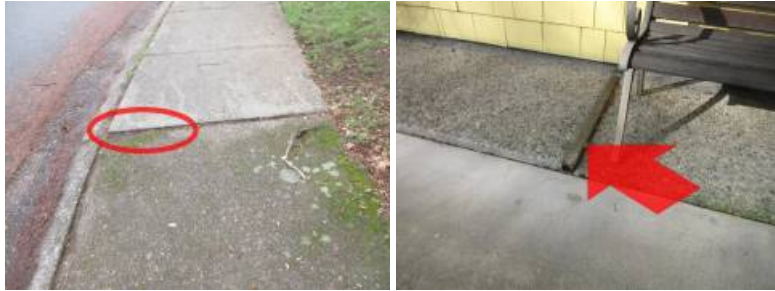
The walkway has cracked and settled differentially. This was probably caused by inadequate preparation of the soil prior to the placement of the concrete. This condition can be repaired by pressure grouting the sunken portion of the walkway or by removing and replacing it. Grinding down the raised edges of the concrete will also mitigate the hazard. The walkway remains functional despite this condition. However, the raised edges of the concrete can be a trip hazard for some people. Repairs should be made as necessary.

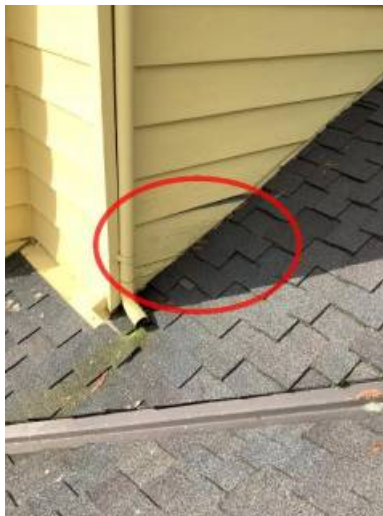
The siding above the roof is damaged where it has been in contact with the roofing material. The loose siding should be repaired and a minimum of a 2" clearance should be maintained between the top of the roofing and bottom of the siding.

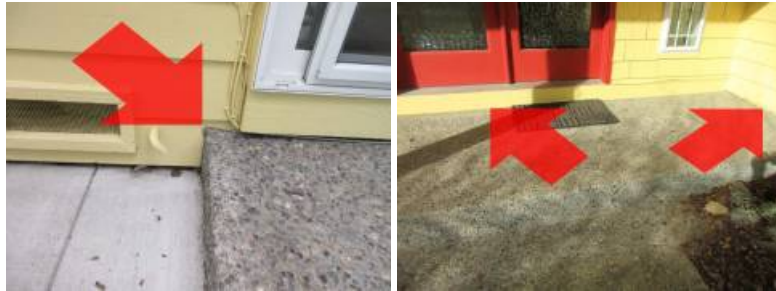
Untreated wood in direct contact with concrete was observed along the front porch and patio stoop. Untreated wood should be raised 1-2" above the concrete. Treating the wood with a preservative sometimes will prevent wood destroy organism damage.

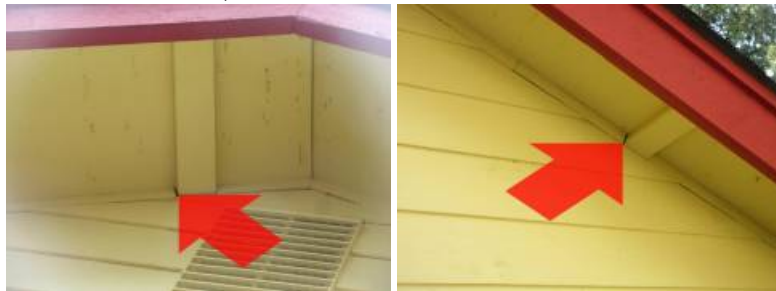
There are openings adjacent the ends of the outlook boards under the overhang through which insects and rodents can enter into the attic. These openings should be covered with wood, wire mesh or filled with aerosol foam.

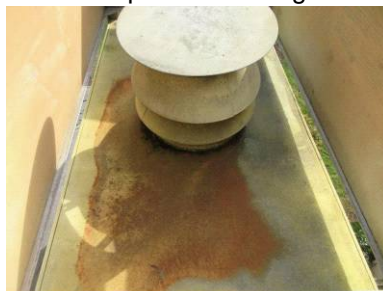
West chimney

The chase covers for the fireplaces are concave and hold water. This has resulted in corrosion of the sheet metal. When rust holes form the cover will begin to leak. Leakage was observed from within the attic. Chase cover replacement is recommended. The new chase cover should be sloped for drainage.

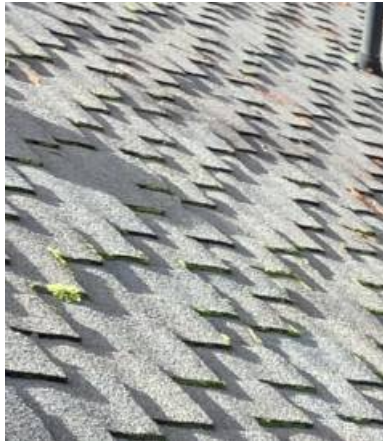
The roof is in need of routine maintenance. The surface should be treated for moss, lichen, and algae growth, then brushed and washed off with a high volume low pressure hose to remove moss and organic debris. Performing this maintenance will improve the appearance and increase the life expectancy of the roof.

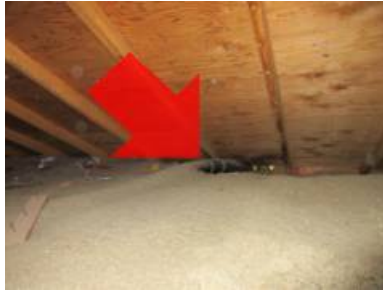
Flexible plastic duct is used to direct air from the vent fans to the exterior. This type of material is unreliable. Replacing the plastic duct with 4" smooth-wall sheet metal duct is recommended.

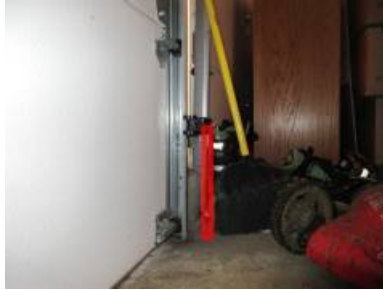
The Photo-eye beam was installed too high above the floor of the garage to adequately offer protection for small children and/or pets. We recommend that the photo-eye be lowered to within 4-6" of the floor.

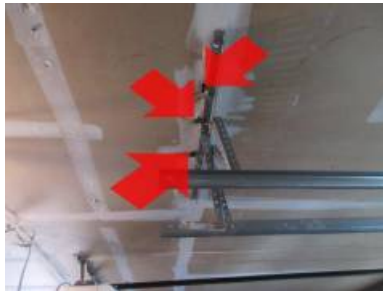
6.4 FIRE SEPARATION

There are voids in the fire resistive barrier between the living space and garage that will allow flames to penetrate. The gypsum barrier slows the spread of a fire from the garage to the structure and/or living space. Patching the voids with a fire retardant caulk is recommended.

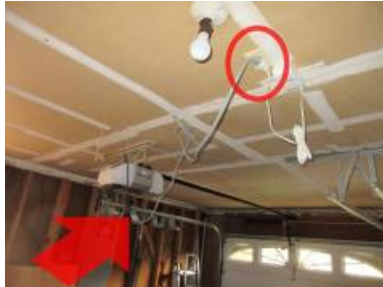
An extension cord is used as a temporary power source for the garage door opener. An extension cord is not suitable as a permanent wiring method. The installation of a receptacle within cords length of the motor is recommended.

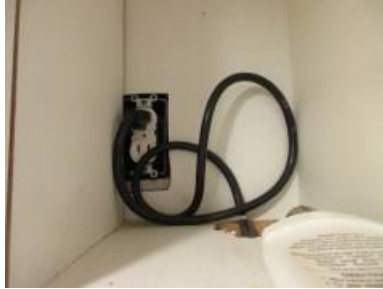
There are several loose receptacles throughout the home. This is a potential shock and a fire hazard. All loose receptacles should be repaired as necessary.

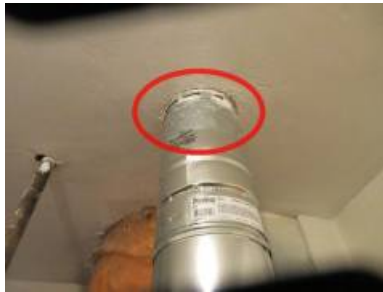
The furnace vent connector is too close to a combustible material. This is a hazard. A minimum clearance of 6" is required between the single wall vent connector and the combustible material. The double wall type B vent requires only 1" of clearance. Repairs are recommended.

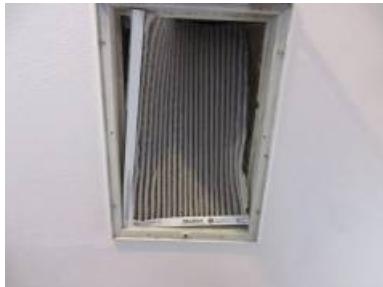
The air filter is ill-fitting and clogged with dust. This reduces air flow and furnace efficiency. Removal and replacement of the air filter is recommended. Pleated style air filters are recommended as they offer better filtration of dust than the coarser hogs hair or fiberglass filters.

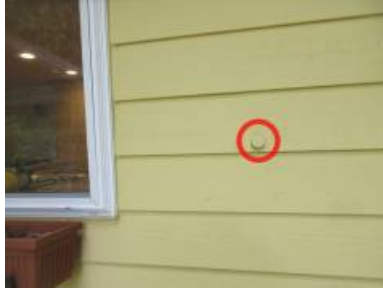
An air gap called a Johnson Tee is installed in the kitchen wall. This air gap protects the dishwasher from contamination caused by a backflow of waste water. The cap protruding on the exterior wall opposite the dishwasher is not drilled. This renders the air gap non-functional. Drilling a 1/4" hole in the end of the cap will restore its function. The remaining visible portions of the Johnson Tee were properly installed and functioning as intended.

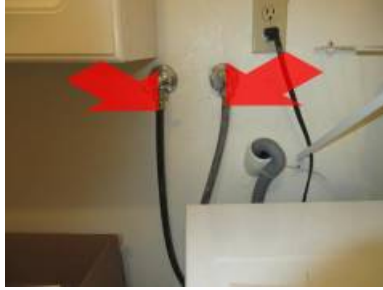
Upgrading the washer connections to high pressure (steel braided) lines is recommended.

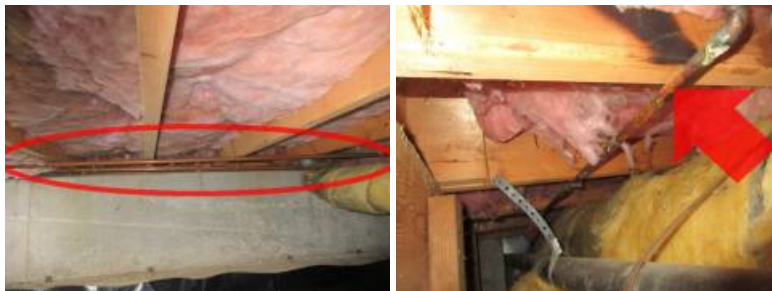
There are water pipes in the crawlspace that are not adequately insulated and could freeze. The installation of foam pipe insulation on all exposed water pipes is recommended.

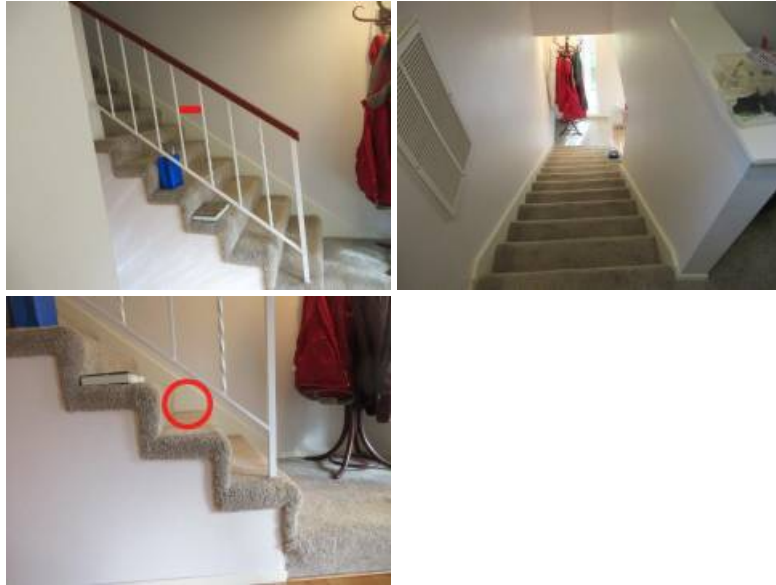
The stair railing spacing at the stair treads is too wide. This is a hazard for small children. The railing spacing should be reduced as a safety upgrade. Current standards require that a 6" sphere not pass through or under the railing.

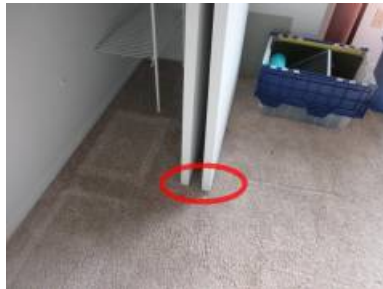
The floor guides are missing from the bypass closet doors in the bedroom. Missing floor guides could result in damage to the doors. The installation of floor guides is recommended.

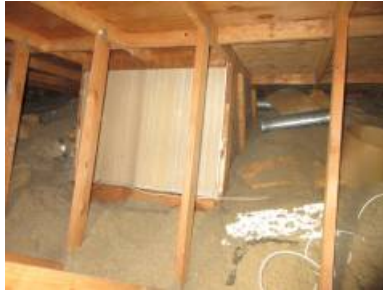
The skylight shaft is not insulated. This condition will result in significant heat loss. The installation of additional attic insulation around the skylight shafts is recommended.

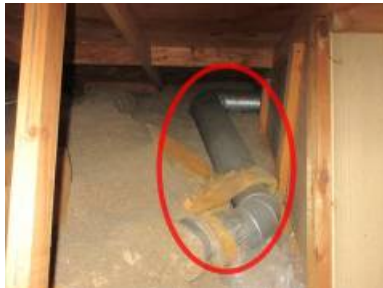
Some of the duct insulation is missing or has fallen off the ducts in the attic. This increases the amount of heat loss. The installation of new duct insulation is recommended in areas where insulation is missing.
