## NOTICE TO BUYER: SELLER-PROCURED INSPECTION REPORT

The following notice is given with respect to the Purchase and Sale Agreement dated \_\_\_\_\_ between \_\_\_\_\_ ("Buyer") and **Drew Groshong** **Jamie Groshong** ("Seller") concerning **13216 46th Pl W Mukilteo WA 98275** ("the Property").

**Jamie and Drew Groshong  
13216 46<sup>th</sup> PI W  
Mukilteo, WA 98275**

**Per the seller, the following items listed on the pre-sale inspection summary dated (April 27<sup>th</sup>, 2023), are being corrected by the seller as part of preparation for sale in good faith.**

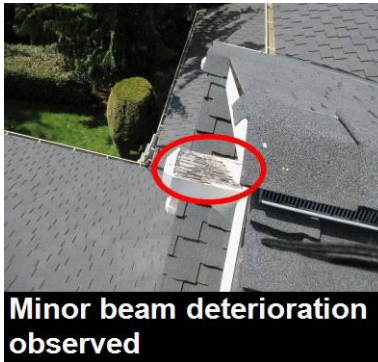
The beams that stick out beyond the drip edge of the roof are vulnerable to rot damage. They should be covered with a metal cap flashing or cut off flush with the edge of the overhang.

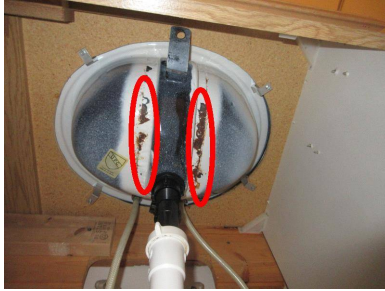
The overflow portion of the sink drain is rusted. This will cause the sink to leak. Replacement of the sink is recommended.

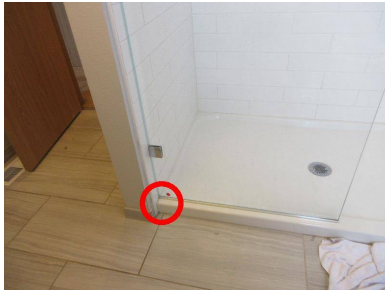
The glass enclosure has been leaking at the lower corners. No damage was visible, but resealing or repairing the enclosure is recommended as preventive maintenance.

**Upper Floor Bathroom:** Calked the lower corners of the glass enclosure

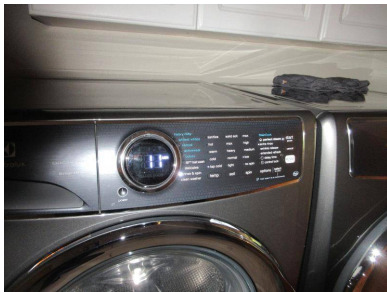
The washer would not respond to its control panel. Repairs are recommended.

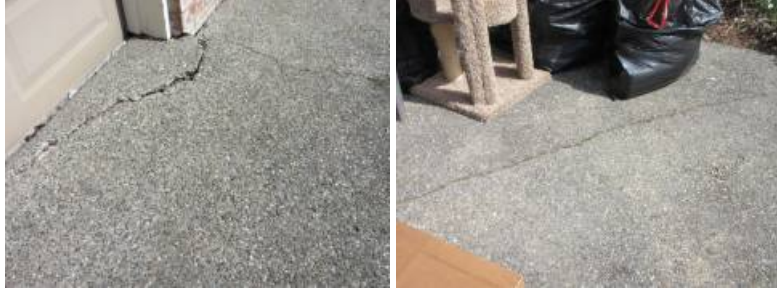
Cracks were observed in the concrete surface of the driveway. Minor cracks can be sealed to minimize moisture entry and further settlement of the concrete. Minor cracks are common and do not affect the serviceability of the concrete.

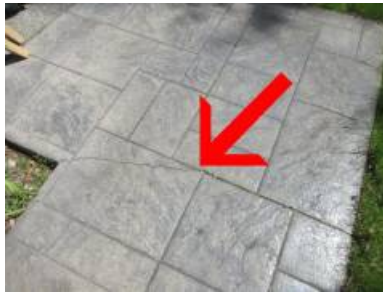
Many legal and public works departments have defined a trip hazard as an irregularity in a walking surface exceeding one inch (1") in height. All walking surfaces should maintain, free of a vertical surface change of 3/4" or more, in the interest of public and personal safety.

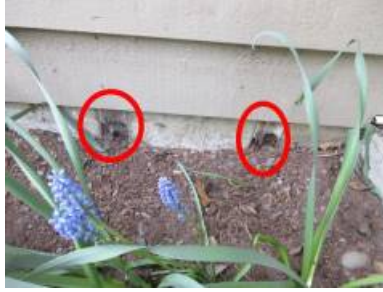
Good building practice requires that foundation walls or pier footings supporting wood frame construction, extend at least 8" above the finish grade with at least a 6" clearance between the top of the soil and the bottom of the wood finish materials. Untreated wood should be raised 1-2" above surrounding flatwork and should have a moisture barrier installed between the concrete and wood. For additional information and treatment options, you should retain the services of a qualified pest control operator.

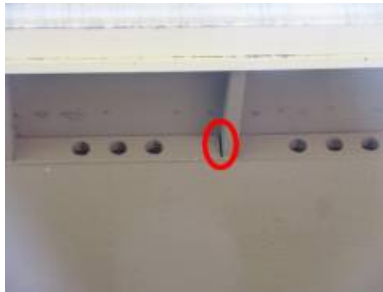
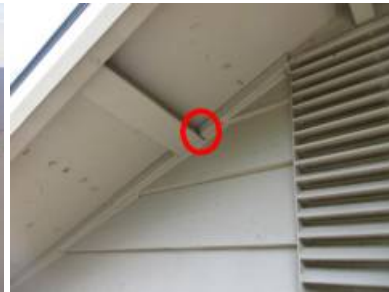
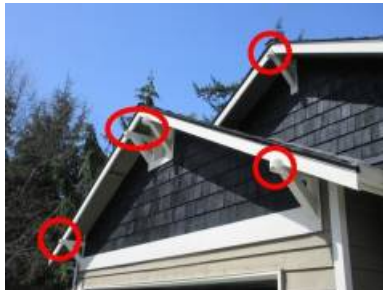
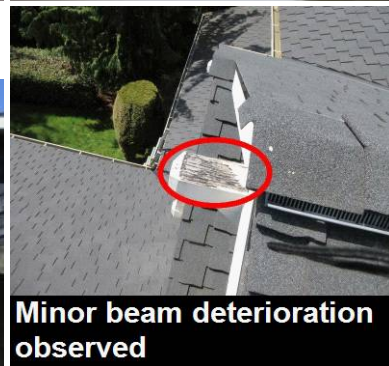
The beams that stick out beyond the drip edge of the roof are vulnerable to rot damage. They should be covered with a metal cap flashing or cut off flush with the edge of the overhang.

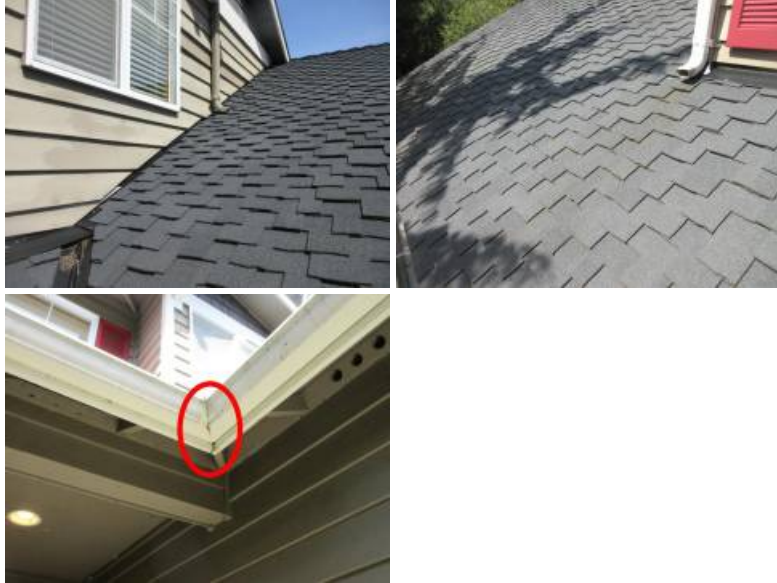
The gutters are leaking at the miter joints. The miter joints should be cleaned and sealed with "Gutter Seal" or a similar type gutter joint sealant.

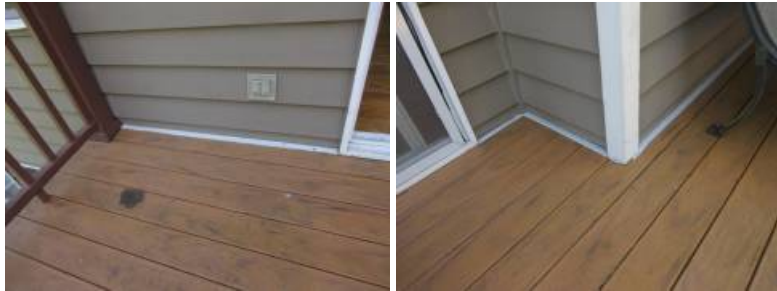
There is no flashing at the intersection between the deck and house. This will allow water to enter behind the siding. The installation of flashing in this area is recommended.

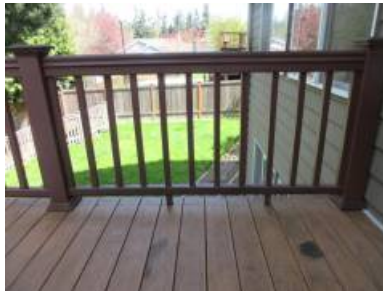
**DECK RAILINGS**

The spacing between the balusters is too wide. This is a hazard to small children. The balusters should be spaced close enough together so that a 4" sphere cannot pass through. Upgrading the deck railing is recommended if small children are present.

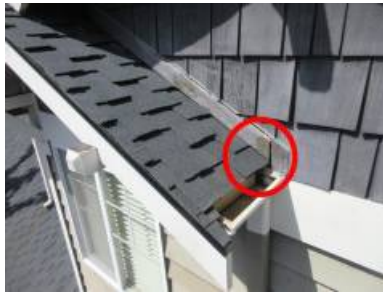
There is no kick out flashing at the roof edge to wall intersection above the gutter. This will allow water to enter the wall behind the siding. The installation of a kick-out flashing is recommended.

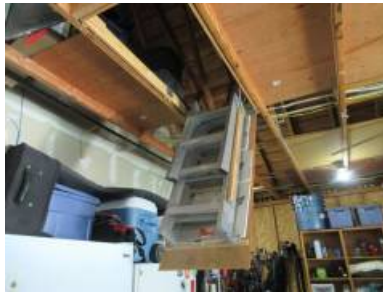
The attic area over the garage is accessible via a retractable fold down ladder in the garage. The ladder was tested and was found in need of repairs and adjustments. Caution should be used when using this ladder.

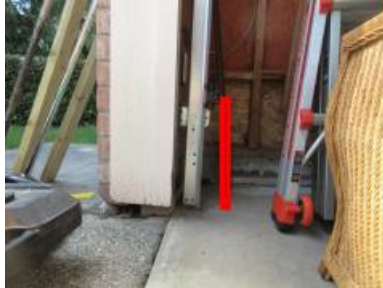
The Photo-eye beam was installed to high above the floor of the garage to adequately offer protection for small children and/or pets. We recommend that the photo-eye be lowered to within 4-6" of the floor.

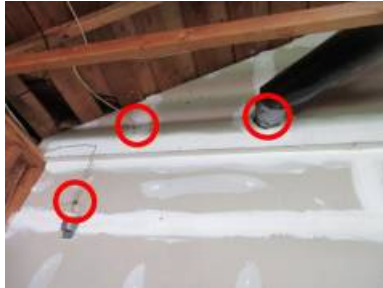
#### *FIRE SEPARATION*

There are voids in the fire resistive barrier between the living space and garage that will allow flames to penetrate. The gypsum barrier slows the spread of a fire from the garage to the structure and/or living space. Patching the voids with a fire retardant caulk is recommended.

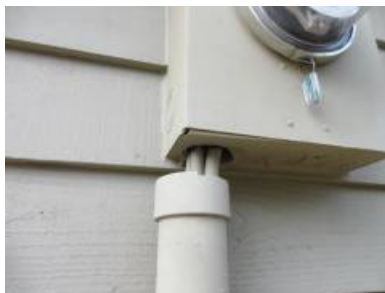
The electrical feed PVC coming out of the ground is separated from the meter housing. We recommend calling the power company and asking them to check and see if the settlement is causing downward tension on the conductor terminations in the meter base that could break the lugs.

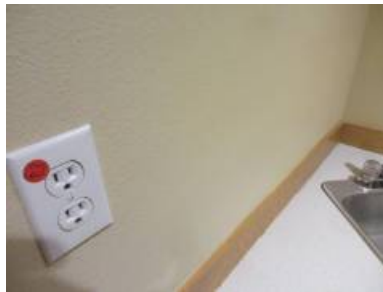
Testing revealed open grounds (ungrounded receptacles) in the bar sink area. Open grounds are a potential hazard and could damage some electronic equipment. All receptacles with open grounds should be repaired in accordance with applicable electrical codes.

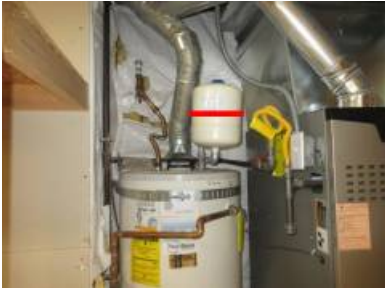
LOCATION OF UNIT	The water heater is located in the garage.
GENERAL INFORMATION	The water heater fuel is natural gas. The capacity of the water heater is 50 gallons. The input rating of the burner is approximately 40,000 BTU. The water heater is approximately 17 years old. Water heaters of this type typically last about 10-15 years.
PRESSURE RELIEF VALVE	The pressure relief valve is properly installed. The valve was not tested, as this could cause the valve to leak.
SHUTOFF VALVE	The shutoff valve for the water supply to the water heater is properly installed and is functioning as intended.
WATER CONNECTIONS AT TANK	The water connections at the tank are properly installed and are performing their intended function.
EXPANSION TANK	The expansion tank is not adequately secured to the wall. As code requirements start to call for engineered expansion tank supports we recommend the installation of seismic restraints to secure the expansion tank instead of allowing it to simply depend on piping connections that could result in damage to the water pipe and leakage during an earthquake.

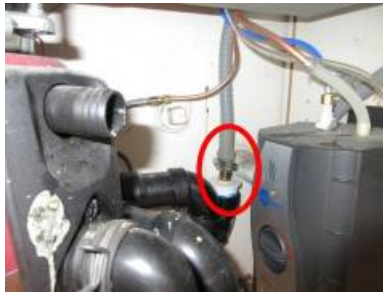
<i>COUNTERTOPS</i>	The countertops are covered with slab quartz. The counter tops are properly installed and are in good condition.
<i>CABINETS</i>	The finish on the kitchen cabinets is slightly worn. The cabinets are otherwise in good condition.
<i>FLOORING MATERIAL</i>	The floor is covered with hardwood. The floor is properly installed and is in good condition.
<i>VENTILATION</i>	Ventilation in the kitchen is provided by a range hood over the stove. The vent is ducted to the exterior. The vent fan is properly installed and is performing its intended function.
<i>SINK FAUCET</i>	The sink faucet is properly installed and is in good condition.
<i>SINK</i>	The kitchen sink is properly installed and is in good condition.
<i>DRAINS, TRAPS AND TRAP ARMS</i>	The sink drain is properly installed and is performing its intended function.
<i>AIR GAP</i>	The dishwasher drain lacks an air gap. The dishwasher will function without one, but there is a risk of contamination of the inside of the dishwasher by waste water. The installation of an air gap above the flood rim of the sink is recommended.

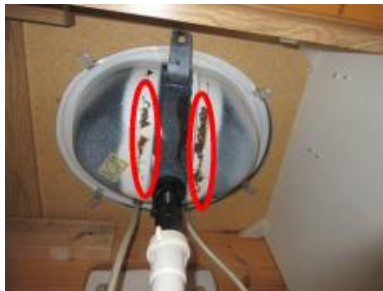
LOCATION	Lower Floor.
BATHTUB	The one piece fiberglass bathtub and shower unit is properly installed and in good condition.
FLOORING MATERIAL	The floor is covered with ceramic tile. The tile is properly installed and is in good condition.
TOILET	The toilet was flushed and was functioning as intended.
SINK	The overflow portion of the sink drain is rusted. This will cause the sink to leak. Replacement of the sink is recommended.

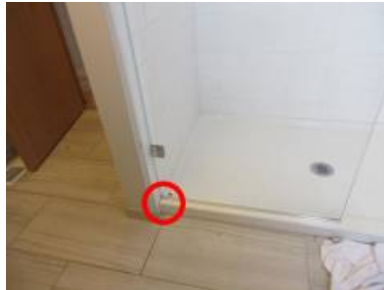
The glass enclosure has been leaking at the lower corners. No damage was visible, but resealing or repairing the enclosure is recommended as preventive maintenance.

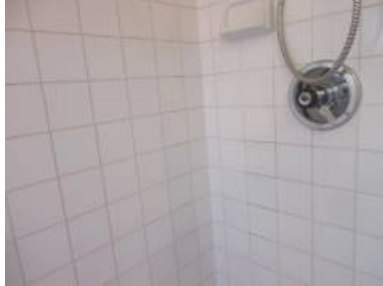
Grout is missing from between some of the wall tiles. This can allow water to enter through the tile and can damage the walls. Regrouting the wall tile is recommended.

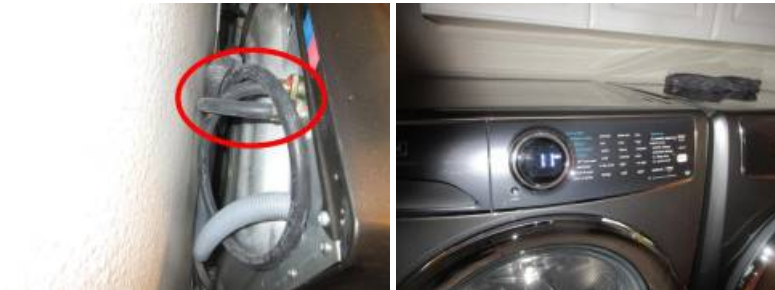
<i>DRYER VENT</i>	<p>The visible portions of the dryer vent are properly installed and in serviceable condition. Dryer ducts should be cleaned annually as part of routine home maintenance. A dryer duct that is clogged with lint is a fire hazard.</p> <p>The washer would not respond to its control panel. Repairs are recommended.</p>
