NOTICE TO BUYER: SELLER-PROCURED INSPECTION REPORT

**Gregory and Karen Wisont
16910 NE 131st Place
Redmond, WA 98052**

Re: 16910 NE 131st Place
Redmond, WA.

DATE OF INSPECTION: 3/4/2024.
 INSPECTOR'S NAME: Terry Clark.
 CLIENT NAME: Mr. & Mrs. Greg & Karen Wisont.
 MAILING ADDRESS: 16910 NE 131st Place
 Redmond, WA.
 CLIENT E-MAIL ADDRESS: kdwisont@gmail.com; gwisont@gmail.com.
 ADDRESS OF PROPERTY INSPECTED: 16910 Northeast 131st Place
 Redmond, WA.

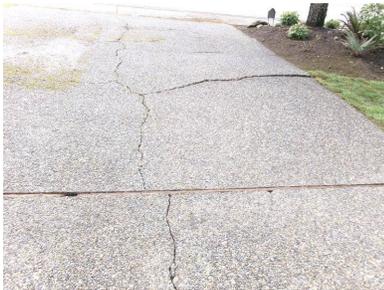
DRIVEWAY

The driveway has cracked and settled differentially. This was probably caused by inadequate preparation of the soil prior to the placement of the concrete. This condition can be repaired by pressure grouting the sunken portion of the driveway or by removing and replacing it. The driveway remains functional despite this condition.

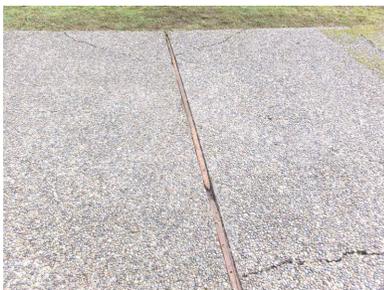
One or more of the wooden dividers separating the concrete driveway sections were infested by wood destroying organisms and have deteriorated to a point where they are becoming a trip hazard. Replacement with mortar is recommended.

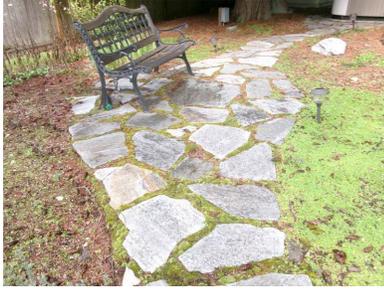
PATIO

The walking surface was not even and trip hazards were present. We recommend all walking surfaces be maintained free of trip hazards.

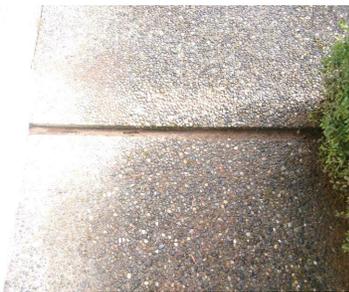
WALKWAY

One or more of the wooden dividers separating the concrete walkway sections were infested by wood destroying organisms and have deteriorated to a point where they are becoming a trip hazard. Replacement with mortar is recommended.

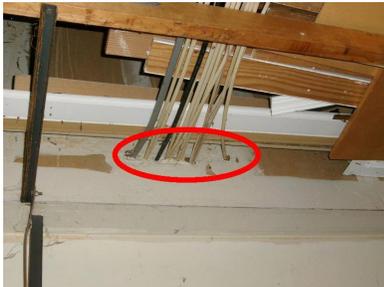
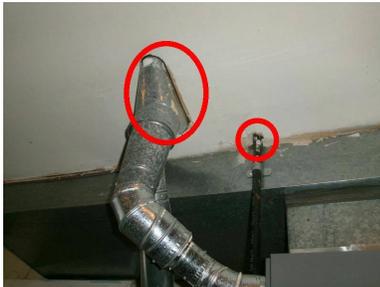
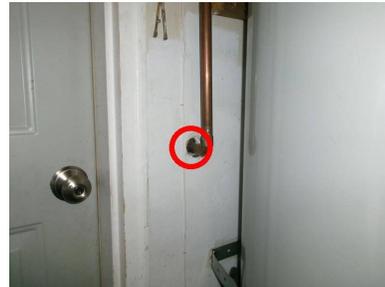
ATTACHED GARAGE
FIRE SEPARATION

There are voids in the fire resistive barrier between the living space and garage that will allow flames to penetrate. The gypsum barrier slows the spread of a fire from the garage to the structure and/or living space. Patching the voids with a fire retardant caulk is recommended.

- Garage fire separation: Fire retardant caulk has been applied as recommended
- Electrical system service panel: Blunt end screws have been placed as recommended
- Electrical receptacles: Loose receptacle in laundry room corrected; cover plates installed as recommended; GFCI receptacle replaced as recommended
- Ceiling fan: Remote control is present in the bedroom and working
- Heating system blower: Cut-out switch has been enabled and is not restricted, per recommendation
- Toilet in main floor powder room: New wax seal has been installed and toilet re-mounted to the floor as recommended
- Dishwasher: Unit has been secured as recommended

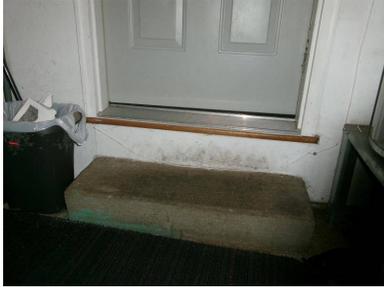
STAIRS

The garage steps are non-conforming due to the variable and/or excessive rise. Stair design standards require that stair risers do not exceed 8" and that the variation in rise not exceed 3/8" in order to reduce falls from tripping. To increase the margin of safety, consideration should be given to reconfiguring the steps so that rise and run do not vary by more than 3/8". If this proves to be too impractical or expensive, then we recommend exercising caution when using these steps.

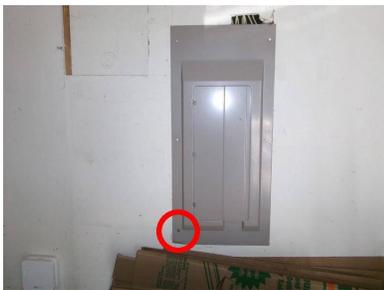
SERVICE PANEL

Screws that secure the panel cover to the panel box are missing. This is a potential hazard. Missing screws should be replaced with the original style blunt end screws.

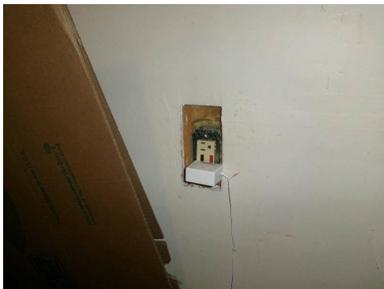
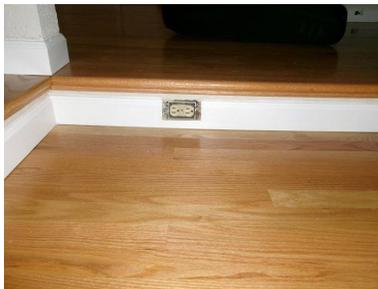
RECEPTACLES

The receptacle on the east wall of the laundry room is loose. This is a potential shock and a fire hazard. All loose receptacles should be repaired as necessary.

Cover plates are missing from several receptacles. This is a shock and fire hazard. The installation of cover plates on all receptacles is recommended.

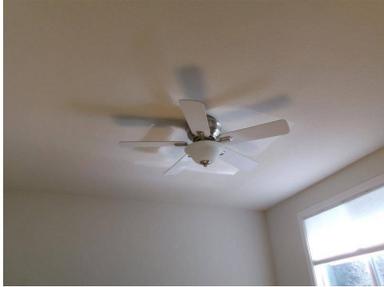
The bedroom ceiling fan/light remote was not present and its function was not verified.

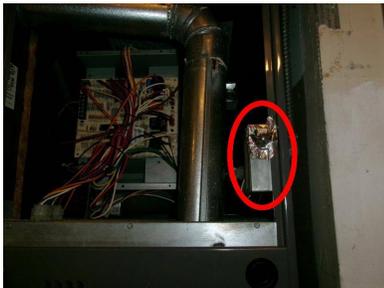
The blower door cut-out switch has been disabled. This is a potential hazard. The cut-out switch should be not be restricted.

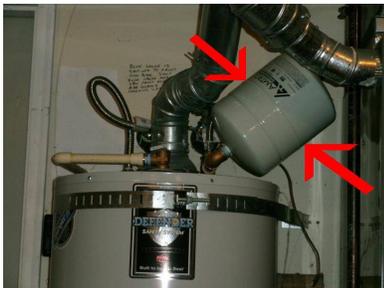
EXPANSION TANK

The expansion tank is not adequately secured to the wall. As code requirements start to call for engineered expansion tank supports we recommend the installation of seismic restraints to secure the expansion tank instead of allowing it to simply depend on piping connections that could result in damage to the water pipe and leakage during an earthquake.

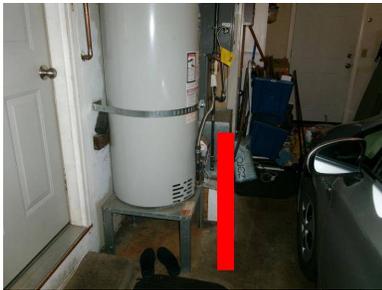
The gas pipes in front of the furnace and water heater are not protected by a bumper stop. A vertical steel pipe, bolted to the floor, is typically installed in front of the water heater to prevent a car bumper from damaging the gas lines.

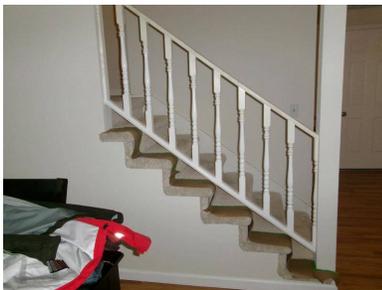
STAIRS

The stair railing baluster spacing is too wide. This is a hazard for small children. The baluster spacing should be reduced as a safety upgrade. Current standards require that a 4-3/8" sphere not pass through the railing.

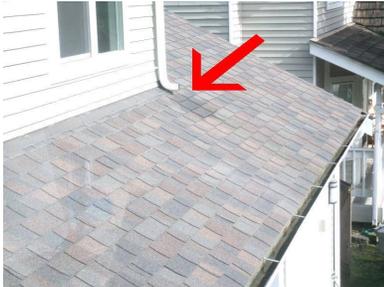
Downspouts draining directly onto the asphalt shingle surface causes excessive wear of the roofing material. Downspout extensions to the lower gutters should be installed to prevent excessive wear and tear of the roofing.

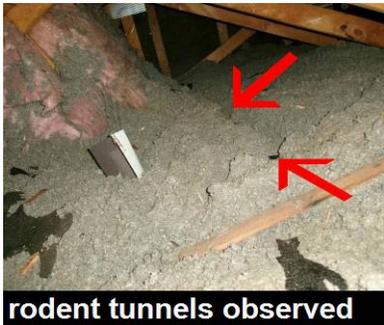
PEST CONTROL

There is evidence of rodent activity in the attic. The first step in eliminating rodents from the attic is to seal all possible entry points using wire mesh, caulking, wood, stainless steel wool, or aerosol foam. Careful work sealing cracks, holes and gaps will discourage further activity. Once this work is completed, snap traps baited with peanut butter should be installed and monitored. The absence of rodents in the traps typically means that the rodents have been excluded from the area.

- Oven broiler element: To be repaired or replaced prior to closing
- Attic pest control: Seller disputes any rodent activity in the attic or perimeter of the house; there has been no evidence of such activity. Seller will arrange for professional pest inspection and remediation as necessary prior to closing.
- Hot tub is non-functional and will be removed prior to closing.
- Deck will be re-stained prior to close.

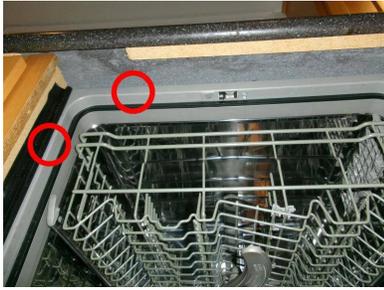
DISHWASHER

The dishwasher is not secured to the cabinet or countertop. This allows the appliance to move around. The dishwasher should be secured to the cabinet or to the bottom of the countertop in accordance with industry standards.

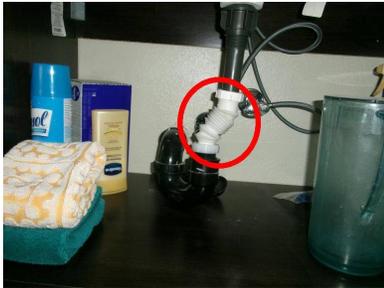
MAIN FLOOR POWDER ROOM
DRAINS, TRAPS AND TRAP ARMS

Improper, non-conforming material has been used for the drain pipe fitting. This material will not function reliably. Replacement with industry standard fittings is recommended.

- Powder room drain pipe fitting: Seller has had no issue with existing fittings but will consider replacement if requested.

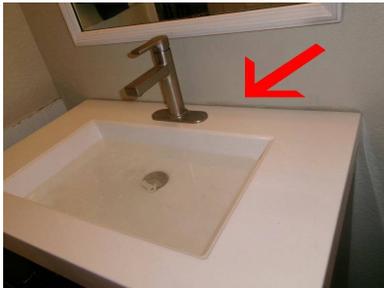
COUNTERTOP

The backsplash is missing. The installation of a backsplash is recommended.

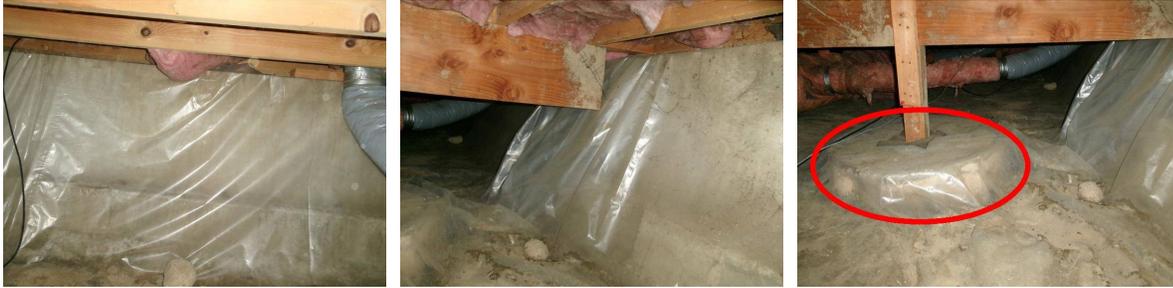
The foundation walls are covered with the plastic vapor retarder. This allows the transmission of water vapor from the soil up and into the exterior wall framing. The plastic vapor retarder should be removed from the foundation so that it covers at least 85% of the entire surface of the soil only.

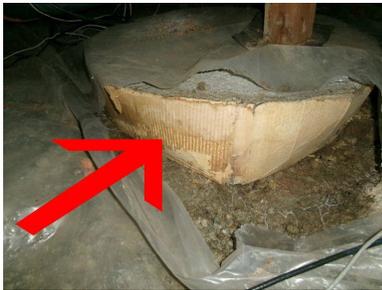
PEST CONTROL

Cellulose forms were left in place on the pier footings. This cellulose is conducive to the infestation of various wood destroying organisms. The removal of the cellulose is recommended.

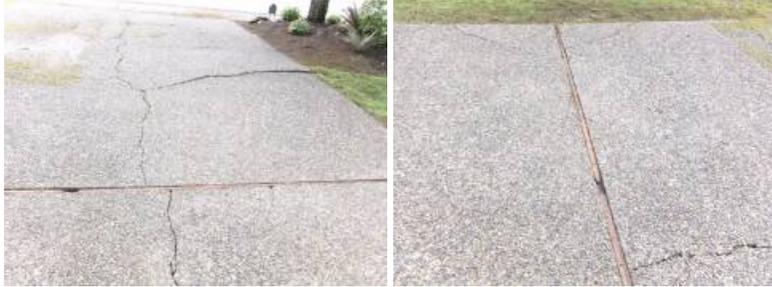
One or more of the wooden dividers separating the concrete driveway sections were infested by wood destroying organisms and have deteriorated to a point where they are becoming a trip hazard. Replacement with mortar is recommended.

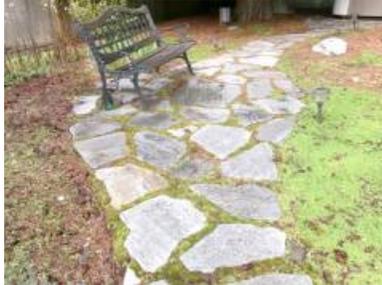
PATIO

The walking surface was not even and trip hazards were present. We recommend all walking surfaces be maintained free of trip hazards.

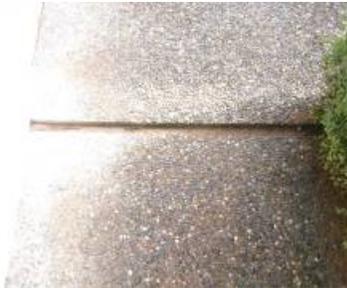
WALKWAY

One or more of the wooden dividers separating the concrete walkway sections were infested by wood destroying organisms and have deteriorated to a point where they are becoming a trip hazard. Replacement with mortar is recommended.

Many legal and public works departments have defined a trip hazard as an irregularity in a walking surface exceeding one inch (1") in height. All walking surfaces should maintain, free of a vertical surface change of 3/4" or more, in the interest of public and personal safety.

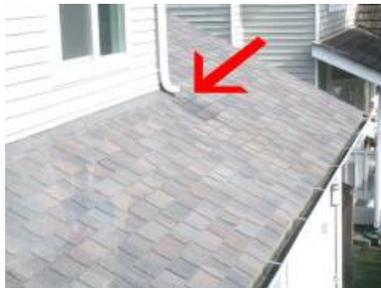
Downspouts draining directly onto the asphalt shingle surface causes excessive wear of the roofing material. Downspout extensions to the lower gutters should be installed to prevent excessive wear and tear of the roofing.

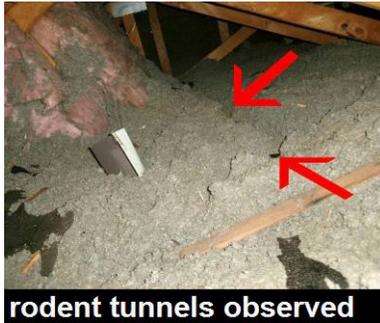
There is evidence of rodent activity in the attic. The first step in eliminating rodents from the attic is to seal all possible entry points using wire mesh, caulking, wood, stainless steel wool, or aerosol foam. Careful work sealing cracks, holes and gaps will discourage further activity. Once this work is completed, snap traps baited with peanut butter should be installed and monitored. The absence of rodents in the traps typically means that the rodents have been excluded from the area.

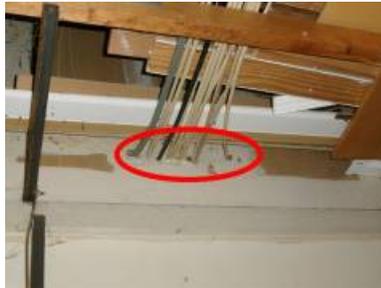
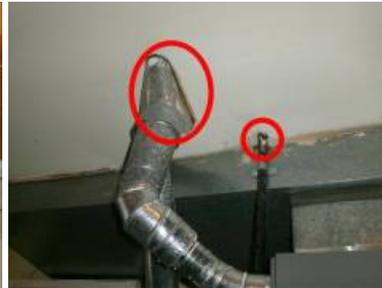
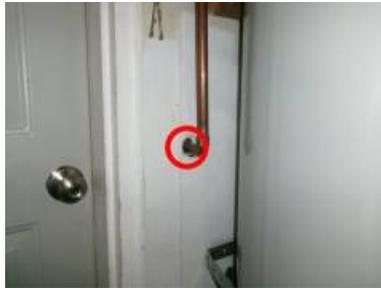
There are voids in the fire resistive barrier between the living space and garage that will allow flames to penetrate. The gypsum barrier slows the spread of a fire from the garage to the structure and/or living space. Patching the voids with a fire retardant caulk is recommended.

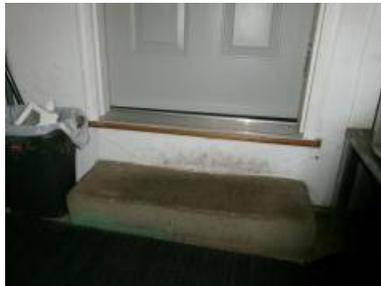
The garage steps are non-conforming due to the variable and/or excessive rise. Stair design standards require that stair risers do not exceed 8" and that the variation in rise not exceed 3/8" in order to reduce falls from tripping. To increase the margin of safety, consideration should be given to reconfiguring the steps so that rise and run do not vary by more than 3/8". If this proves to be too impractical or expensive, then we recommend exercising caution when using these steps.

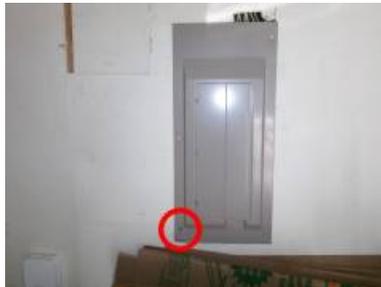
Screws that secure the panel cover to the panel box are missing. This is a potential hazard. Missing screws should be replaced with the original style blunt end screws.

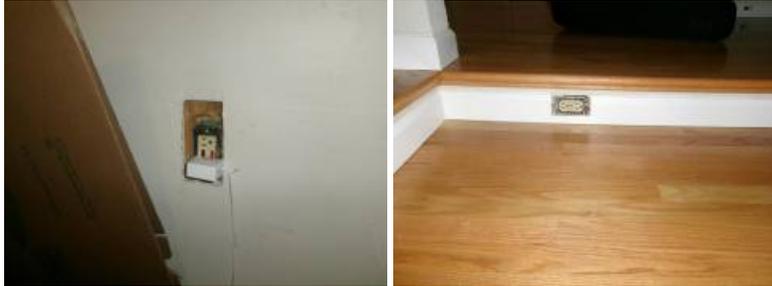
Cover plates are missing from several receptacles. This is a shock and fire hazard. The installation of cover plates on all receptacles is recommended.

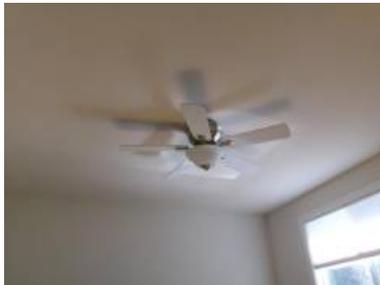
The bedroom ceiling fan/light remote was not present and its function was not verified.

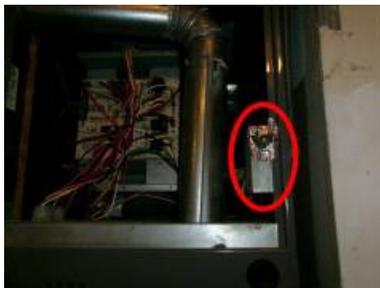
The blower door cut-out switch has been disabled. This is a potential hazard. The cut-out switch should be not be restricted.

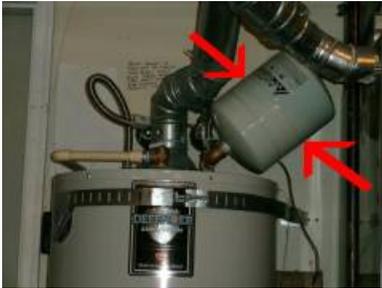
<i>LOCATION OF UNIT</i>	The water heater is located in the garage.
<i>GENERAL INFORMATION</i>	The water heater fuel is natural gas. The capacity of the water heater is 50 gallons. The input rating of the burner is approximately 40,000 BTU. The water heater is approximately 14 years old. Water heaters of this type typically last about 10-15 years.
<i>PRESSURE RELIEF VALVE</i>	The pressure relief valve is properly installed. The valve was not tested, as this could cause the valve to leak.
<i>SHUTOFF VALVE</i>	The shutoff valve for the water supply to the water heater is properly installed and is functioning as intended.
<i>WATER CONNECTIONS AT TANK</i>	The water connections at the tank are properly installed and are performing their intended function.
<i>EXPANSION TANK</i>	The expansion tank is not adequately secured to the wall. As code requirements start to call for engineered expansion tank supports we recommend the installation of seismic restraints to secure the expansion tank instead of allowing it to simply depend on piping connections that could result in damage to the water pipe and leakage during an earthquake.

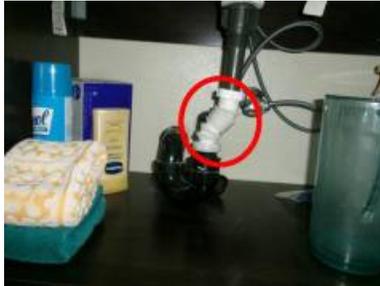
DRAINS, TRAPS AND TRAP ARMS Improper, non-conforming material has been used for the drain pipe fitting. This material will not function reliably. Replacement with industry standard fittings is recommended.

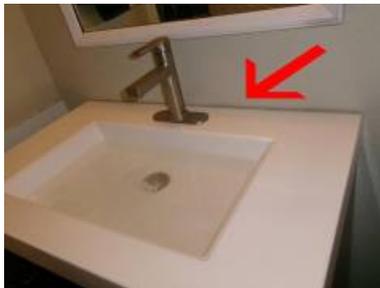
The backsplash is missing. The installation of a backsplash is recommended.

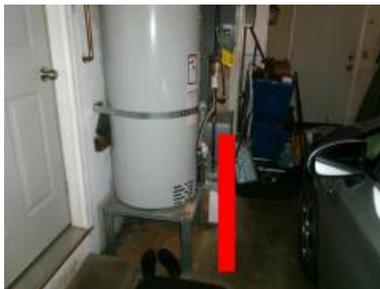
The gas pipes in front of the furnace and water heater are not protected by a bumper stop. A vertical steel pipe, bolted to the floor, is typically installed in front of the water heater to prevent a car bumper from damaging the gas lines.

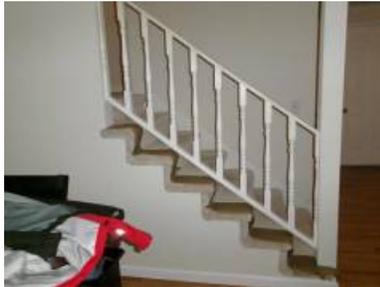
The stair railing baluster spacing is too wide. This is a hazard for small children. The baluster spacing should be reduced as a safety upgrade. Current standards require that a 4-3/8" sphere not pass through the railing.

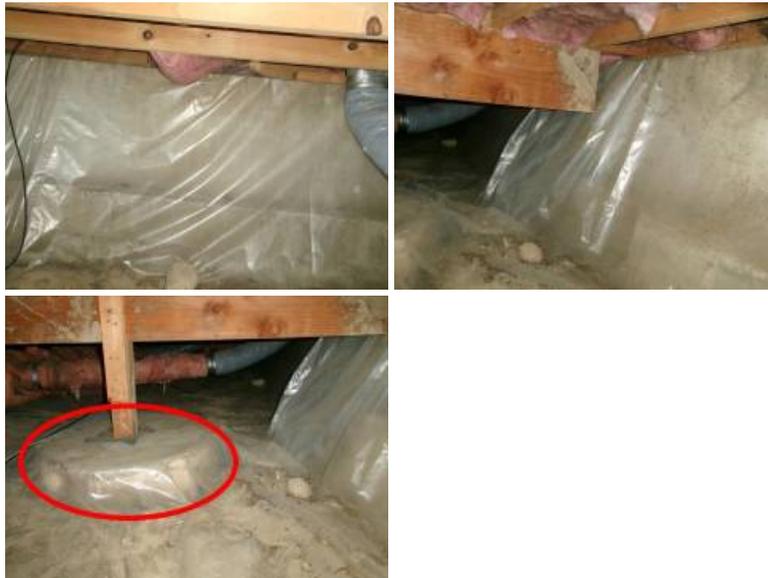
The foundation walls are covered with the plastic vapor retarder. This allows the transmission of water vapor from the soil up and into the exterior wall framing. The plastic vapor retarder should be removed from the foundation so that it covers at least 85% of the entire surface of the soil only.

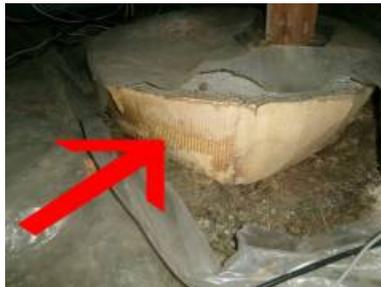
Good building practice requires that foundation walls or pier footings supporting wood frame construction, should extend at least 8" above the finish grade with at least a 6" clearance between the top of the soil and the bottom of the wood finish materials. Untreated wood should be raised 1-2" above surrounding flatwork and should have a moisture barrier such as 30 lb. asphalt impregnated felt installed between the concrete and wood. For additional information and treatment options, you should retain the services of a qualified pest control operator.
