#### NOTICE TO BUYER: SELLER-PROCURED INSPECTION REPORT

# Ajeet Kumar and Juhi Amitkumar Naik 14153 176th Ave NE Redmond, WA 98052

20250602-14153-176th-Ave-NE

# GENERAL SUMMARY

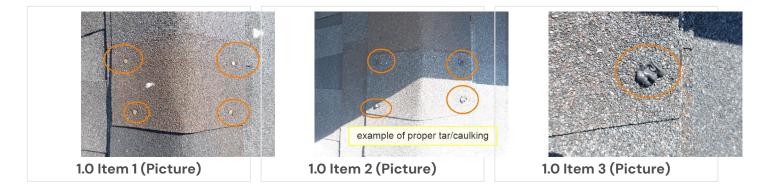
The exposed nails on the roof should be sealed with tar or caulking. I would recommend contacting your roofer to have this done.

Exposed nails on roof - sealed

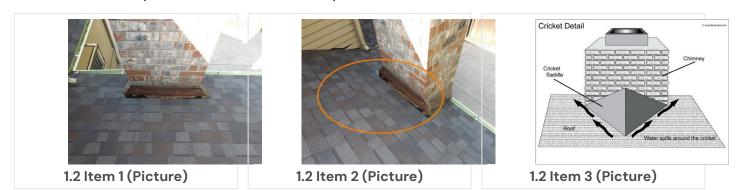
By today's standards all chimneys that exceed 30" in width above the roof line should have a water diversion "cricket" built on the up roof side to more effectively divert water around it.

Addition of water diversion "cricket" to chimney on roof

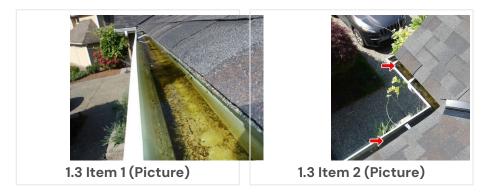
The gutters on the front of the home are clogged and need to be cleaned of any debris.

Clogged Gutter - cleaner

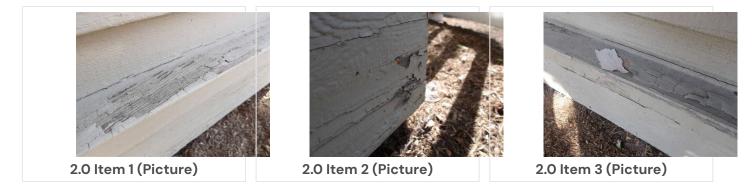
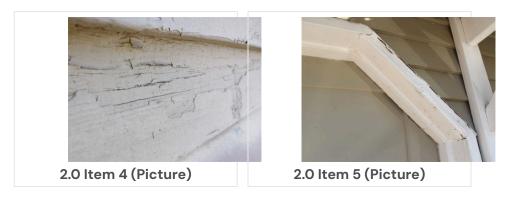
(1) The exterior paint finishes are in generally poor condition. This finish protects the envelope of the home from the elements. I recommend that a professional painting company evaluate, prep and re-paint in the near future.

Exterior paint finishes - touched up

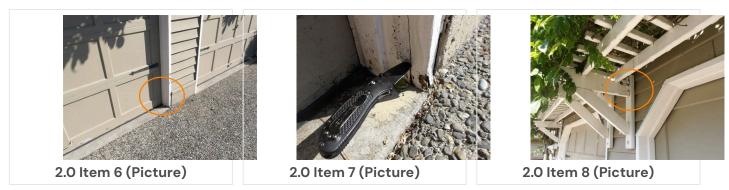
(2) Wood rot was found on the lap siding and trim pieces of the home. I would recommend having a contractor to further evaluate and remove any rotten wood pieces and replace with prepped and painted pieces.

Rotten wood portions on exterior sidings and trims - replaced and repainted

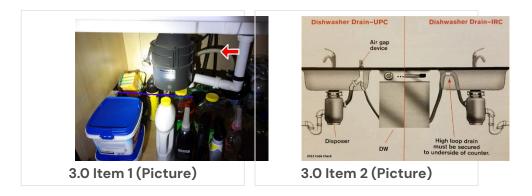
The dishwasher drain line was not properly routed. There should be an air gap device installed or a high loop drain line method. If the drain "P" trap were to become clogged the water would run back the dishwasher drain line and not up into the sink, causing potential flooring damage.

Dishwasher - Replaced and drain line properly routed

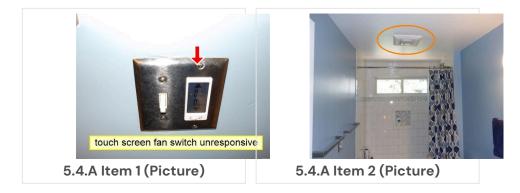
The exhaust fan was not operational at the time of inspection. I recommend having this repaired or replaced by a licensed electrician.

Exhaust fan switch fixed in guest bathroom

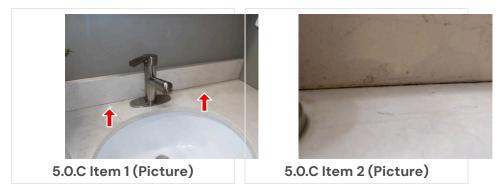
14153 176th Ave NE Page 7 of 46 The caulking is failing at the back splash. I recommend removing the old failed caulking and new caulking is recommended to fill the cracks at the counter to backs splash connection.

New caulking in powder room

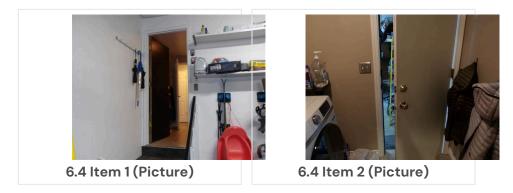
The occupant door from inside garage to inside the home is not a fire rated door nor does it have self closing hinges. This means that should a fire occur in garage, the occupant door does not afford protection until fireman arrive. This door should be replaced with a fire rated door and self closing hinges.

Occupant door from garage to the home to be replaced with fire rated door

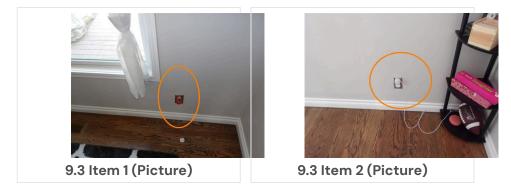
- 9.3 CONNECTED DEVICES AND FIXTURES (OBSERVED FROM A REPRESENTATIVE NUMBER OPERATION OF CEILING FANS, LIGHTING FIXTURES, SWITCHES AND RECEPTACLES LOCATED INSIDE THE HOUSE, GARAGE, AND ON THE DWELLING'S EXTERIOR WALLS)
  - REPAIR OR REPLACE
  - (1) In the dining room there are two outlets that do not have power. After speaking with the homeowner, hearing how this outlet will gain power randomly makes me think there possible could be a loose wire. Loose

wires can be a safety issue and a fire hazard. I would recommend an electrician to evaluate and make repairs/ replace these outlets.

All electrical outlets fixed

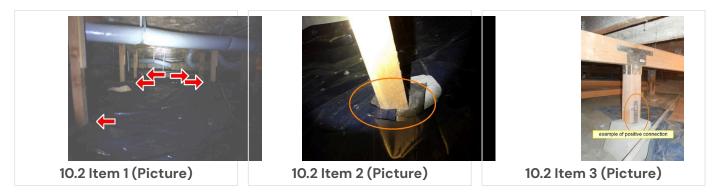
Although not likely required at the time of construction, I recommend that positive connection brackets be installed at all of the post bases to the concrete pads. Post to beam gussets are also recommended, both of these recommendations are meant to bring these connections up to today's standards for improved

#### earthquake stability.

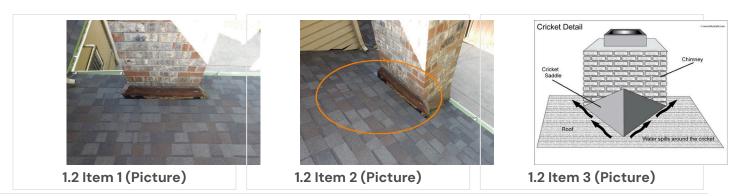
14153 176th Ave NE Page 13 of 46 By today's standards all chimneys that exceed 30" in width above the roof line should have a water diversion "cricket" built on the up roof side to more effectively divert water around it.

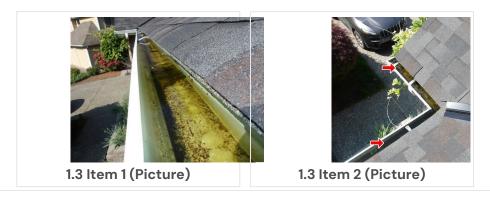
The gutters on the front of the home are clogged and need to be cleaned of any debris.

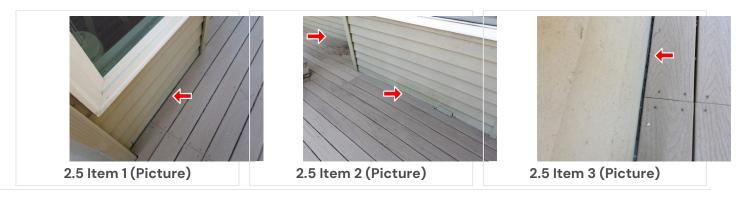
There is no deck to wall flashing visible above or below the deck. This flashing is intended to divert water away from the ledger board connection to the home where water could penetrate into the wall framing along the lag bolts fasteners. I recommend that an appropriate flashing be installed.

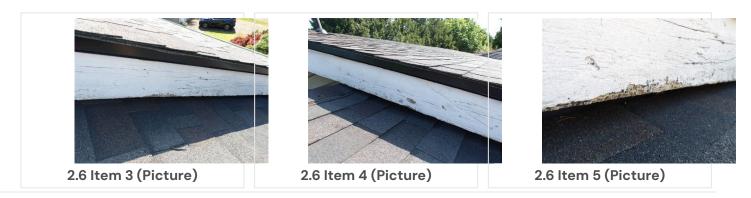
(1) Rot was found on the fascia of the home. I would recommend a contractor to further evaluate and remove and replace any rotten wood with new prepped and painted pieces.

(2) The paint on the soffit and fascia is failing. I recommend that a professional painting company evaluate, prep and re-paint in the near future.

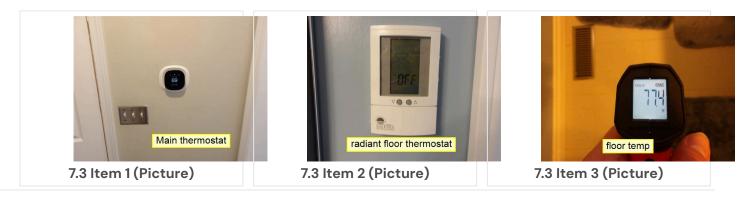
The digital thermostat for the furnace is located on the main floor in the hall way. The thermostat for the heated bathroom floor is in the hall bath upstairs.
