NOTICE TO BUYER: SELLER-PROCURED INSPECTION REPORT

Re: 748 Kirkland Circle F-103
Kirkland, WA.

At your request, a visual inspection of the above referenced property was conducted on 08/04/2025. We have inspected the major structural components, plumbing, heating and electrical systems for signs of significant non-performance, excessive or unusual wear and general state of repair.

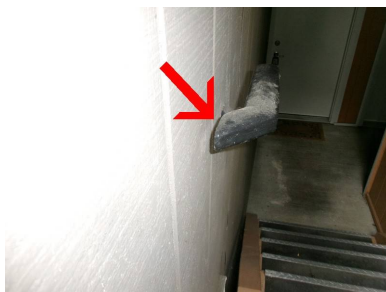
PORCH STEPS

The railing ends in the stairwell does not return to the wall. This is a safety hazard. The installation of a continuous handrail should be considered as a safety upgrade.

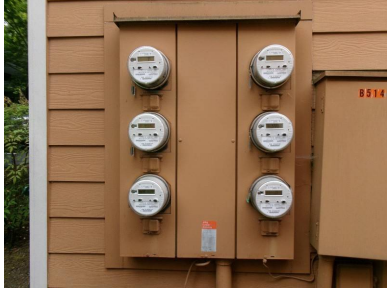
MAIN DISCONNECT LOCATION

The electrical meters are not labeled. Each meter should be labeled to allow servicing and repair of each units electrical circuits and equipment without having to shut off power to all meters. The services of a qualified electrician should be retained to perform this service.

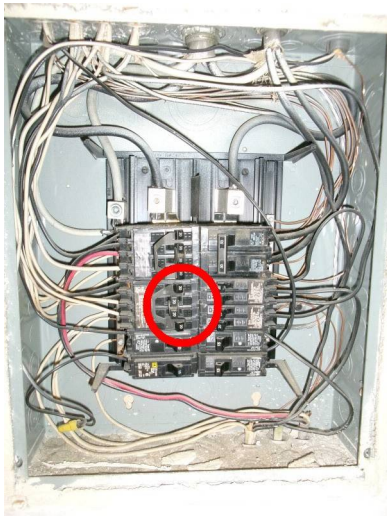
OVER CURRENT PROTECTION

The circuit breakers #5 & #7 in the panel would "trip" off when the baseboard heaters were tested. This is a hazard. A qualified electrical contractor should be retained to repair the circuit.

Circuit breakers #5 and #7 corrected and repaired

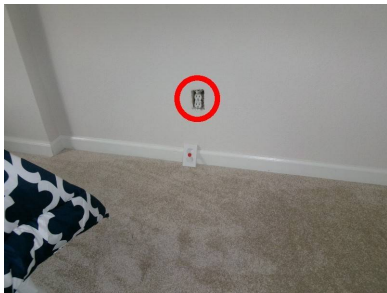
RECEPTACLES

The cover plate is missing from a receptacle in the front bedroom. This is a shock and fire hazard. The installation of cover plates on all receptacles is recommended.

Cover plate in front bedroom installed

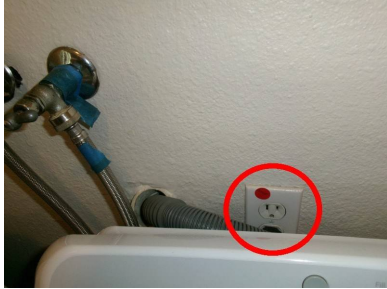
There are several loose receptacles both in the bedrooms and laundry room. This is a potential shock and a fire hazard. All loose receptacles should be repaired as necessary.

Loose receptacles in bedroom and laundry room repaired

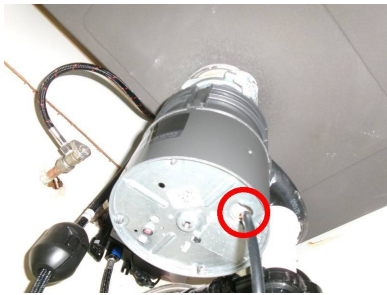
GARBAGE DISPOSAL

The cord is not clamped where it enters the disposal. This could damage the wires or cause a ground fault. The cord should be clamped in accordance with industry standards.

Garbage disposal cord and drain line corrected

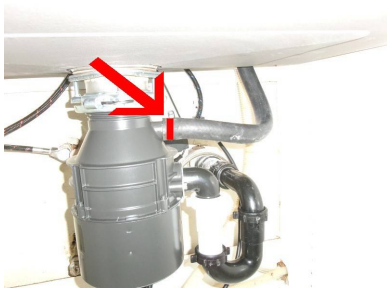
The drain line from the air gap is not clamped where it connects to the disposal. The drain line should be clamped in accordance with industry standards.

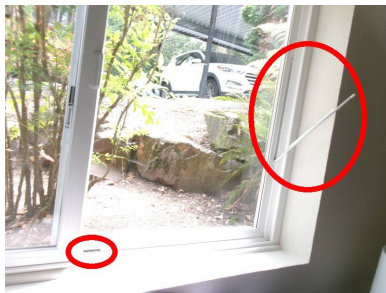
WINDOWS

The vent stop for one of the bedroom windows is missing. The trickle vent is loose/damaged. We recommend repairs as necessary to restore the windows proper operation.

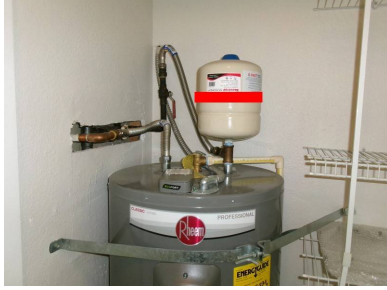
EXPANSION TANK

The expansion tank is not adequately secured to the wall. As code requirements start to call for engineered expansion tank supports we recommend the installation of seismic restraints to secure the expansion tank instead of allowing it to simply depend on piping connections that could result in damage to the water pipe and leakage during an earthquake.

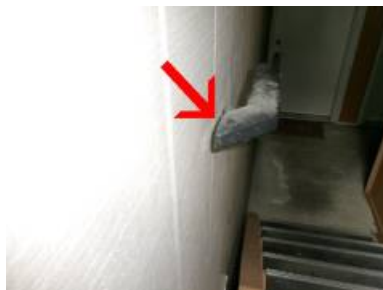
The railing ends in the stairwell does not return to the wall. This is a safety hazard. The installation of a continuous handrail should be considered as a safety upgrade.

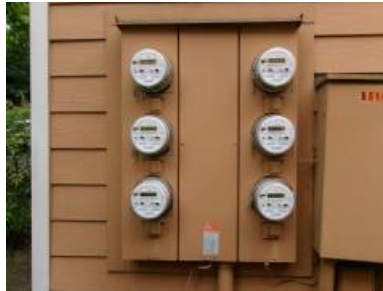
The electrical meters are not labeled. Each meter should be labeled to allow servicing and repair of each units electrical circuits and equipment without having to shut off power to all meters. The services of a qualified electrician should be retained to perform this service.

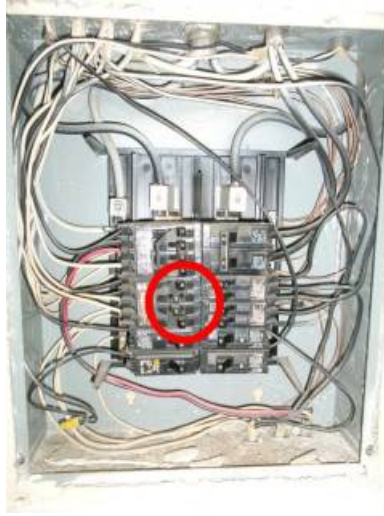
<i>OVER CURRENT PROTECTION</i>		Circuit breakers are used for over current protection. The circuit breakers are properly installed and the ampacity of the connected wires is compatible with that of the circuit breakers. The circuit breakers #5 & #7 in the panel would "trip" off when the baseboard heaters were tested. This is a hazard. A qualified electrical contractor should be retained to

repair the circuit.

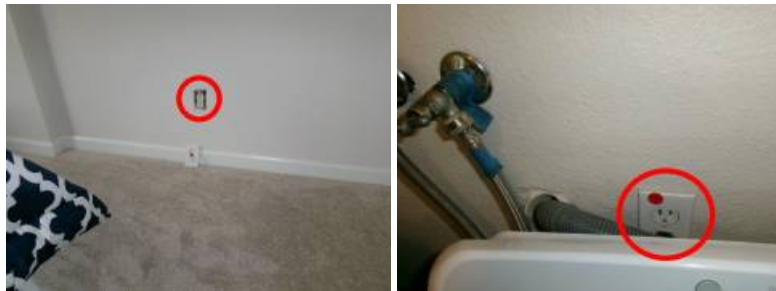
The cover plate is missing from a receptacle in the front bedroom. This is a shock and fire hazard. The installation of cover plates on all receptacles is recommended.

There are several loose receptacles both in the bedrooms and laundry room. This is a potential shock and a fire hazard. All loose receptacles should be repaired as necessary.

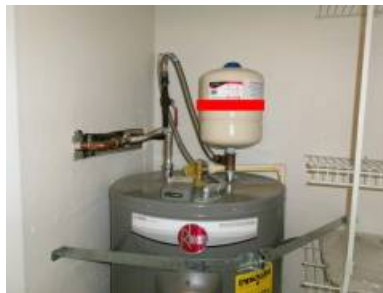
LOCATION OF UNIT	The water heater is located in the bedroom.
GENERAL INFORMATION	The water heater is electric. The capacity of the water heater is 50 gallons. The water heater is approximately 2 years old. Water heaters of this type typically last about 10-15 years.
PRESSURE RELIEF VALVE	The pressure relief valve is properly installed. The valve was not tested, as this could cause the valve to leak.
SHUTOFF VALVE	The shutoff valve for the water supply to the water heater is properly installed and is functioning as intended.
WATER CONNECTIONS	AT The water connections at the tank are properly installed and are performing their intended function.
TANK	
EXPANSION TANK	The expansion tank is not adequately secured to the wall. As code requirements start to call for engineered expansion tank supports we recommend the installation of seismic restraints to secure the expansion tank instead of allowing it to simply depend on piping connections that could result in damage to the water pipe and leakage during an earthquake.

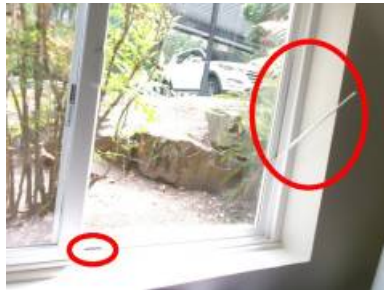
The vent stop for one of the bedroom windows is missing. The trickle vent is loose/damaged. We recommend repairs as necessary to restore the windows proper operation.
