**NOTICE TO BUYER: SELLER-PROCURED INSPECTION REPORT**

The following notice is given with respect to the Purchase and Sale Agreement dated \_\_\_\_\_ between \_\_\_\_\_ (“Buyer”) and **Justin Stobb** **Deedee Stobb** (“Seller”) concerning **20026 105th Ave SE** **Snohomish** **WA 98296** (“the Property”).

March 12, 2021

At your request, a visual inspection of the above referenced property was conducted on 03/11/2021. We have inspected the major structural components, plumbing, heating and electrical systems for signs of significant non-performance, excessive or unusual wear and general state of repair.

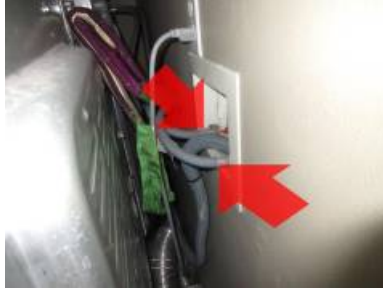
The hookups for the dryer are properly installed and in serviceable condition. The dryer itself was operated through a partial cycle, however we did not confirm the complete operation of the cycle timer.

Upgrading the washer connections to high pressure (steel braided) lines is recommended.
