**NOTICE TO BUYER: SELLER-PROCURED INSPECTION REPORT**

**Zeinab Birjandian, Omid Mola  
13626 179th Ave NE  
Redmond, WA, 98052**

**Per the seller, the following items listed on the pre-sale inspection summary dated 10/7/2021, are being corrected by the seller as part of preparation for sale in good faith.**

13626 179th Ave. NE  
Redmond WA.

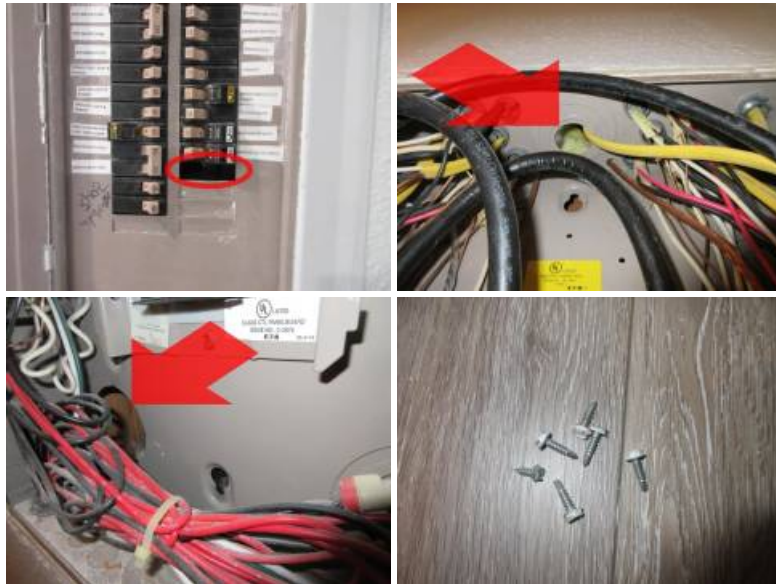
Screws that secure the panel cover to the panel box are the wrong type. This is a potential hazard. Screws should be replaced with the original style blunt end screws.

The circuits are labeled. The accuracy of the labeling was not verified. Do not assume the labeled circuit is off unless it has been checked with a voltage tester.

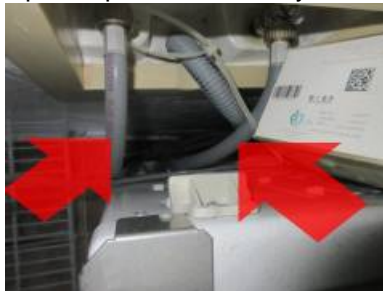
The hookups for the dryer are properly installed and in serviceable condition. The dryer itself was operated through a partial cycle, however we did not confirm the complete operation of the cycle timer.

High pressure (steel braided) washer line connections is recommended.
