### NOTICE TO BUYER: SELLER-PROCURED INSPECTION REPORT

The following notice is given with respect to the Purchase and Sale Agreement dated \_\_\_\_\_  
between \_\_\_\_\_ ("Buyer")  
and Robin Shelley ("Seller")  
concerning 1520 NE 75th St. Seattle WA 98115 ("the Property").

June 15, 2022

**Re: 1520 NE 175th St.  
Seattle, WA.**

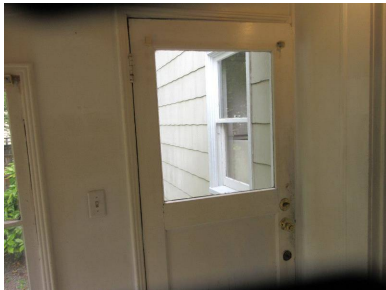
The glass in the back door is not tempered safety glass. Tempered glass can be identified by the etched emblem in one corner of each pane. A higher margin of safety could be achieved if the glass was approved safety glass. Consideration should be given to replacing the glass as a safety upgrade.

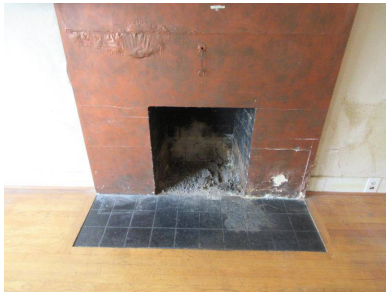
The hearth in front of the firebox does not extend out far enough. This is a safety concern. The hearth should stick out 18" in front of and 12" to either side of the fire box. Portable hearth extensions are available for this type of application. The hearth should be modified as necessary.

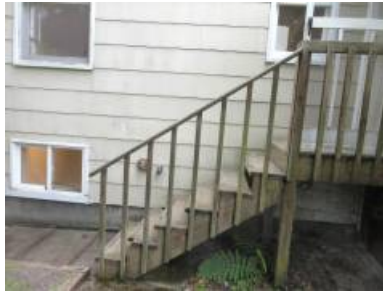
The spacing between the balusters is too wide. This is a hazard to small children. The balusters should be spaced close enough together so that a 4" sphere cannot pass through. Upgrading the porch railing is recommended if small children are

present.

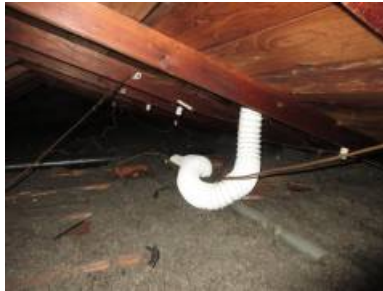
Flexible plastic duct is used to direct air from the vent fan to the exterior. This type of material is unreliable. Replacing the plastic duct with 4" smooth-wall sheet metal duct is recommended.

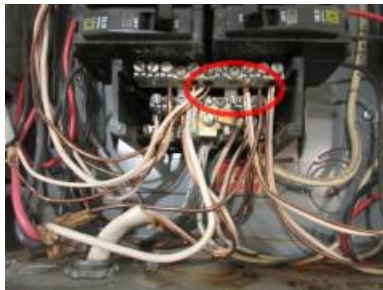
Neutral (white wire) and equipment grounding conductors (bare wire) terminate under the same lug. An individual terminal should be provided for the connection of each branch-circuit neutral conductor. When the neutral is disconnected, the objective is to still have the equipment ground connected. If both the neutral and grounded conductor is under the same terminal, this cannot be accomplished. The services of a qualified electrical contractor should be retained to repair the circuit(s).

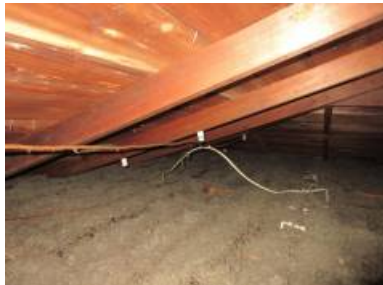
Improperly modified knob and tube wiring was observed in the attic. This is a fire hazard. The services of a qualified electrical contractor should be retained for repairs.

Splices in cable made outside of a junction box were observed in the attic. This is a fire hazard. The splices should be made inside an approved box with a cover.

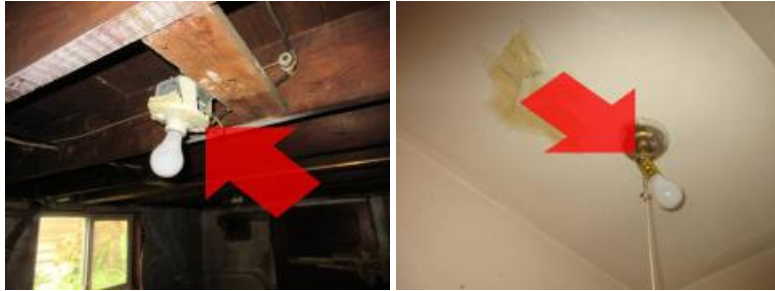
The light fixtures in the closet and one in the basement are detached and are hanging from their wires. This is a hazard. The fixtures should be reattached and secured to the ceiling.

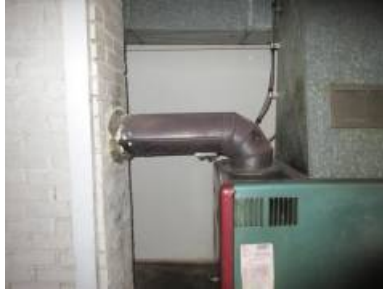
The pitch of the vent connector is inadequate. This can result in spillage of combustion gases. The vent connector should be reconfigured so that it slopes 1/4" per foot up towards the outlet.

The pitch of the vent connector is inadequate. This can result in spillage of combustion gases. The vent connector should be

reconfigured so that it slopes 1/4" per foot up towards the outlet.

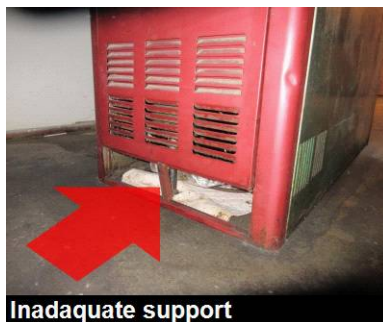
The oil burner motor cover is not fitted properly and the piece of wood is inadequate support. The vestibule cover should be modified or replaced.

The furnace responded to the thermostats call for heat and all major components were functional however, the furnace is 60 years old and is nearing the end of its service life. The need for furnace replacement should be anticipated. This type of furnace should be serviced annually.

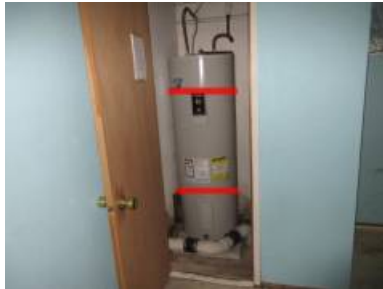
The water heater is not secured to the wall. A seismic restraint should be installed to secure the water heater and prevent it from falling over during an earthquake. This prevents the gas and water lines from rupturing.

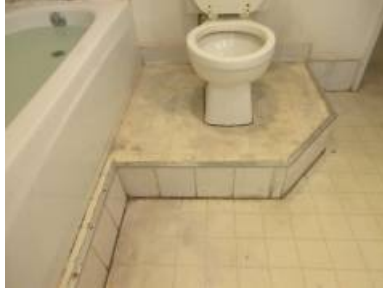
The vinyl flooring is damaged from water intrusion into the substrate. The flooring should be replaced as necessary to restore cosmetic appearance. The subfloor underneath the vinyl flooring appears to be solid.

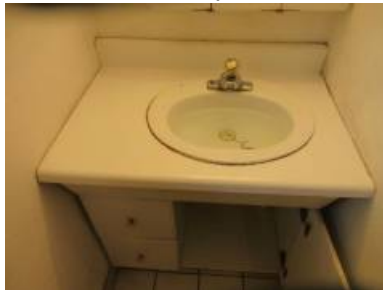
The side backsplash is missing. The installation of a backsplash is recommended.

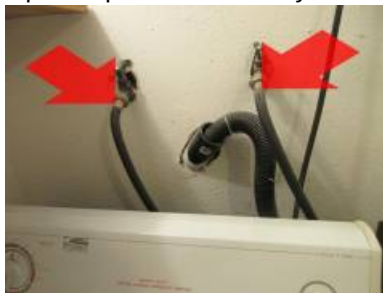
High pressure (steel braided) washer line connections is recommended.

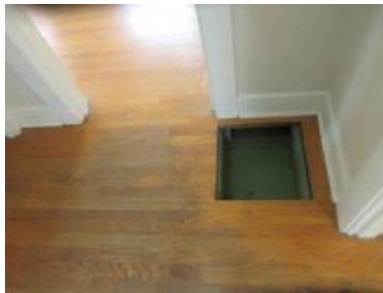
The large hole in the flooring is a hazard. We recommend the installation of a floor grate or other suitable cover.

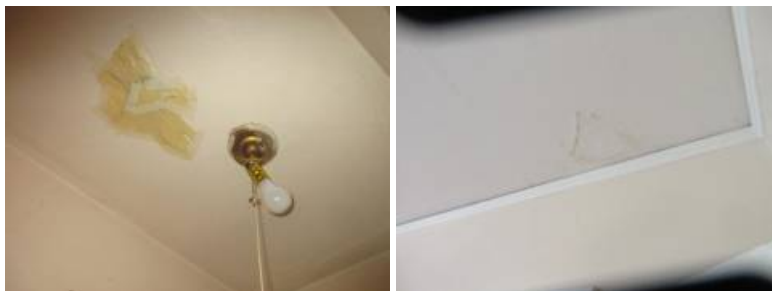
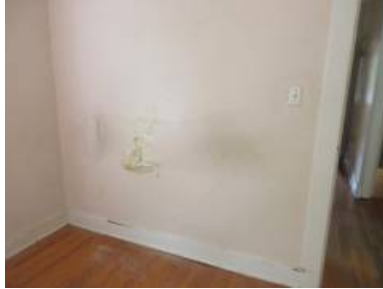
There are notable signs of damage on the walls. This is a cosmetic condition with this type of construction and does not indicate a structural deficiency. The cracks should be repaired, nails reset, seams repaired and painted over.

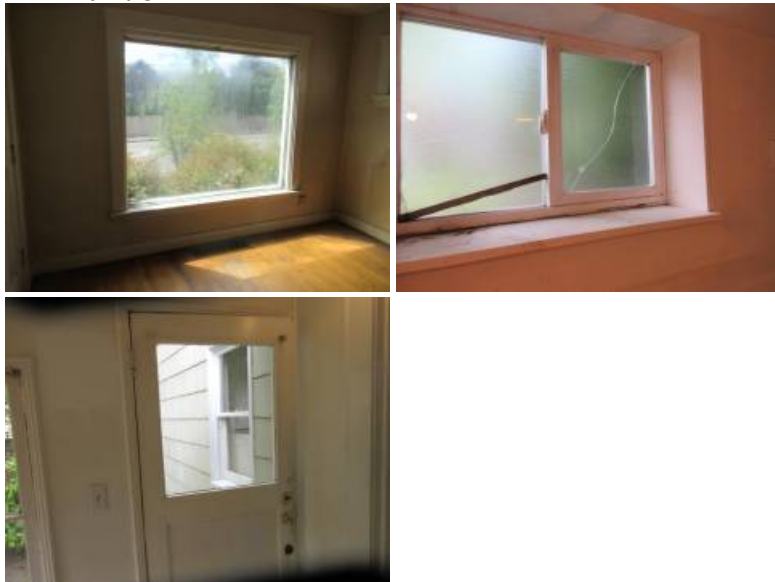
Several of the windows are stuck. They should be adjusted or repaired as necessary to restore proper operation.

The glass in the back door is not tempered safety glass. Tempered glass can be identified by the etched emblem in one corner of each pane. A higher margin of safety could be achieved if the glass was approved safety glass. Consideration should be given to replacing the glass as a safety upgrade.

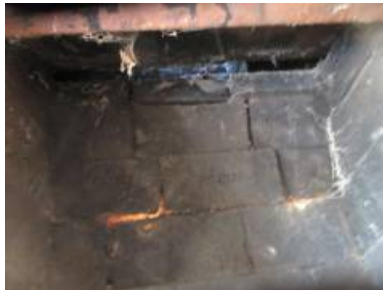
Deterioration of the fire brick was observed inside the firebox. Loose bricks should be reset, cracks and voids should be filled with refractory cement.

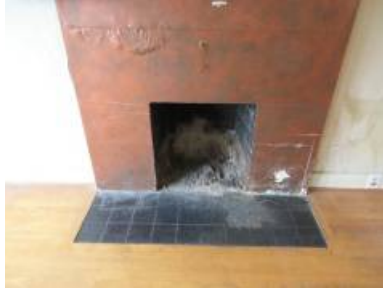
The hearth in front of the firebox does not extend out far enough. This is a safety concern. The hearth should stick out 18" in front of and 12" to either side of the fire box. Portable hearth extensions are available for this type of application. The hearth should be modified as necessary.

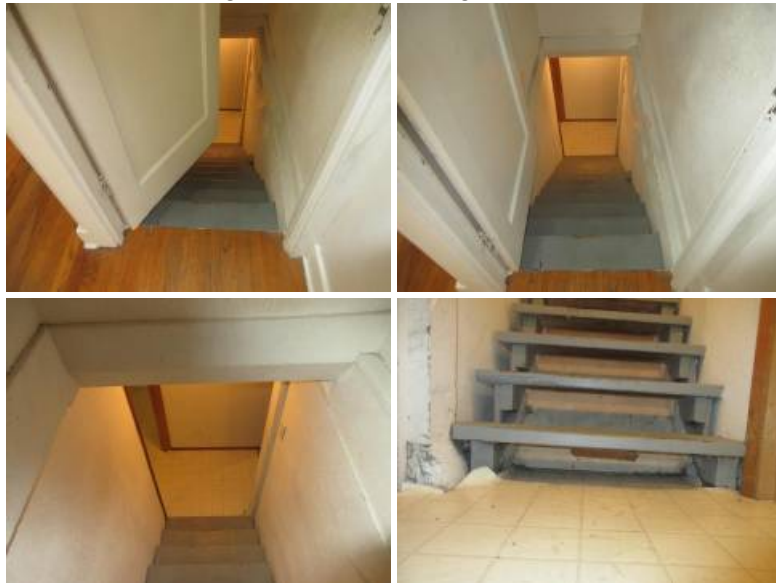
The head clearance above the stairs is less than the normal 6'- 8" presently required. This could result in head injuries. To reduce the risk of head injuries, padding should be installed at low points and/or care should be exercised when using these stairs.

The stairs are non-conforming due to the variable and/or excessive rise. Stair design standards require that stair risers do not exceed 8" and that the variation in rise not exceed 3/8" in order to reduce falls from tripping. To increase the margin of safety, consideration should be given to reconfiguring the stairs so that rise and run do not vary by more than 3/8". If this proves to be too impractical or expensive, then we recommend exercising caution when using these stairs.

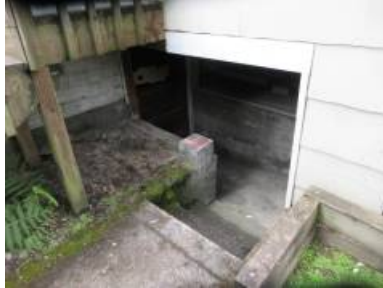
The basement walkout stairs are non-conforming due to the variable and/or excessive rise and head clearances. Stair design standards require that stair risers do not exceed 8" and that the variation in rise not exceed 3/8" in order to reduce falls from tripping. To increase the margin of safety, consideration should be given to reconfiguring the stairs so that rise and run do not vary by more than 3/8". If this proves to be too impractical or expensive, then we recommend exercising caution when using these stairs.
