NOTICE TO BUYER: SELLER-PROCURED INSPECTION REPORT

Ralph & Debbie Kappelhoff
13327 157th Ave NE
Redmond, WA, 98052

At your request, a visual inspection of the above referenced property was conducted on 02/20/2023. We have inspected the major structural components, plumbing, heating and electrical systems for signs of significant non-performance, excessive or unusual wear and general state of repair.

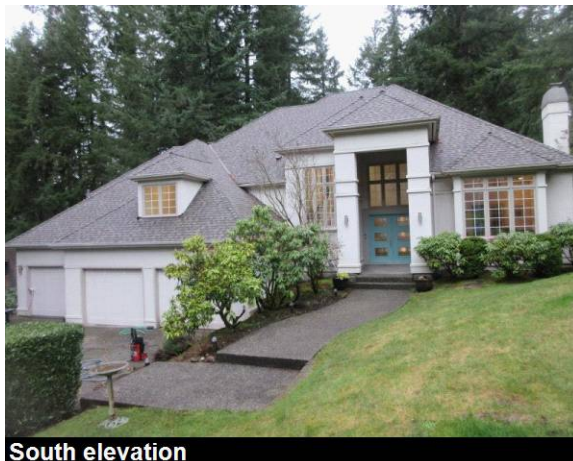
South elevation

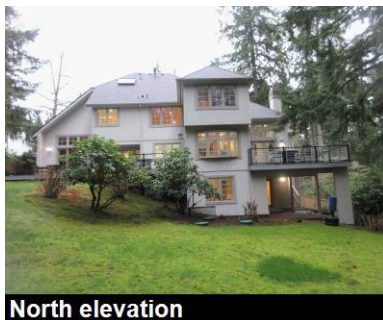
North elevation

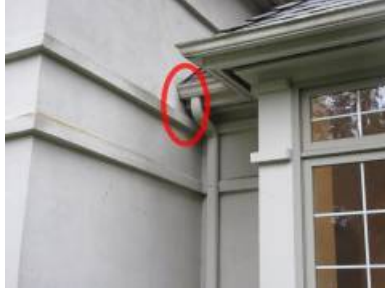
The gutters are corroded and beginning to leak. Replacement of the gutters will be required in the near future.

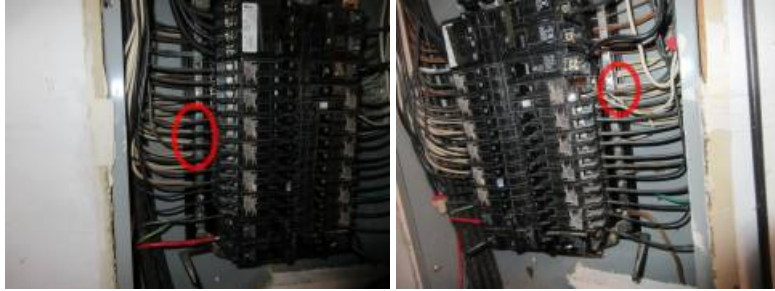
listed for multiple wires. This defect is easily repaired by connecting the two wires to a "pig tail", securing them with a wire cap, and then inserting the pig tail conductor under the terminal.

The circuits are labeled. The accuracy of the labeling was not verified. Do not assume the labeled circuit is off unless it has been checked with a voltage tester.

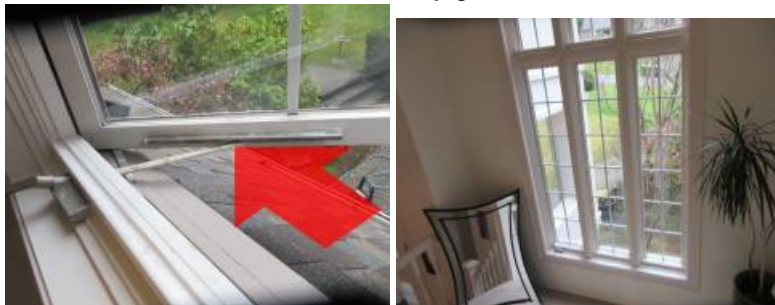
The stairway landing window glass is not labeled as tempered safety glass. The existing glass is nonconforming by current building standards and would be hazardous if broken. The installation of safety glass is recommended as a safety upgrade.

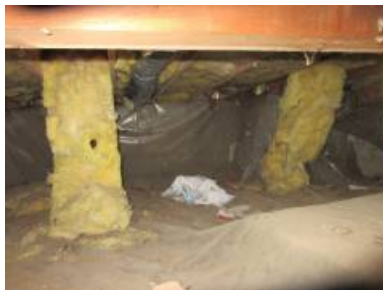
Some of the insulation batts were not properly secured and have falling down. The fallen batts should be reinstalled and secured.

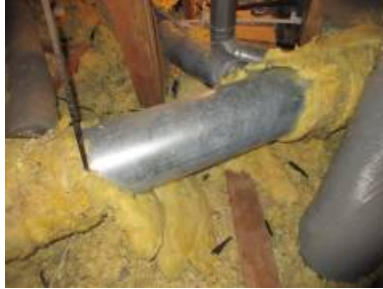
Some of the duct insulation is missing or has fallen off the ducts. This increases the amount of heat loss. The installation of new duct insulation is recommended in areas where insulation is missing.

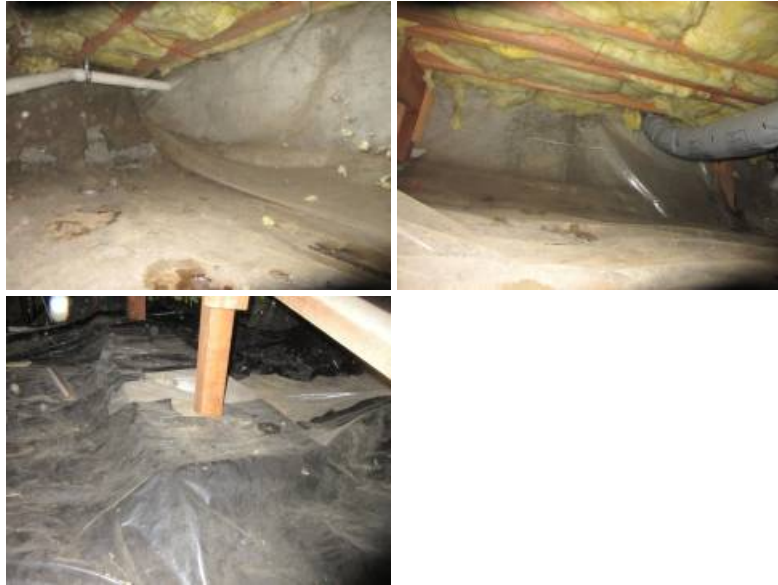
The foundation walls are covered with the plastic vapor retarder. This allows the transmission of water vapor from the soil up and into the exterior wall framing. The plastic vapor retarder should be removed from the foundation.

The support post concrete piers are covered with the plastic vapor retarder. This allows the transmission of water vapor from the soil up and into the floor framing. The plastic vapor retarder should be removed from the piers.

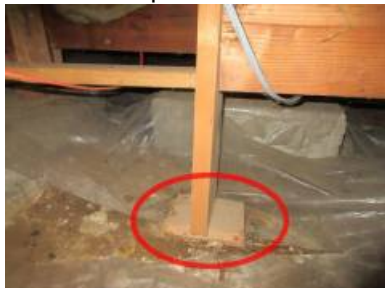
Soil is in contact with at least one of the wood posts in the crawl space. Good building practice requires that foundation walls or pier footings supporting wood frame construction, extend at least 8" above the finish grade with at least a 6" clearance between the top of the soil and the bottom of the wood finish materials. Soil in direct contact with wood creates a hospitable environment for wood destroying organisms. Establishing these minimum clearances is recommended.

There should be no soil to wood contact in any part of the building exterior or crawlspace, unless that wood is pressure treated. For the greatest safety to permanent structures there should be no soil to wood contact of any kind. Untreated wood in direct contact with exterior flatwork should also be avoided.

Good building practice requires that foundation walls or pier footings supporting wood frame construction, should extend at least 8" above the finish grade with at least a 6" clearance between the top of the soil and the bottom of the wood finish materials. Untreated wood should be raised 1-2" above surrounding flatwork and should have a moisture barrier such as 30 lb. asphalt impregnated felt installed between the concrete and wood. For additional information and treatment options, you should retain the services of a qualified pest control operator.
