NOTICE TO BUYER: SELLER-PROCURED INSPECTION REPORT

The following notice is given with respect to the Purchase and Sale Agreement dated _____ between _____ ("Buyer") and **Mats Helander** **Theza Helander** ("Seller") concerning **14349 172nd Ave NE Redmond WA 98052** ("the Property").

April 9, 2024

Re: 14349 172nd Ave. NE
Redmond, WA.

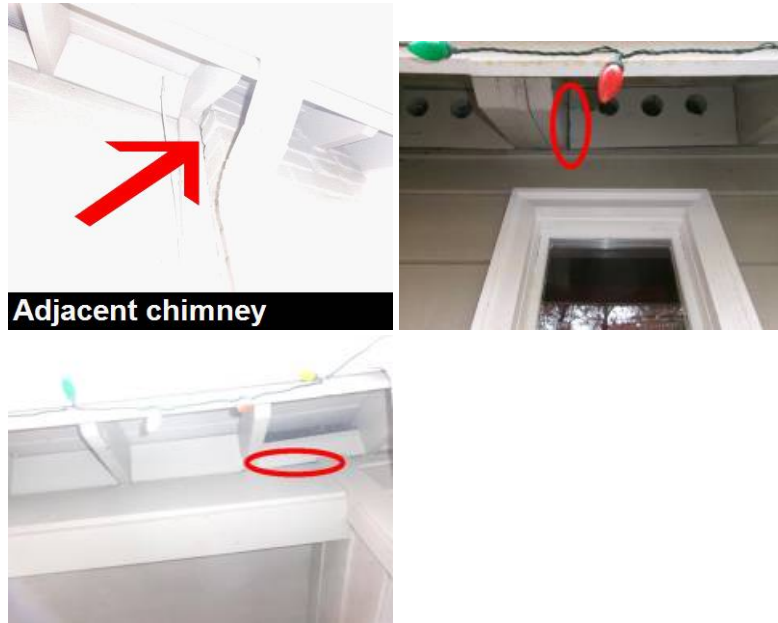
Gaps over 1/4" in size adjacent the brick cladding and soffit vent blocks will allow insects and rodents to enter the structure. Covering any gaps with screening, a strip of trim and/or caulking is recommended.

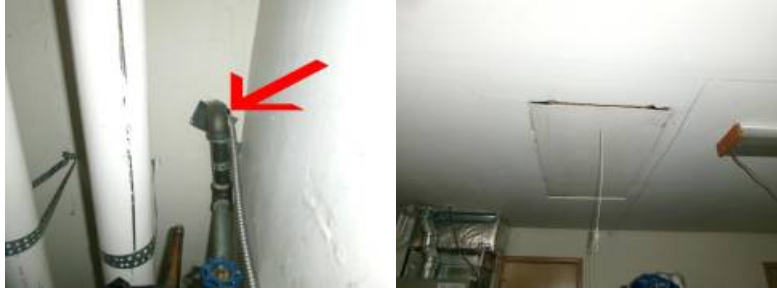
The pull down ladder is a breach in the fire resistive barrier in the garage. This is a safety concern. The gypsum barrier on the ceiling slows the spread of a fire from the garage to the attic. The installation of a layer of 5/8" gypsum type X board over the 1/4" plywood is recommended.

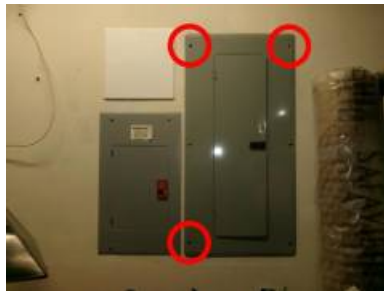
Screws that secure the panel cover to the panel box are missing. This is a potential hazard. Missing screws should be replaced with the original style blunt end screws.
