**James & Deborah Hunt
14320 173rd Place NE
Redmond, WA 98052**

Per the seller, the following items listed on the pre-sale inspection summary dated April 16, 2024, are being corrected by the seller as part of preparation for sale in good faith.

At your request, a visual inspection of the above referenced property was conducted on 04/15/2024. We have inspected the major structural components, plumbing, heating and electrical systems for signs of significant non-performance, excessive or unusual wear and general state of repair.

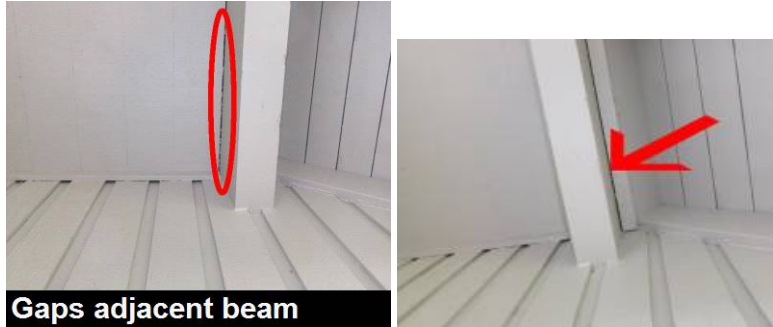
There are large gaps over 1/4" in size adjacent the beam. These gaps allow insects and rodents to enter the attic. Covering the gaps with screening, a strip of wood and/or caulking is recommended.

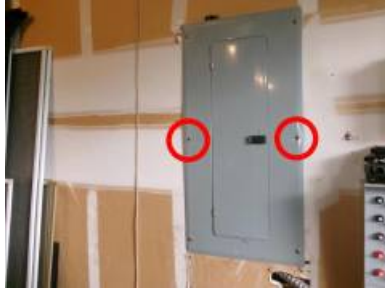
Screws that secure the panel cover to the panel box are missing. This is a potential hazard. Missing screws should be replaced with the original style blunt end screws.

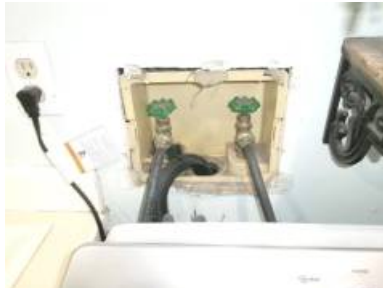
The hookups for the dryer are properly installed and in serviceable condition. The dryer itself was operated through a partial cycle, however we did not confirm the complete operation of the cycle timer.

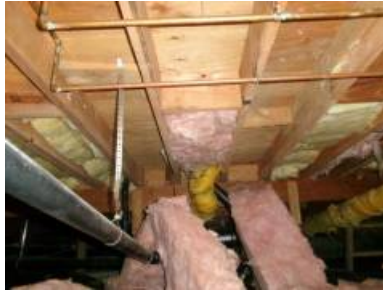
Some of the insulation batts are missing and several were not properly secured and have falling down. The fallen batts should be reinstalled and secured. The missing batts should be replaced.

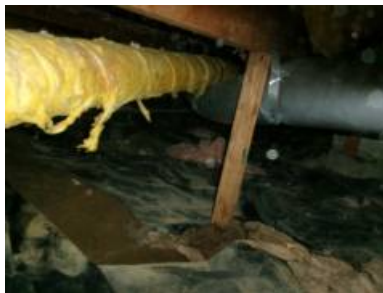
One 2x4 post has been propped up under the family room floor and is improperly supported by a block of wood. Water seeping into the crawlspace over the 1-1/2" piece of wood block has caused the bottom of the post to rot. Damaged posts should be replaced. Replacement should be done under current industry standards.

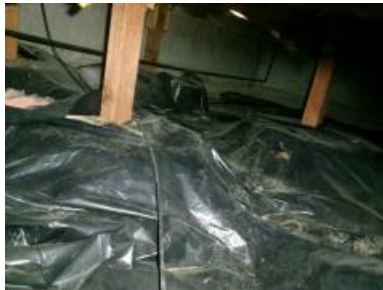
Some of the soil under the house is not covered with a polyethylene plastic vapor retarder. This component is typically referred to as a "vapor barrier". While not a true vapor barrier, it does reduce the transmission of water vapor from the soil to the air. The vapor retarder should be maintained so that it covers at least 85% of the entire surface of the soil.

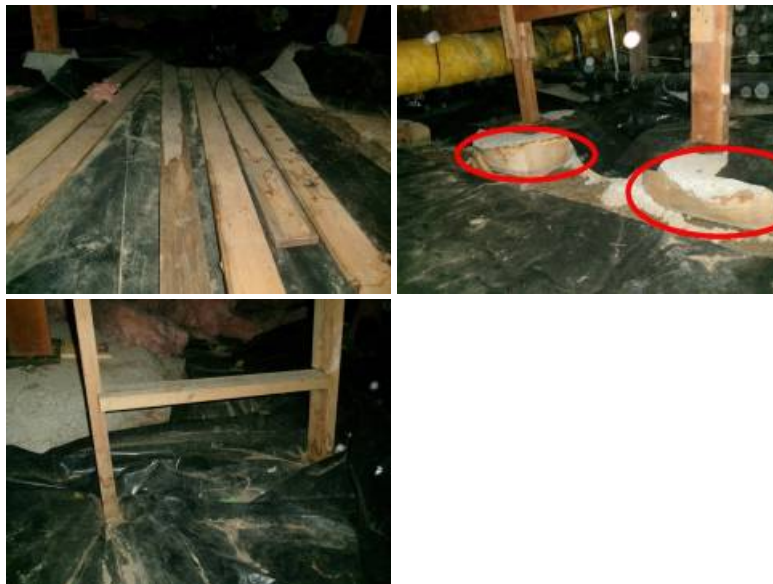
There should be no soil to wood contact in any part of the building exterior or crawlspace, unless that wood is pressure treated. For the greatest safety to permanent structures there should be no soil to wood contact of any kind. Untreated wood in direct contact with exterior flatwork should also be avoided.

Good building practice requires that foundation walls or pier footings supporting wood frame construction, should extend at least 8" above the finish grade with at least a 6" clearance between the top of the soil and the bottom of the wood finish materials. Untreated wood should be raised 1-2" above surrounding flatwork and should have a moisture barrier such as 30 lb. asphalt impregnated felt installed between the concrete and wood. For additional information and treatment options, you should retain the services of a qualified pest control operator.
