NOTICE TO BUYER: SELLER-PROCURED INSPECTION REPORT

May 21, 2024

**Re: 3432 175th Ave. NE
Redmond, Wa.**

At your request, a visual inspection of the above referenced property was conducted on 05/20/2024. We have inspected the major structural components, plumbing, heating and electrical systems for signs of significant non-performance, excessive or unusual wear and general state of repair.

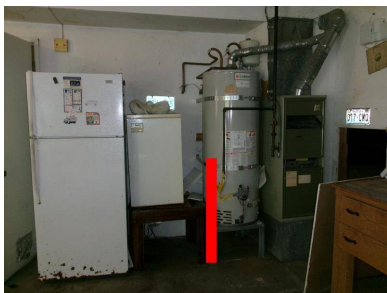
The gas pipes in front of the furnace and water heater are not protected by a bumper stop. A vertical steel pipe, bolted to the floor, is typically installed in front of the water heater to prevent a car bumper from damaging the gas lines.

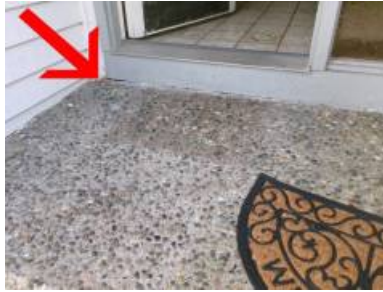
The front porch stoop has rotated towards the foundation. This is caused by settlement

of the backfill under the stoop. This will not adversely affect the foundation.

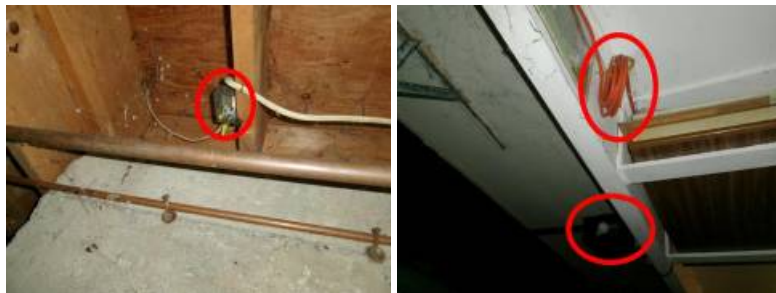
There are junction boxes with missing covers in the crawlspace. This is a fire/shock hazard. Covers should be installed on all junction boxes.

An extension cord is used as a temporary power source for the garage door opener. An extension cord is not suitable as a permanent wiring method. The installation of a receptacle within cords length of the motor is recommended.

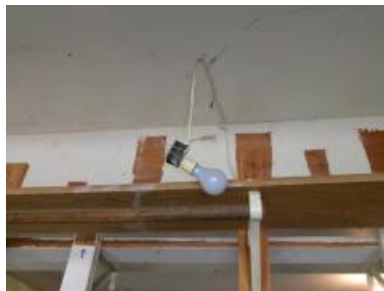
The laundry closet luminaries is not working. Testing the luminaries with a voltage tester revealed that there is current to them. Light bulbs should be replaced in non-functional luminaries and then they should be tested for proper operation.

The luminaires in the garage is detached and is hanging from its wires. This is a hazard. The luminaires should be reattached and secured to the ceiling.

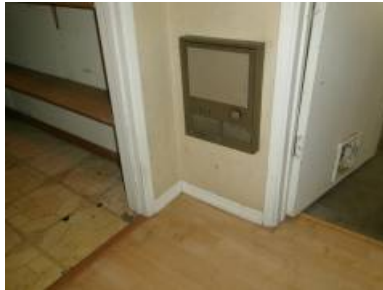
An electric fan assisted wall heater is used for heating in the family room. The heater was not working. Repairs or replacement is recommended.

This type of heater must be cleaned annually. An accumulation of dust inside this type of heater is a fire hazard. To clean the heater, turn off the power at the circuit breaker panel then remove the cover from the front of the heater. Use a paint brush to loosen the dirt and then vacuum it up.

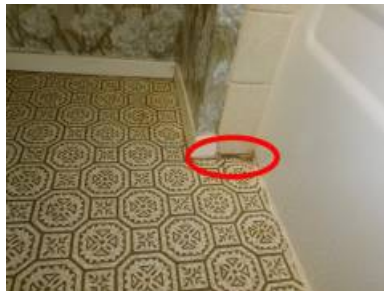
The caulking is deteriorated at the intersection between the tub/shower and floor. This can lead to water damage to the flooring and substrate. Recaulking this area is recommended.

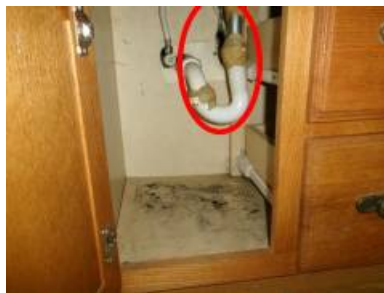
Improper, non-conforming material has been used for the drain pipe fitting. This material will not function reliably. Replacement with industry standard fittings is recommended.

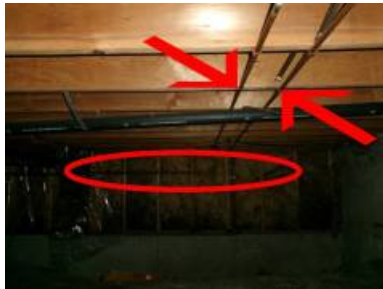
There are water pipes in the crawlspace that are not adequately insulated and could freeze. The installation of foam pipe insulation on all exposed water pipes is recommended.

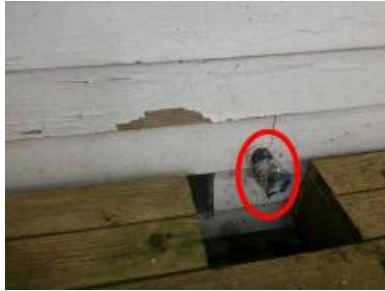
Replacement of the hose bibb is recommended.

The hose bibb on the rear of the house is also loose. This could result in damage to the water pipe and leakage. The bibb should be securely fastened to the wall.

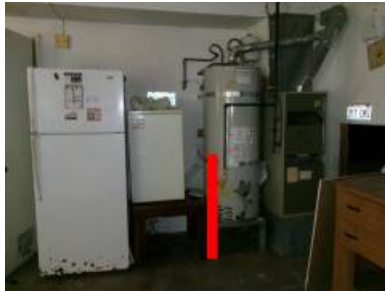
The gas pipes in front of the furnace and water heater are not protected by a bumper stop. A vertical steel pipe, bolted to the floor, is typically installed in front of the water heater to prevent a car bumper from damaging the gas lines.

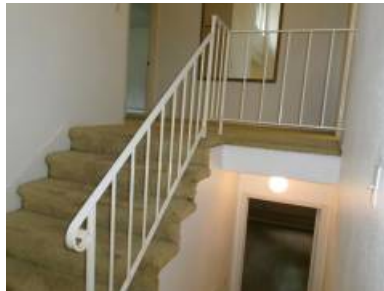
The stair railing baluster spacing is too wide. This is a hazard for small children. The baluster spacing should be reduced as a safety upgrade. Current standards require that a 4-3/8" sphere not pass through the railing.

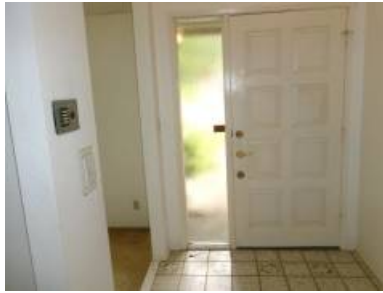
The glass adjacent the door is not tempered safety glass. Tempered glass can be identified by the etched emblem in one corner of each pane. The existing glass is nonconforming by current building standards and would be hazardous if broken. Consideration should be given to replacing the glass as a safety upgrade. The installation of safety glass is recommended as a safety upgrade for all windows less than 18" from the walking surface.

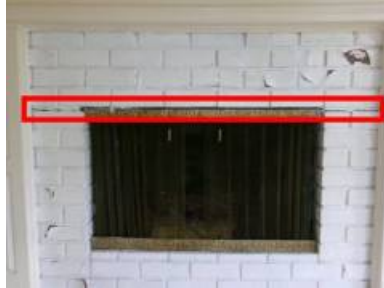
Deteriorated mortar joints of the brick veneer was observed outside the firebox adjacent the firebox lintel. Steel lintels with chronic exposure to moisture will rust, expand and damage the brick veneer. Consideration should be given to retooling (Tuck pointing) the defective mortar joints. An evaluation of the smoke chamber was not made. If you have concerns regarding the condition of the chimney's interior, the services of a certified chimney sweep is likely to determine the condition of the smoke chamber and flue.

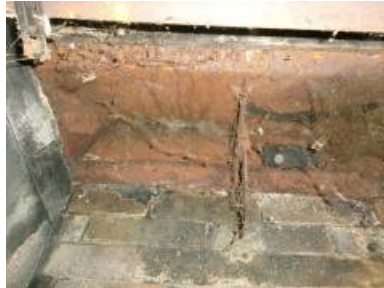
The fireplace damper is rusted stuck in the closed position. This condition is a hazard and therefore should be repaired prior to using the fireplace. Lintel.

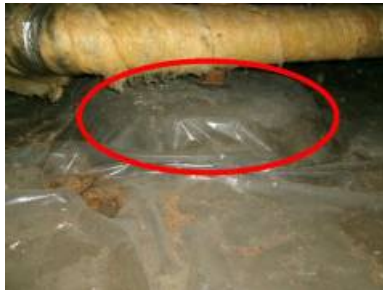
The support post concrete piers are covered with the plastic vapor retarder. This allows the transmission of water vapor from the soil up and into the floor framing. The plastic vapor retarder should be removed from the pier so that it covers at least 85% of the entire surface of the soil only.

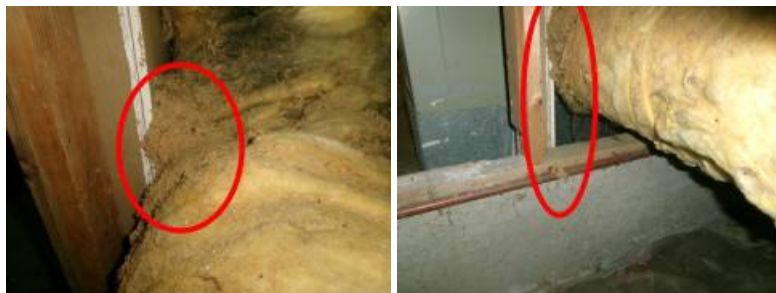
There should be no soil to wood contact in any part of the building exterior or crawlspace, unless that wood is pressure treated. For the greatest safety to permanent structures there should be no soil to wood contact of any kind. Untreated wood in direct contact with exterior flatwork should also be avoided.

Good building practice requires that foundation walls or pier footings supporting wood frame construction, should extend at least 8" above the finish grade with at least a 6" clearance between the top of the soil and the bottom of the wood finish materials. Untreated wood should be raised 1-2" above surrounding flatwork and should have a moisture barrier such as 30 lb. asphalt impregnated felt installed between the concrete and wood. For additional information and treatment options, you should retain the services of a qualified pest control operator.
