NOTICE TO BUYER: SELLER-PROCURED INSPECTION REPORT

Sushwanth Nimmagadda, Hema Gudavalli
 13619 174th Ave NE,
 Redmond, WA 98052

May 10, 2024

Re: 13619 174th Avenue NE
Redmond, WA.

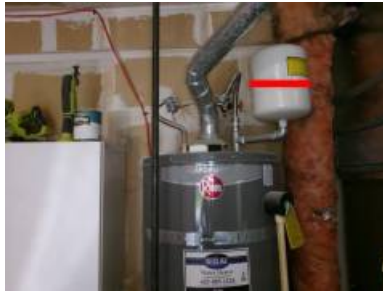
<i>SEISMIC RESTRAINT</i>	The water heater is secured to the wall. This prevents it from falling over during an earthquake and rupturing gas and water lines.
<i>ELEVATION ABOVE GARAGE FLOOR</i>	The burner of the water heater is elevated at least 18" above the garage floor in accordance with industry standards. This elevation prevents ignition of gasoline fumes that might leak from cars, lawn mowers, gas cans, etc.
<i>GENERAL COMMENTS</i>	The water heater is properly installed and is performing its intended function.

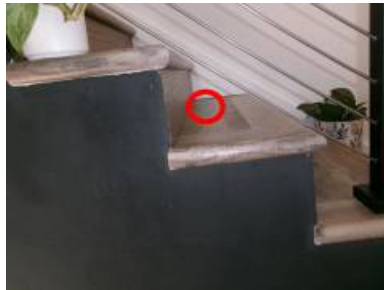
The stair railing spacing at the stair treads is too wide. This is a hazard for small children. The railing spacing should be reduced as a safety upgrade. Current standards require that a 6" sphere not pass through or under the railing.

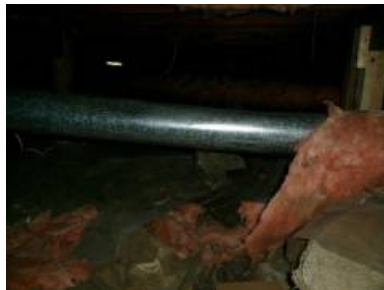
DUCT INSULATION

Some of the duct insulation is missing or has fallen off the ducts. This increases the amount of heat loss. The installation of new duct insulation is recommended in areas where insulation is missing.

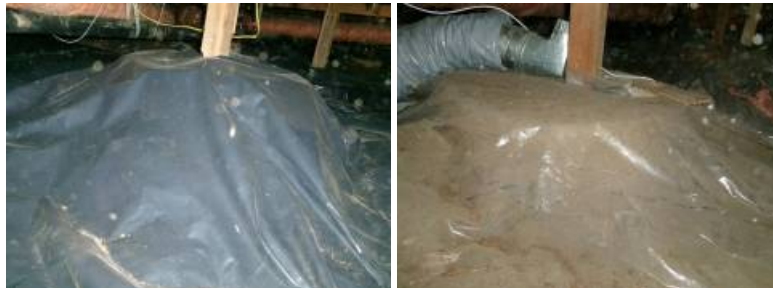
The support post concrete piers are covered with the plastic vapor retarder. This allows the transmission of water vapor from the soil up and into the floor framing. The plastic vapor retarder should be removed from the pier so that it covers at least 85% of the entire surface of the soil only.

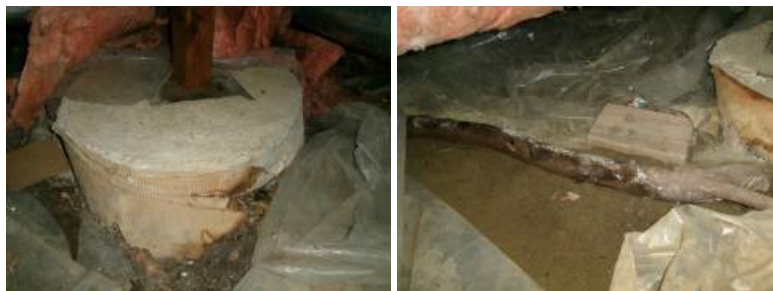
Cellulose forms were left in place on the pier footings. This cellulose is conducive to the infestation of various wood destroying organisms. The removal of the cellulose is recommended.

Scrap-wood and other cellulose debris was observed on the crawl floor. This wood debris creates conducive conditions for wood boring insects. The removal of all cellulose debris is recommended.
