NOTICE TO BUYER: SELLER-PROCURED INSPECTION REPORT

The following notice is given with respect to the Purchase and Sale Agreement dated _____
 between _____ (“Buyer”)
 and **Kevin J Hafer Revocable Living** _____ (“Seller”)
 concerning 8317 NE 120th Pl Kirkland WA 98034 (“the Property”).

DATE OF INSPECTION: 5/1/2024.
 INSPECTOR'S NAME: Terry Clark.
 CLIENT NAME: Mr. Kevin Hafer.
 ADDRESS OF PROPERTY INSPECTED: 8317 NE 120th Pl.
 Kirkland, WA.

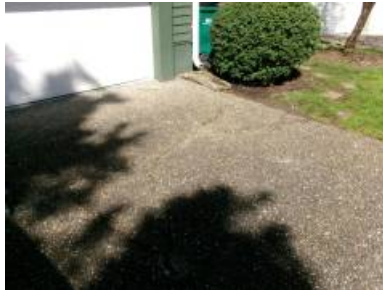
ROOF WATER DRAIN SYSTEM The building lacks a roof water drain system. Roof water discharging on the ground adjacent to the foundation wall is one of the most common causes of water or moisture problems in ground floor occupancies, basements and crawlspaces. Overflowing gutters and clogged downspouts and scuppers also frequently cause or exacerbate moisture or water entry problems in crawlspaces and basements.

If water entry problems develop within the living space, consideration should be given to installing a below grade drain system to divert roof water away from the foundation system.

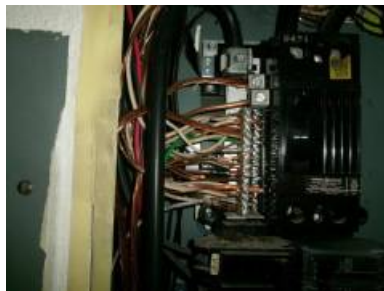
Neutral (white wire) and equipment grounding conductors (bare wire) terminate under the same lug. An individual terminal should be provided for the connection of each branch-circuit neutral conductor. When the neutral is disconnected, the objective is to still have the equipment ground connected. If both the neutral and grounded conductor is under the same terminal, this cannot be accomplished. The services of a qualified electrical contractor should be retained to repair the circuit(s).

The circuits are labeled. The accuracy of the labeling was not verified. Do not assume the labeled circuit is off unless it has been checked with a voltage tester.

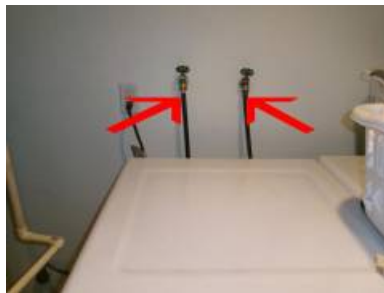
The hookups for the dryer are properly installed and in serviceable condition. The dryer itself was operated through a partial cycle, however we did not confirm the complete operation of the cycle timer.

Upgrading the washer connections to high pressure (steel braided) lines is recommended.
