June 27, 2024

**Re: 23233 SE 242nd St.**  
**Maple Valley, Wa.**

At your request, a visual inspection of the above referenced property was conducted on 06/26/2024. We have inspected the major structural components, plumbing, heating and electrical systems for signs of significant non-performance, excessive or unusual wear and general state of repair.

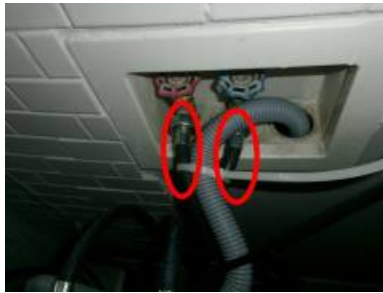
The hookups for the dryer are properly installed and in serviceable condition. The dryer itself was operated through a partial cycle, however we did not confirm the complete operation of the cycle timer.

Upgrading the washer connections to high pressure (steel braided) lines is recommended.
