**NOTICE TO BUYER: SELLER-PROCURED INSPECTION REPORT**

**Terrill Family Living Trust  
14120 176<sup>th</sup> Ave. NE  
Redmond, WA 98052**

At your request, a visual inspection of the above referenced property was conducted on 09/17/2024. We have inspected the major structural components, plumbing, heating and electrical systems for signs of significant non-performance, excessive or unusual wear and general state of repair.

DATE OF INSPECTION: 9/17/2024.  
INSPECTOR'S NAME: Terry Clark.  
CLIENT NAME: Mr. Peter Terrill & Ms. Elizabeth Camper.  
CLIENT E-MAIL ADDRESS mohrscircle73@gmail.com; [elizabethcamperx@gmail.com](mailto:elizabethcamperx@gmail.com).  
ADDRESS OF PROPERTY 14120 176th Ave. NE  
INSPECTED Redmond, WA.

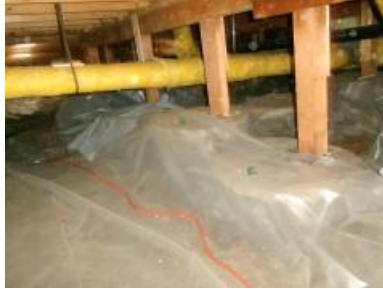
#### PEST CONTROL

There is evidence of rodent activity in the crawlspace. The first step in eliminating rodents from the crawlspace is to seal all possible entry points using wire mesh, caulking, wood, stainless steel wool, aerosol foam or mortar. Careful work sealing cracks, holes, gaps, and covering ground water drain inlets will discourage rodent activity. Once this work is completed, snap traps baited with peanut butter should be installed and monitored. The absence of rodents in the traps typically means that the rodents have been excluded from the area.
