NOTICE TO BUYER: SELLER-PROCURED INSPECTION REPORT

Jonathan and Melanie Liperi
7432 245th Way NE
Redmond, WA 98053

February 11, 2025

DATE OF INSPECTION: 2/10/2025.
 INSPECTOR'S NAME: Terry Clark.
 CLIENT NAME: Mr. Jon & Melanie Liperi.
 MAILING ADDRESS: 7432 245th Way NE
 Redmond WA.
 CLIENT E-MAIL ADDRESS jliperi@outlook.com; mliperi@outlook.com.
 ADDRESS OF PROPERTY 7432 245th Way NE
 INSPECTED Redmond, WA.

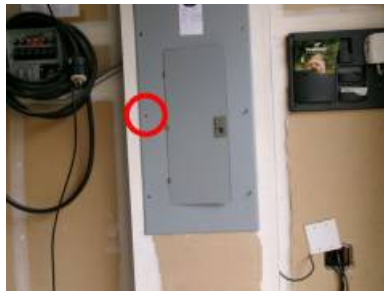
Screws that secure the panel cover to the panel box are missing. This is a potential hazard. Missing screws should be replaced with the original style blunt end screws.

The circuits are labeled. The accuracy of the labeling was not verified. Do not assume the labeled circuit is off unless it has been checked with a voltage tester.
