## NOTICE TO BUYER: SELLER-PROCURED INSPECTION REPORT

Anthony and Christina Monsaas  
18109 NE 108<sup>th</sup> CT.  
Redmond WA 98052

At your request, a visual inspection of the above referenced property was conducted on 02/17/2025. We have inspected the major structural components, plumbing, heating and electrical systems for signs of significant non-performance, excessive or unusual wear and general state of repair.

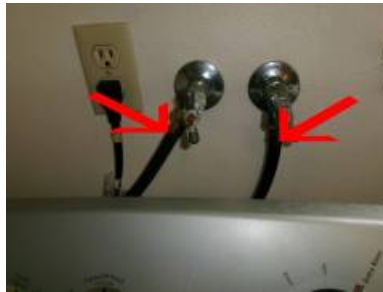
The hookups for the dryer are properly installed and in serviceable condition. The dryer itself was operated through a partial cycle, however we did not confirm the complete operation of the cycle timer.

High pressure (steel braided) washer line connections is recommended.
