## NOTICE TO BUYER: SELLER-PROCURED INSPECTION REPORT

The following notice is given with respect to the Purchase and Sale Agreement dated \_\_\_\_\_  
between \_\_\_\_\_ ("Buyer")  
and **Yuan Ping** **Yue Zhang** ("Seller")  
concerning **17507 Ne 142nd St Redmond WA 98052** ("the Property").

DATE OF INSPECTION: 3/13/2025.  
INSPECTOR'S NAME: Terry Clark.  
CLIENT NAME: Mr. Ian Ping & Ms. Jenny Zhang.  
MAILING ADDRESS: 17507 NE 142nd St.  
Redmond Wa.  
CLIENT E-MAIL ADDRESS: ggtdddgg@gmail.com; [doule2024@outlook.com](mailto:doule2024@outlook.com).  
ADDRESS OF PROPERTY INSPECTED: 17507 NE 142nd St.  
Redmond, WA.

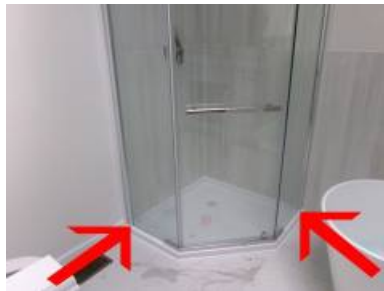
| GLASS ENCLOSURE | The glass shower enclosure is labeled as tempered safety glass, is properly installed and in serviceable condition. |

| FLOORING MATERIAL | The floor is covered with ceramic tile. The tile is properly installed and is in good condition. |
