NOTICE TO BUYER: SELLER-PROCURED INSPECTION REPORT

The following notice is given with respect to the Purchase and Sale Agreement dated _____
between _____ (“Buyer”)
and **Tom Stimach** **Lisa Stimach** (“Seller”)
concerning **24225 Ne 10th St Sammamish WA 98074** (“the Property”).

Tom & Lisa Stimach
24225 NE 10th Street
Sammamish, WA 98074

At your request, a visual inspection of the above referenced property was conducted on 08/21/2025. We have inspected the major structural components, plumbing, heating and electrical systems for signs of significant non-performance, excessive or unusual wear and general state of repair.

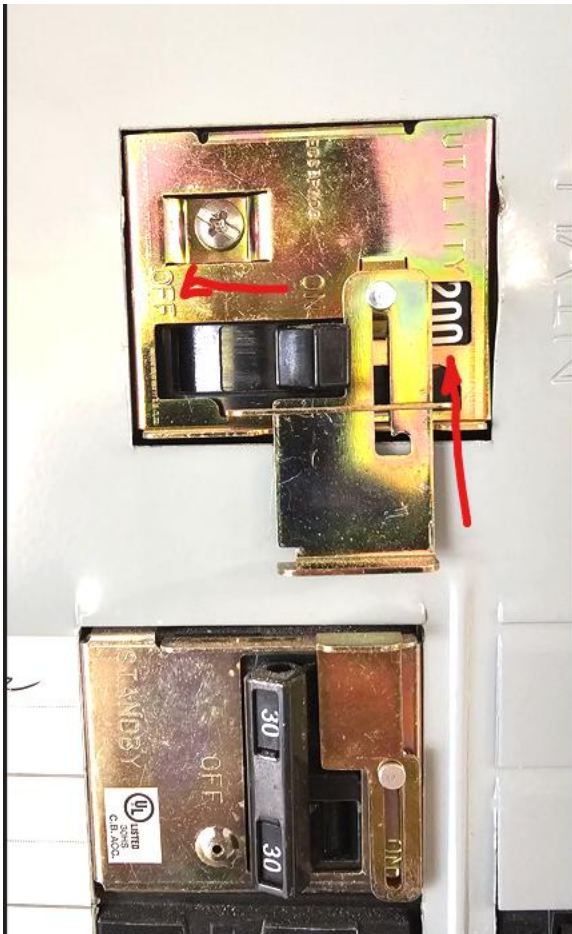
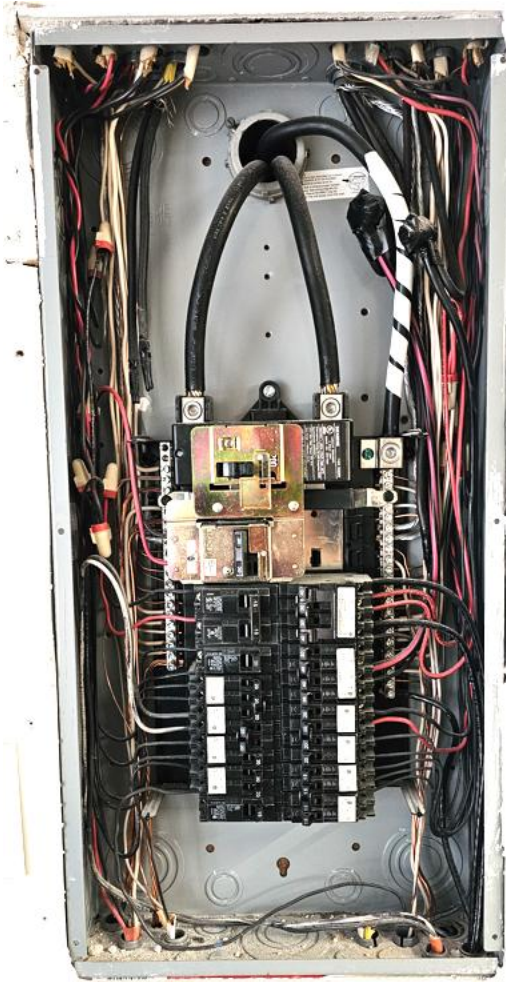
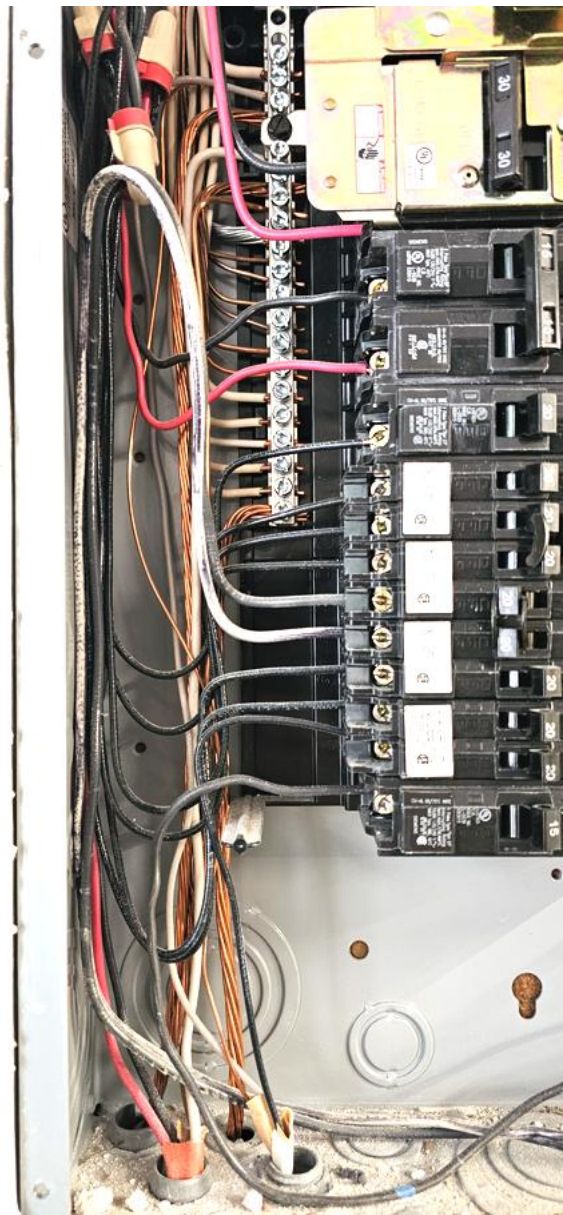
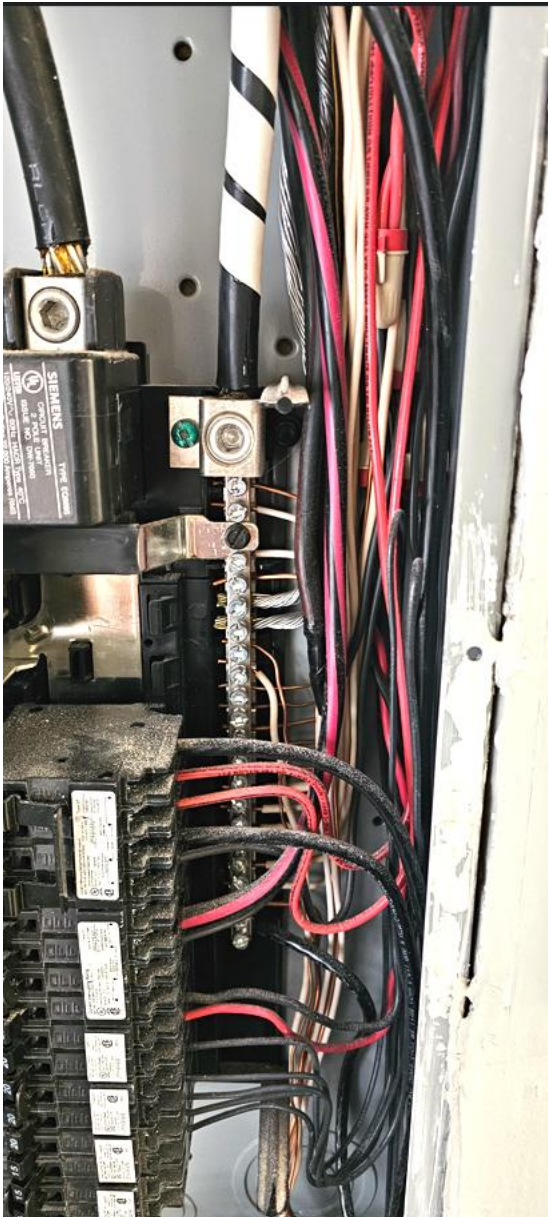
1. **GARAGE: ATTACHED GARAGE PASSAGE DOOR** – Self closing hinges are now armed and door closes.
2. **ELECTRICAL SYSTEM: SERVICE PANEL & OVER CURRENT PROTECTION** – The inspector did not open the service panel. This is a Siemens panel and was installed by McGinnis Electric LLC on November 5, 2012. This panel has not been modified; to access you need to shut off the main breaker and slide up the generator switch to pull off. On September 9, 2025, McGinnis Electric accessed the main panel and confirmed all wiring is correct and all breakers are providing the correct overcurrent protection.

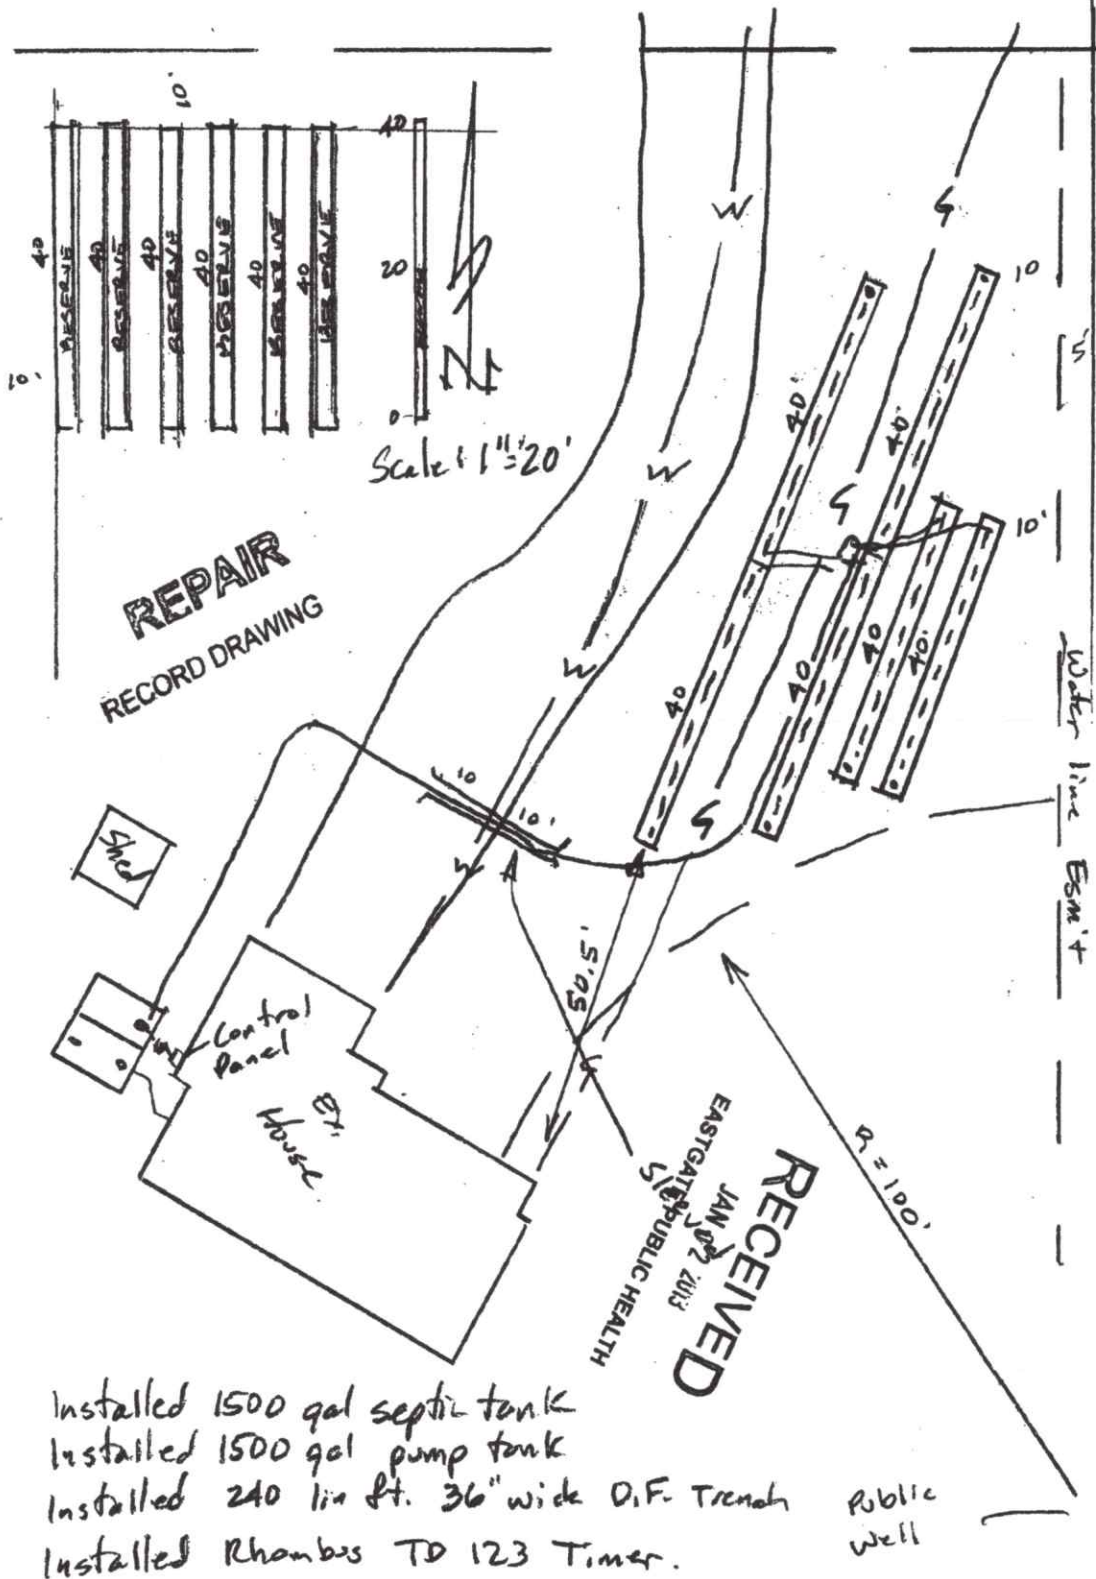
REVIEWER - 9/16/2025 - Inspection report indicates pump drawdown is 50 gallons per minute (gpm), design specification is 75 gpm. Recommend monitoring Onsite Sewage System (OSS) at annual intervals or sooner if needed, diagnosing OSS pump and OSS mound and performing maintenance / repairs as needed to restore OSS to design specifications. If residence is to be occupied at or near maximum occupancy of eight people, recommend diagnosing and restoring OSS to design specifications sooner than next annual inspection.

The comment added by King County on 9/16/25 to the report is not a deficiency. Although the new septic system installed in 2012 was designed using a 75 GPM pump, a 50 GPM pump was installed, which is a standard, commonly used model that has operated reliably since installation. The inspector explained that the 75 GPM pump shown on the design is not typically stocked on their trucks, and the 50 GPM pump is the standard and sufficient option. The inspector confirmed the system is functioning as intended and additional comments will be added to the report
