September 9, 2025

Re: 12900 182nd Ave. NE
Redmond, WA.

At your request, a visual inspection of the above referenced property was conducted on 09/08/2025. We have inspected the major structural components, plumbing, heating and electrical systems for signs of significant non-performance, excessive or unusual wear and general state of repair.

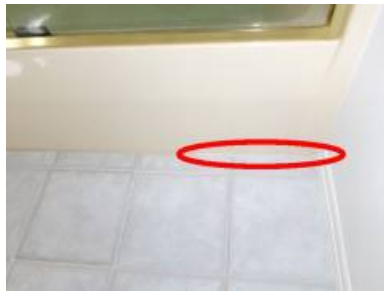
WALLS

A portion of the caulking is missing at the intersection between the tub/shower and floor. Cracking of the grout can lead to water damage to the flooring and substrate. Caulking this area is recommended.
