NOTICE TO BUYER: SELLER-PROCURED INSPECTION REPORT

Comments on Home Inspection Summary Items dated 7/15/2021

Prepared For: Jeffrey Linstad

Property Address: 13314 174th Ave NE, Redmond, WA 98052

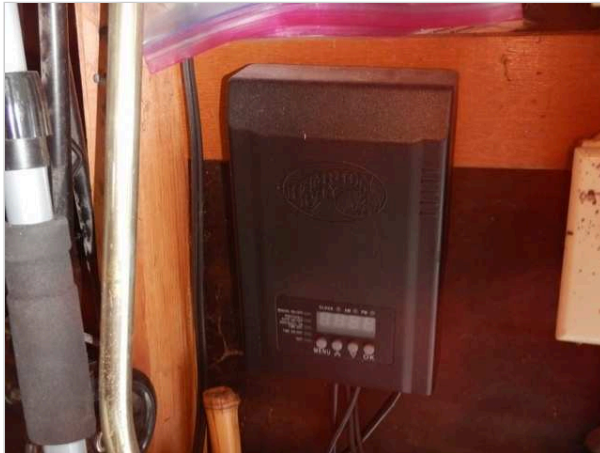
This property is equipped with an exterior lighting system adding to the safety and security of the residence. Testing of the lighting system is not within the scope of the inspection. Questioning the seller about the system's operation is recommended.

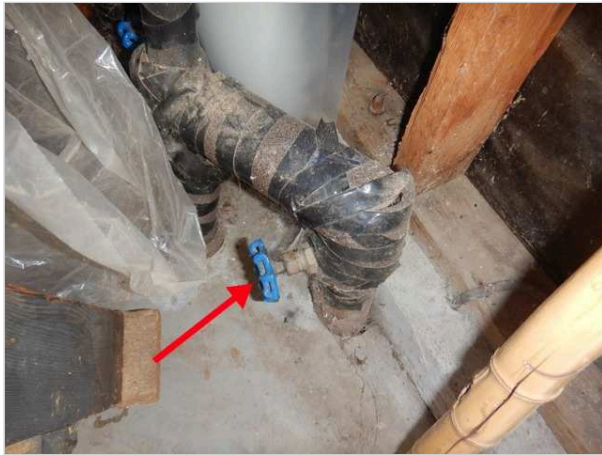
The main water shutoff valve is located in the garage.

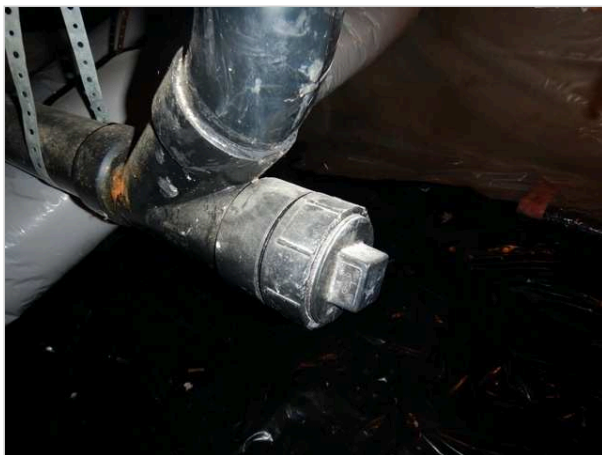
The sewer clean out is located in the crawl space.

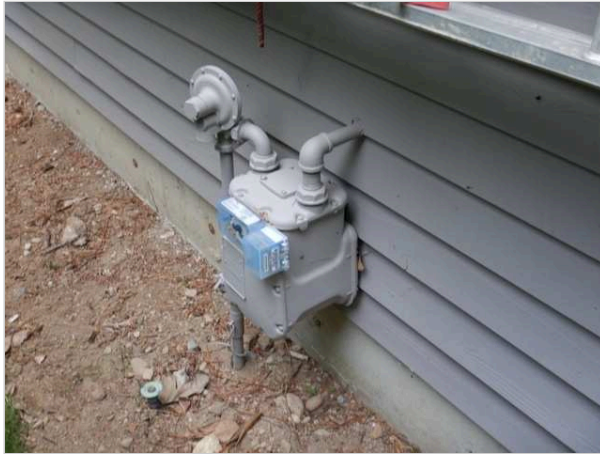
The gas meter is located at the S exterior. There appears to be gas shut off valves at the appliances that are often colored "red" or metal shut offs installed in the floor or walls that turn off the gas with a special key. These allow quick shut off in the event of a gas leak at the appliance. The inspector recommends purchasing an emergency shut off tool for the main shut off valve at the gas meter. A crescent wrench or special shut off tool can be purchased at your local hardware or home improvement center. The inspector recommends attaching the shut off tool to the meter with a piece of string for easy accessibility. In the event you still smell gas at the appliance after the appliance valve is shut off, go to the exterior, locate the meter and turn the main shut off valve 90 degrees to shut the gas off to the structure. Once this has been done, call your local gas utility provider and notify them of the situation.

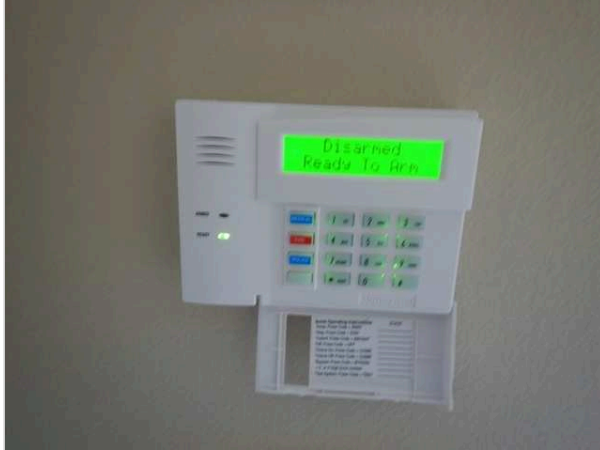
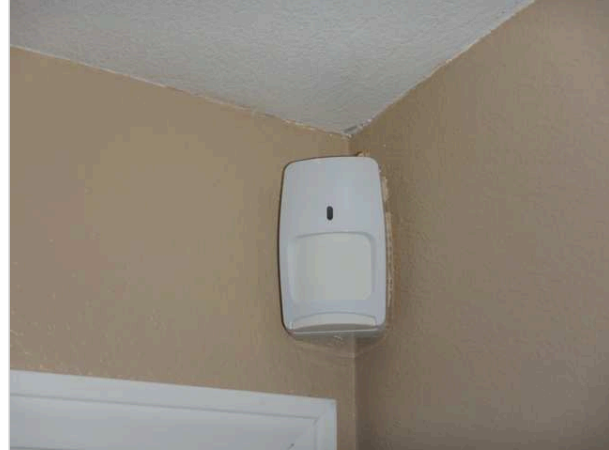
The structure is equipped with a security system. Inspecting security alarm systems is outside the scope of the national home inspection standards as the inspector is not an expert in such systems. The inspector recommends questioning the current home owner on its condition and operation and/or having the system inspected by a professional security company to ensure functional service is provided.

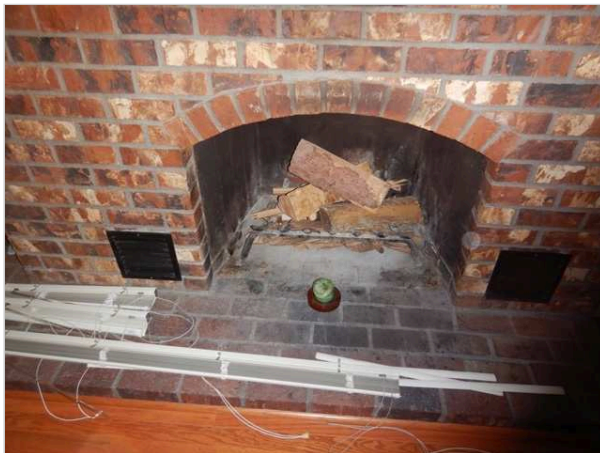
The fireplace(s) appear(s) to be in functional condition.

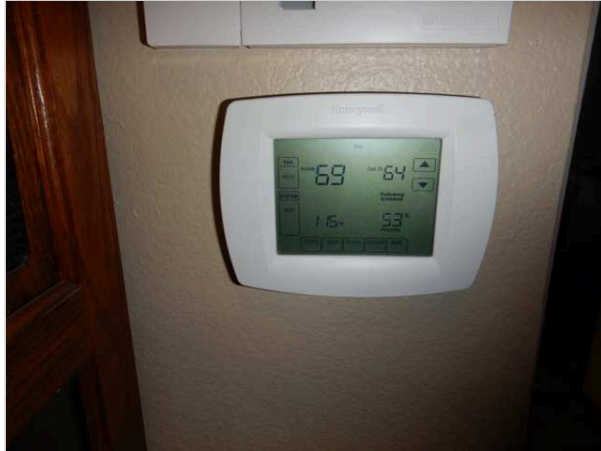
The heating system is controlled by an energy saving thermostat that should provide a higher degree of functionality and result in lower heating costs.

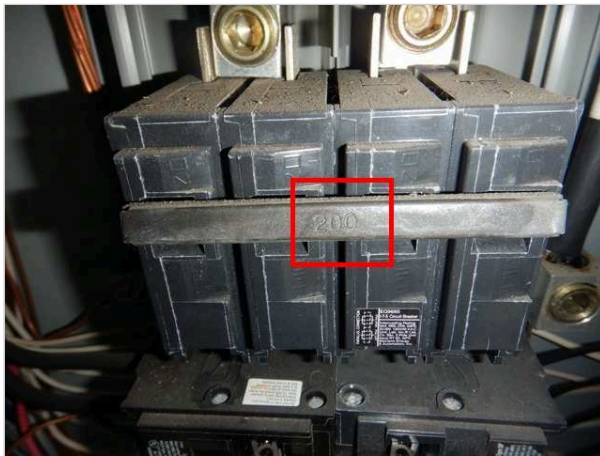
The voltage was determined by the stated capacity from the data plate in the panel(s). The actual voltage was not measured at the time of the inspection. If such information is desired, contact a qualified professional to verify the actual measurements.

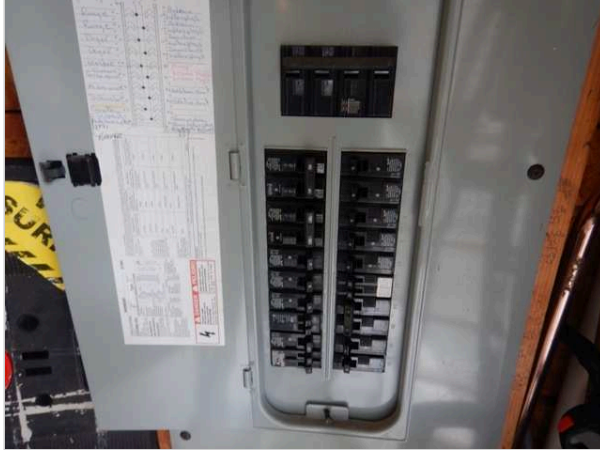
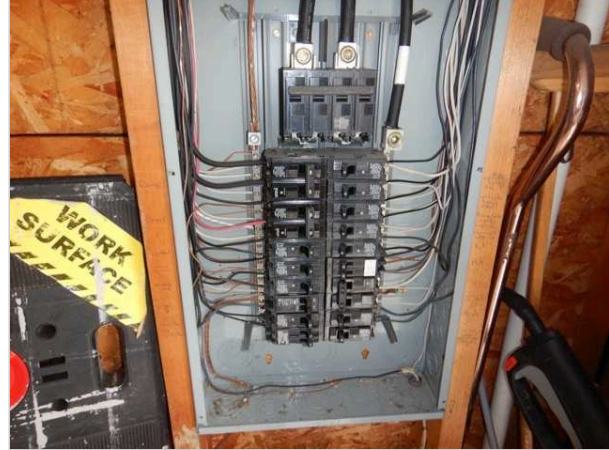
The electrical panel cover(s) was/were removed to provide access to the interior of the panel(s) for inspection.

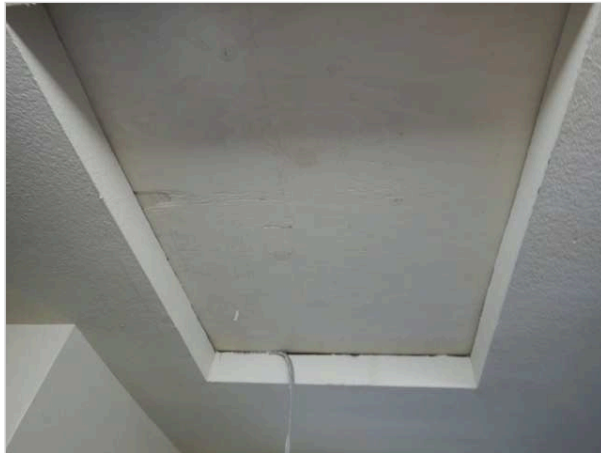
The attic was accessible at the time of the inspection.

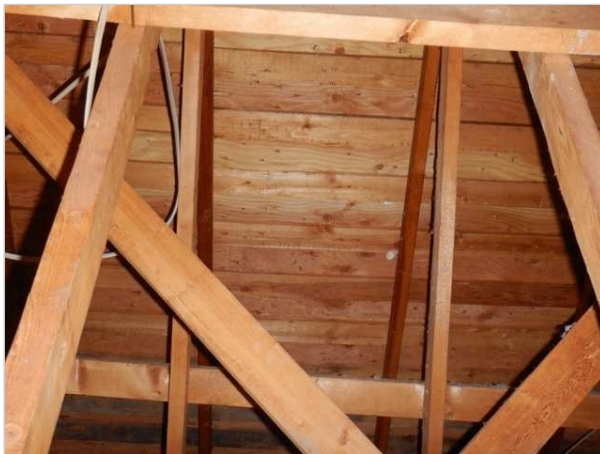
The roof rafters/trusses and sheathing in visible areas of the attic appear to be providing functional service at this time.

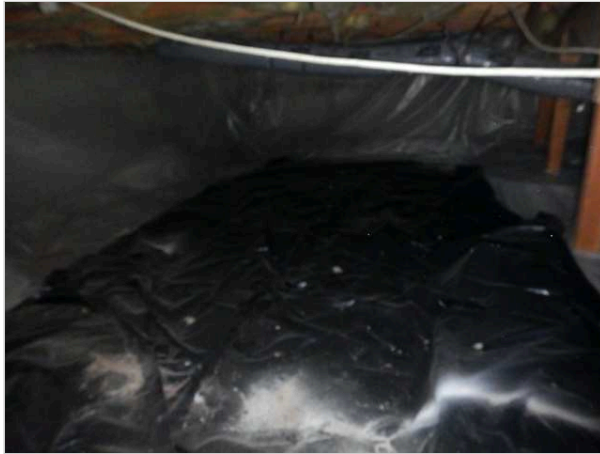
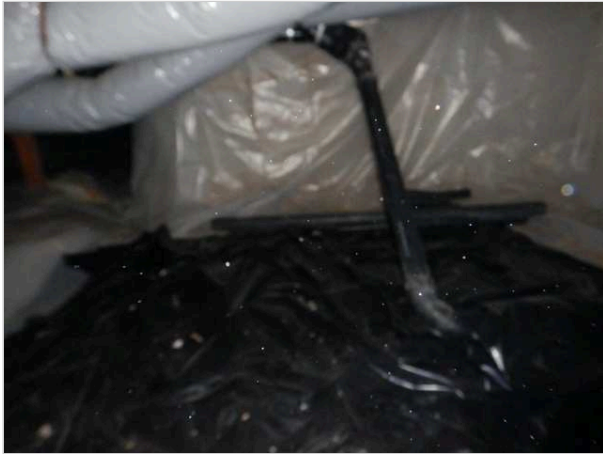
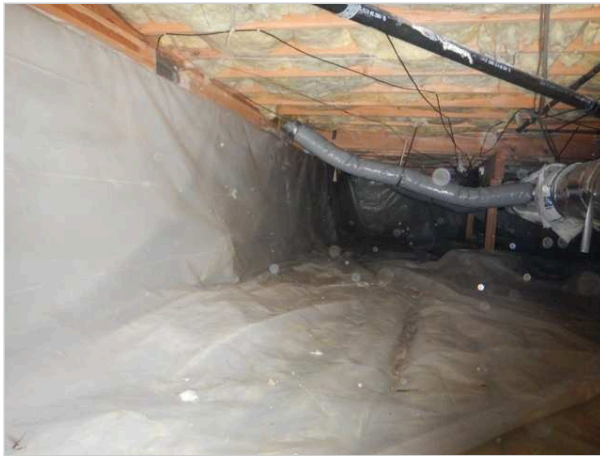
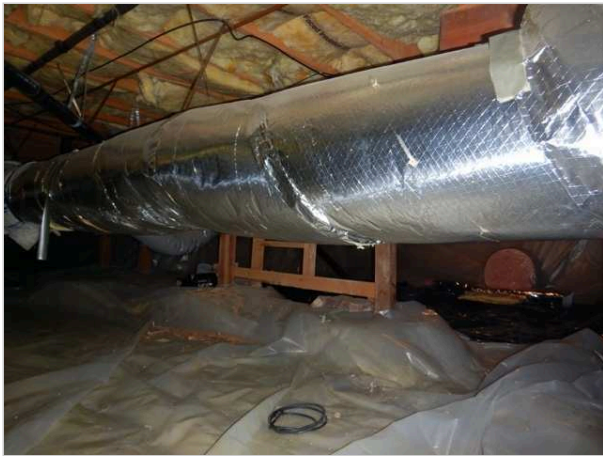
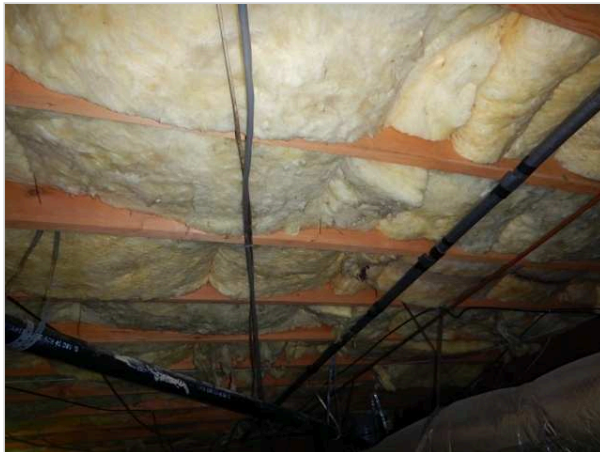
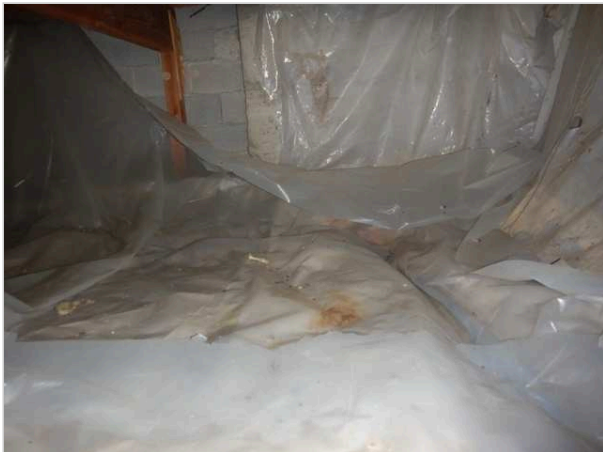
The crawl space was accessible and entered at the time of the inspection.
