**Re: 13828 180th Ave. NE  
Redmond, WA.**

At your request, a visual inspection of the above referenced property was conducted on 12/13/2021. We have inspected the major structural components, plumbing, heating and electrical systems for signs of significant non-performance, excessive or unusual wear and general state of repair.

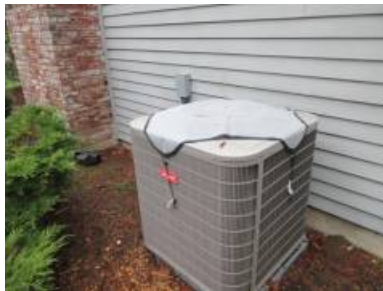
Also, if the condenser is not level, then the air conditioner will not work correctly. Specifically, the pump may not work the way it is supposed to. The condenser pump contains some oil that travels with the cooling fluid and then redeposits itself back into the pump. This helps to keep the device well lubricated. Sometimes the oil can separate from the coolant and pool in one area of the condenser. For example, a good deal of the oil can end up in the condenser coil. This is the case if the unit were tipped towards the coil. When this happens, the pump no longer has the lubrication it needs. The result is a pump that can wear out more quickly and also overheat.

One of the only ways to make sure that the condenser oil stays moves smoothly and mostly deposits in the compressor is to keep the unit upright and level.

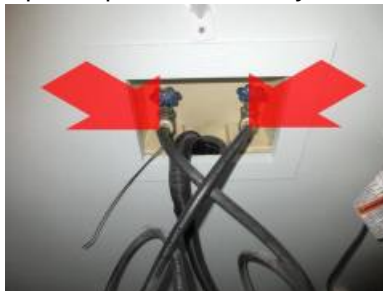
The hookups for the dryer are properly installed and in serviceable condition. The dryer itself was operated through a partial cycle, however we did not confirm the complete operation of the cycle timer.

Upgrading the washer connections to high pressure (steel braided) lines is recommended.
