NOTICE TO BUYER: SELLER-PROCURED INSPECTION REPORT

George and Kellie Anderson
14145 177TH AVE NE
Redmond, WA 98052

At your request, a visual inspection of the above referenced property was conducted on 03/03/2022. We have inspected the major structural components, plumbing, heating and electrical systems for signs of significant non-performance, excessive or unusual wear and general state of repair.

14145 177th Ave. NE
Redmond WA.

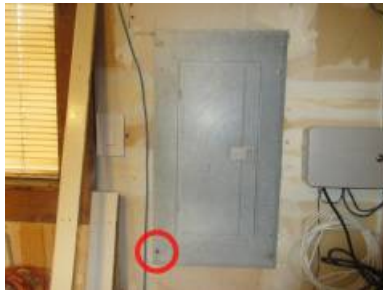
7.9 OVER CURRENT PROTECTION

One of the circuits is double tapped. Double tapping means that two conductors share a single terminal. Double tapped terminals can loosen and overheat and therefore are not permitted unless the terminal is specifically listed for multiple wires. This defect is easily repaired by connecting the two wires to a "pig tail", securing them with a wire cap, and then inserting the pig tail conductor under the terminal.
