Home Inspection - MCI

Property Address: 27908 NE 147th PI

Property City, State Zip: Duvall, WA 98019

Worldwide ERC® Relocation Property Assessment

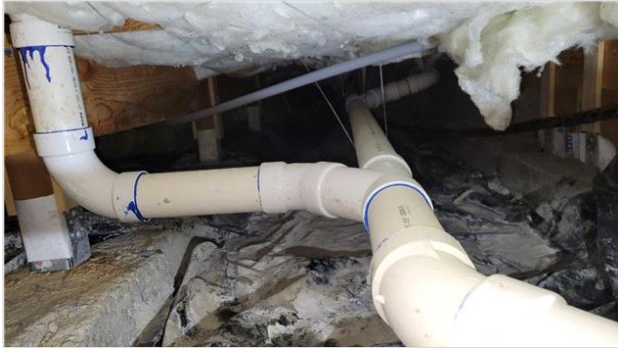
Crawl Space

The following conditions conducive to wood destroying insects were observed: Standing water at the vapor barrier in the crawlspace.

Description	Amount
1. Installed a full crawl space perimeter footing drainage system with perforated pipe 2. Drainage gravel 3. Installed a 1/3 hp sump pump assembly 4. 1 1/2" ABS pipe discharged 5. Cleaned up crawl space and removed debris 6. Replaced and installed a new 6 mil black vapor barrier 7. Replaced all missing or damaged heat duct insulation	\$5,450.00
Subtractions/Discounts/Credits	
Subtotal:	\$5,450.00
Tax:	\$485.00
Total:	\$5,935.00
After 30 Days (Unless Otherwise Stated):	\$6,647.00
