NOTICE TO BUYER: SELLER-PROCURED INSPECTION REPORT

Alexander and Victoria Bogomolny
1384 Greenwich Walk NE
Issaquah, WA, 98029

At your request, a visual inspection of the above referenced property was conducted on 02/15/2023. We have inspected the major structural components, plumbing, heating and electrical systems for signs of significant non-performance, excessive or unusual wear and general state of repair.

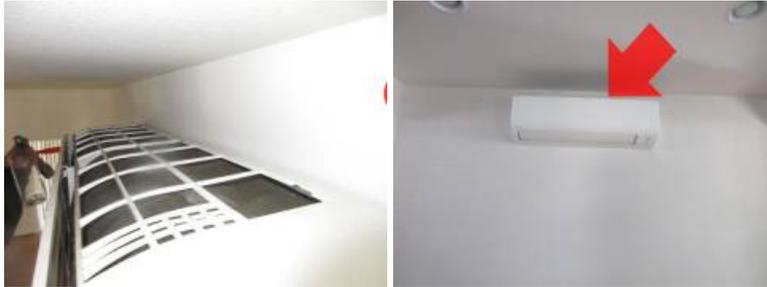
The ventilation unit was functioning as intended. Servicing the unit is regular replacement and cleaning of the filter(s)

integrated in front of the unit. The heat exchanger should be cleaned every 3-4 years depending on how dirty the outside air is. Refer to unit manual for additional servicing tasks.
