**NOTICE TO BUYER: SELLER-PROCURED INSPECTION REPORT**

The following notice is given with respect to the Purchase and Sale Agreement dated \_\_\_\_\_ between \_\_\_\_\_ (“Buyer”) and **Christina M Matthews** **Luke J Matthews** (“Seller”) concerning **15040 116th PINE** **Kirkland** **WA 98034** (“the Property”).

**Luke & Christina Matthews**  
**15040 116<sup>th</sup> Place NE**  
**Kirkland, WA 98034**

At your request, a visual inspection of the above referenced property was conducted on 02/13/2023. We have inspected the major structural components, plumbing, heating and electrical systems for signs of significant non-performance, excessive or unusual wear and general state of repair.

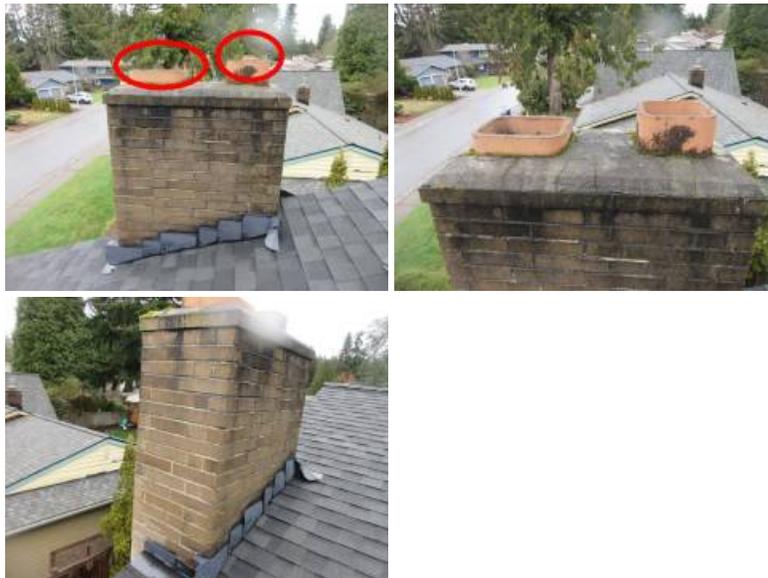
The chimney crown is cracked and deteriorated. The mortar chimney crown prevents water from entering and damaging the masonry. Repairing or replacing the chimney crown will extend the service life of the chimney.

Mortar was missing or deteriorated in numerous areas around the chimney. This has led to accelerated deterioration of the brick masonry. Damaged areas can be repaired by filling in cutout or defective mortar joints with fresh mortar. (Tuck pointing)

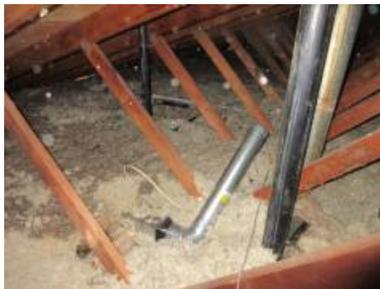
The bathroom vent fan discharges in the attic rather than outside. This is an undesirable condition that causes excessive moisture in the attic and can result in mold or fungus growth. A 4" smooth-wall sheet metal duct should be installed to direct the moisture laden air discharged from the fan out of the attic.

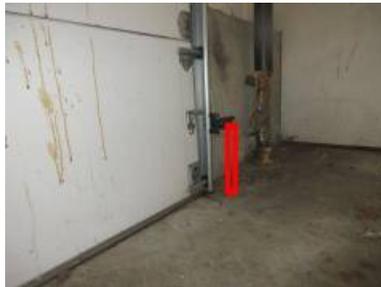
The Photo-eye beam was installed too high above the floor of the garage to adequately offer protection for small children and/or pets. We recommend that the photo-eye be lowered to within 4-6" of the floor.

There was no photo-eye sensor installed for the south garage door to offer protection for small children and/or pets. We recommend that a photo-eye sensor be installed for the garage door at a height of within 4-6" of the floor.

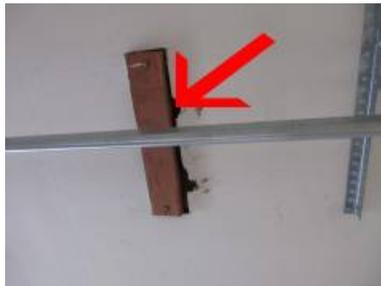
There are voids in the fire resistive barrier between the living space and garage that will allow flames to penetrate. The gypsum barrier slows the spread of a fire from the garage to the structure and/or living space. Patching the voids with a fire retardant caulk is recommended.

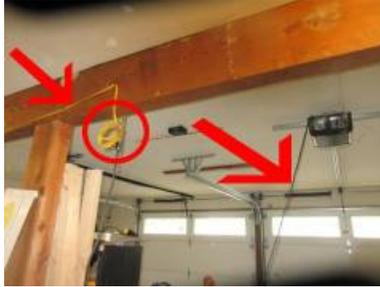
An extension cord is used as a temporary power source for the garage door openers. An extension cord is not suitable as a permanent wiring method. The installation of a receptacle within cords length of the motors is recommended.

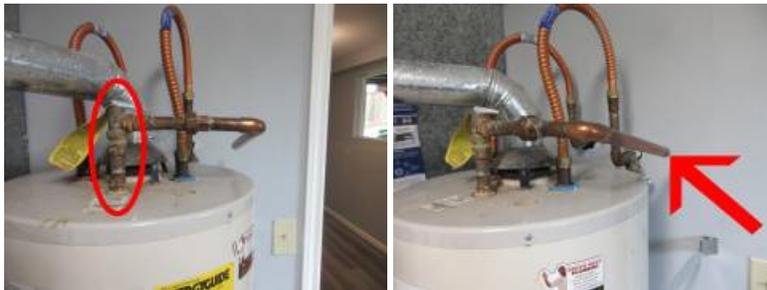
The pressure relief valve is mounted on the external pipe rather than in the water heater. This was a typical installation when this house was built, but is now considered to be non-code compliant in most jurisdictions. The installation of a pressure relief valve on the water heater tank is recommended as a safety upgrade.

The pressure relief valve lacks a drain pipe. This is a scald hazard. The installation of a 3/4" copper, CPVC plastic or galvanized steel drain pipe is recommended. Ideally, the drain should be routed to the exterior. However, running the pipe straight down to the floor eliminates the scald hazard.

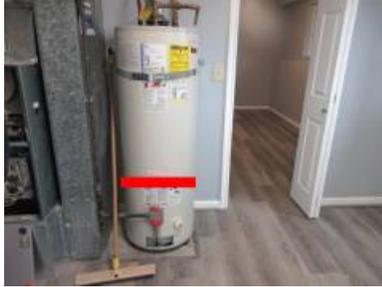
The seismic restraint for the water heater was minimal. Proper strapping is recommended to adequately secure the tank and provide potable water in the event of an earthquake.

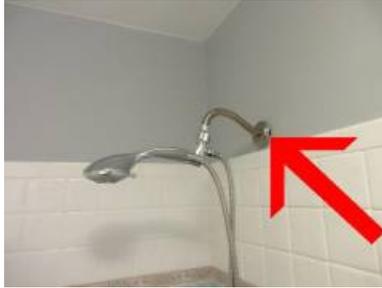
The goose neck is loose inside the wall. This can result in leaks. The goose neck should be secured inside the wall in accordance with industry standards.

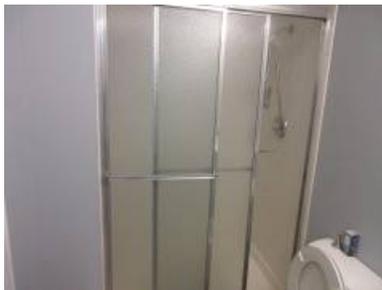
Wire glass has been used in the shower enclosure. Wire glass can be extremely hazardous when broken. As an upgrade, to increase the margin of safety, we recommend installing a tempered safety glass enclosure.

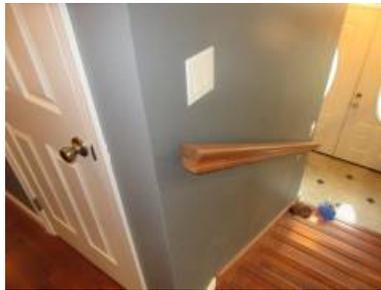
There is no handrail in the lower stairwell. This is a safety hazard. The installation of a graspable handrail that conforms to present industry standards is recommended.

The railing ends in the upper stairwell does not return to the wall. This is a safety hazard. The installation of a continuous handrail should be considered as a safety upgrade.

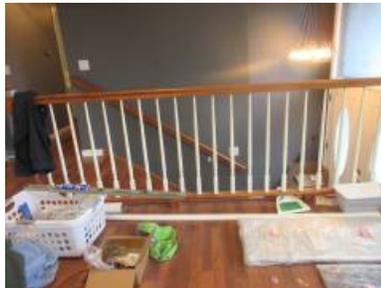
The spacing between the balusters is too wide. This is a hazard to small children. The balusters should be spaced close enough together so that a 4" sphere cannot pass through. Upgrading the guard railing is recommended if small children are present.

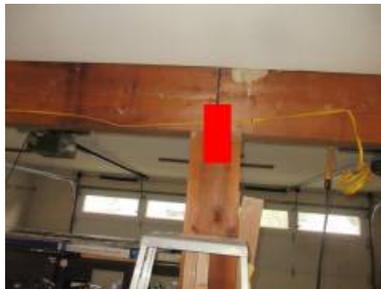
There are no visible positive connections tying the posts and concrete pier footing together. The installation of gusset plates is recommend to reduce the likelihood of damage during an earthquake.

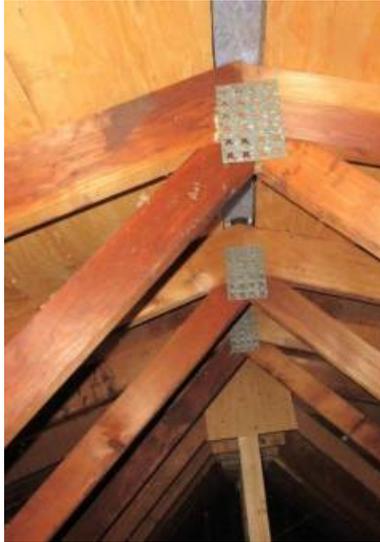
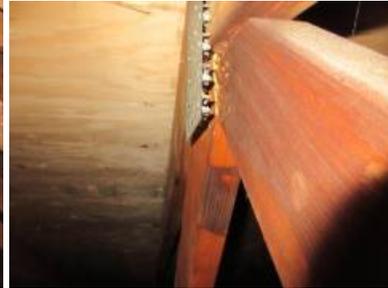
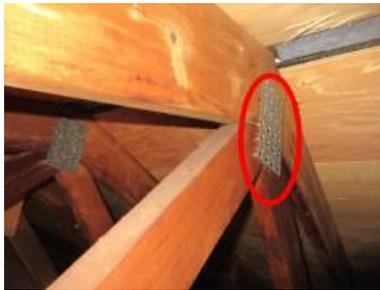
Several of the truss nailing plates are compromised and are inadequately performing their intended function(s). This could cause movement of the roof structure. Repairs are recommended.
