NOTICE TO BUYER: SELLER-PROCURED INSPECTION REPORT

The following notice is given with respect to the Purchase and Sale Agreement dated _____ between _____ (“Buyer”) and **Jennifer Emira** _____ (“Seller”) concerning **17150 NE 140th Ct Redmond WA 98052** (“the Property”).

At your request, a visual inspection of the above referenced property was conducted on 03/14/2023. We have inspected the major structural components, plumbing, heating and electrical systems for signs of significant non-performance, excessive or unusual wear and general state of repair.

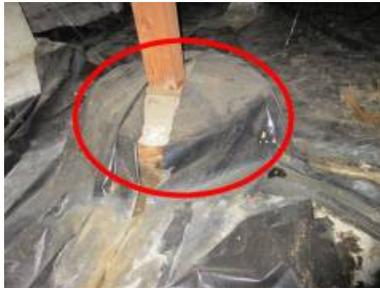
The support post concrete piers are covered with the plastic vapor retarder. This allows the transmission of water vapor from the soil up and into the floor framing. The plastic vapor retarder should be removed from the pier so that it covers at least 85% of the entire surface of the soil only.

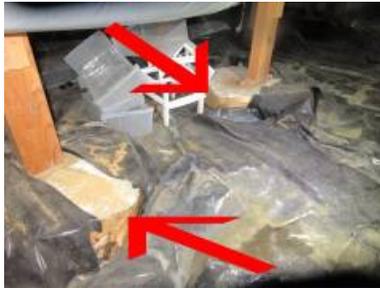
PEST CONTROL

Cellulose forms were left in place on the pier footings. This cellulose is conducive to the infestation of various wood destroying organisms. The removal of the cellulose is recommended.
