## NOTICE TO BUYER: SELLER-PROCURED INSPECTION REPORT

Estate Of Marcia Joy Palmer  
17130 26th Ave SE  
Bothell, WA 98012

May 30, 2023

**Re: 17130 26th Avenue SE  
Bothell, WA.**

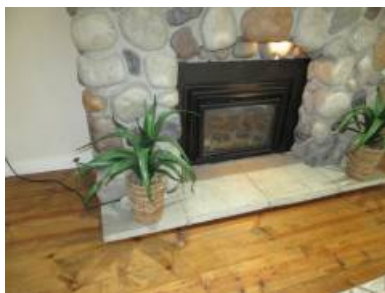
The condition of the fireplace in which the insert is placed was not visible for inspection and its condition was not determined. The smoke pipe should extend from the top of the insert, through the smoke chamber and into the flue. This portion of the installation is not visible for inspection. You should have a chimney sweep examine this component when the chimney flue is cleaned.

The gas supply for the fireplace is located on the wall or floor adjacent to the hearth. The key that turns on this valve should be kept out of the reach of children.

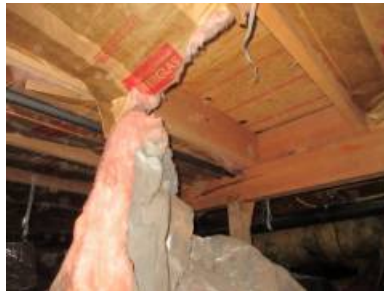
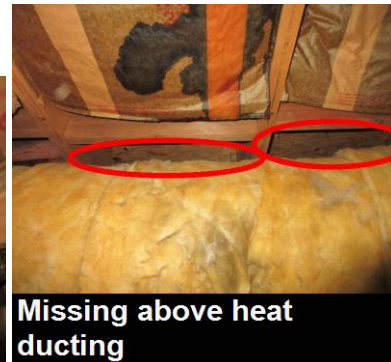
Several insulation batts are missing and numerous were not properly secured and have falling down. The fallen batts should be reinstalled and secured. The missing batts should be replaced.

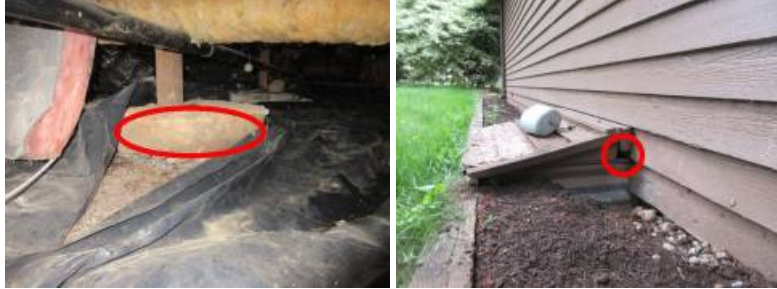
The crawlspace access door is not rodent proof. The installation of a tight fitting access door is recommended to exclude rodents from the crawlspace.
