## NOTICE TO BUYER: SELLER-PROCURED INSPECTION REPORT

17614 NE 138<sup>th</sup> St

At your request, a visual inspection of the above referenced property was conducted on 07/11/2023. We have inspected the major structural components, plumbing, heating and electrical systems for signs of significant non-performance, excessive or unusual wear and general state of repair.

DATE OF INSPECTION: 7/11/2023.  
 INSPECTOR'S NAME: Terry Clark.  
 CLIENT NAME: Mr. & Mrs. Zach & Tessa Holmes.  
 MAILING ADDRESS: 17614 NE 138th St.  
 Redmond WA.  
 CLIENT E-MAIL ADDRESS: tessa.m.holmes73@gmail.com; [zach.holmes275@gmail.com](mailto:zach.holmes275@gmail.com).  
 ADDRESS OF PROPERTY INSPECTED: 17614 NE 138th St.  
 Redmond WA.

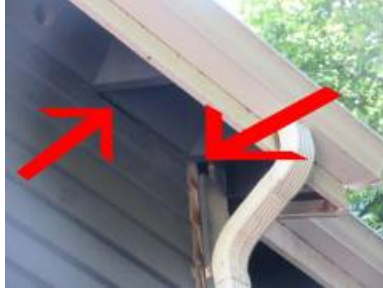
**GUTTERS AND DOWNSPOUTS** Roof runoff is collected and channeled into the downspouts by aluminum gutters fastened to the rafter tails. The gutters and downspouts are properly installed and are performing their intended function. Gutters should be cleaned regularly to prevent clogging and overflow. The downspouts are properly installed and are functioning as intended.

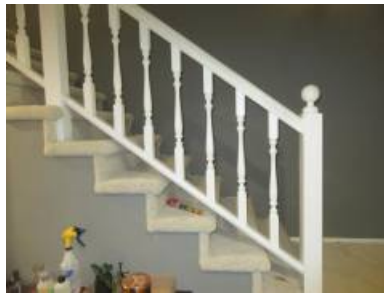
The stair railing baluster spacing is too wide. This is a hazard for small children. The baluster spacing should be reduced as a safety upgrade. Current standards require that a 4-3/8" sphere not pass through the railing.

The stair railing spacing at the stair treads is too wide. This is a hazard for small children. The railing spacing should be reduced as a safety upgrade. Current standards require that a 6" sphere not pass through or under the railing.
