## NOTICE TO BUYER: SELLER-PROCURED INSPECTION REPORT

**Robert and Suzanne Kingsley  
16934 NE 131<sup>st</sup> Pl  
Redmond WA 98052**

**Per the seller, the following items listed on the pre-sale inspection report dated 12/26/2023 have been corrected by the seller as part of preparation for sale in good faith.**

At your request, a visual inspection of the above referenced property was conducted on 12/18/2023. We have inspected the major structural components, plumbing, heating and electrical systems for signs of significant non-performance, excessive or unusual wear and general state of repair.

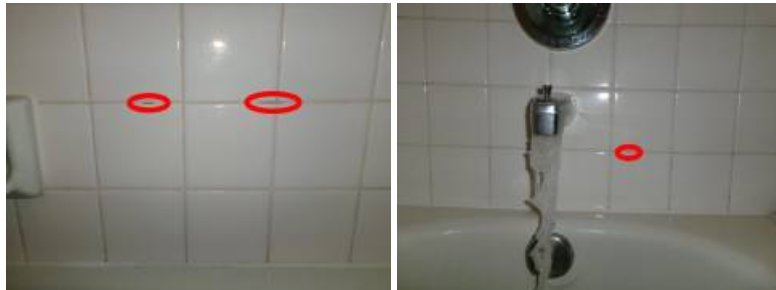
Grout is missing from between some of the wall tiles. This can allow water to enter through the tile and can damage the walls. Regrouting the wall tile is recommended.

Most ceramic tile is applied directly over gypsum board rather than on a concrete board such as "Durock" or "Wonder Board". Where the tile is applied directly over the gypsum board, it is critical that the tile grout be maintained to prevent water intrusion behind the tile. Missing or cracked grout should be repaired. Inside corners, and penetrations in the tile should be kept sealed with a high quality caulk.

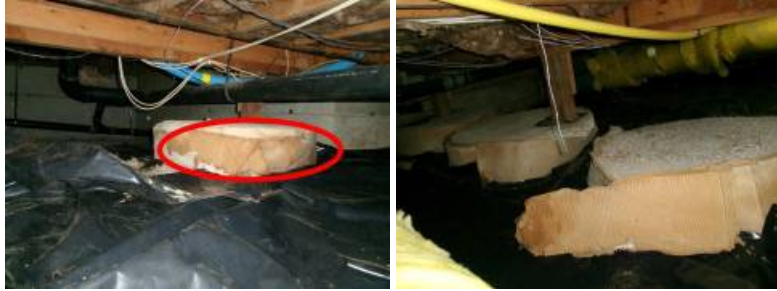
Good building practice requires that foundation walls or pier footings supporting wood frame construction, should extend at least 8" above the finish grade with at least a 6" clearance between the top of the soil and the bottom of the wood finish materials. Untreated wood should be raised 1-2" above surrounding flatwork and should have a

moisture barrier such as 30 lb. asphalt impregnated felt installed between the concrete and wood. For additional information and treatment options, you should retain the services of a qualified pest control operator.
