NOTICE TO BUYER: SELLER-PROCURED INSPECTION REPORT

Linda and Roy McIntosh, Sellers
17617 NE 131st Street
Redmond, WA 98052

As of October 13, 2020 the following items listed on inspection summary for this property by Terry Clark have been corrected by the sellers:

At your request, a visual inspection of the above referenced property was conducted on 09/28/2020. We have inspected the major structural components, plumbing, heating and electrical systems for signs of significant non-performance, excessive or unusual wear and general state of repair.

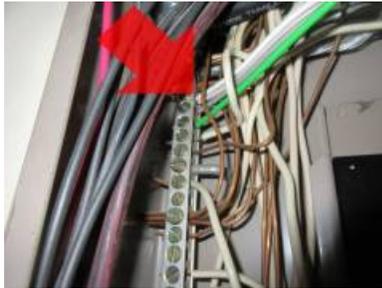
One of the neutral wires is double tapped on the buss bar. Double tapping means that two conductors share a single terminal. Double tapped terminals can loosen and overheat and therefore are not permitted unless the terminal is specifically listed for multiple wires. This defect is easily repaired by connecting the two wires to a "pig tail", securing them with a wire cap, and then inserting the pig tail conductor under the terminal.

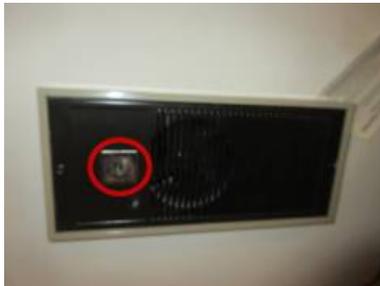
The control knob is missing. We recommend replacement of the heater control knob.

This type of heater must be cleaned annually. An accumulation of dust inside this type of heater is a fire hazard. To clean the heater, turn off the power at the circuit breaker panel then remove the cover from the front of the heater. Use a paint brush to loosen the dirt and then vacuum it up.

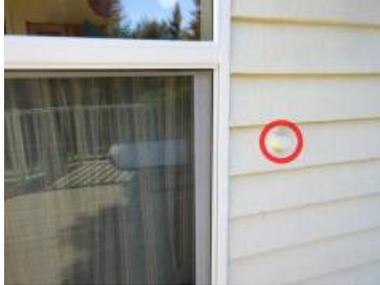
11.8 AIR GAP

An air gap called a Johnson Tee is installed in the kitchen wall. This air gap protects the dishwasher from contamination caused by a backflow of waste water. The cap protruding on the exterior wall opposite the dishwasher is not drilled. This renders the air gap non-functional. Drilling a 1/4" hole in the end of the cap will restore its function. The remaining visible portions of the Johnson Tee were properly installed and functioning as intended.

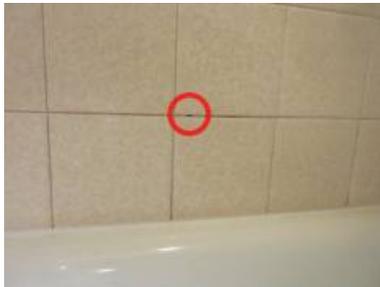
Grout is missing from between some of the wall tiles. This can allow water to enter through the tile and can damage the walls. Regrouting the wall tile is recommended.

Most ceramic tile is applied directly over gypsum board rather than on a concrete board such as "Durock" or "Wonder Board". Where the tile is applied directly over the gypsum board, it is critical that the tile grout be maintained to prevent water intrusion behind the tile. Missing or cracked grout should be repaired. Inside corners, and penetrations in the tile should be kept sealed with a high quality caulk.
