NOTICE TO BUYER: SELLER-PROCURED INSPECTION REPORT

17633 NE 129th Pl

Redmond, WA 98052

At your request, a visual inspection of the above referenced property was conducted on 03/01/2021. We have inspected the major structural components, plumbing, heating and electrical systems for signs of significant non-performance, excessive or unusual wear and general state of repair.

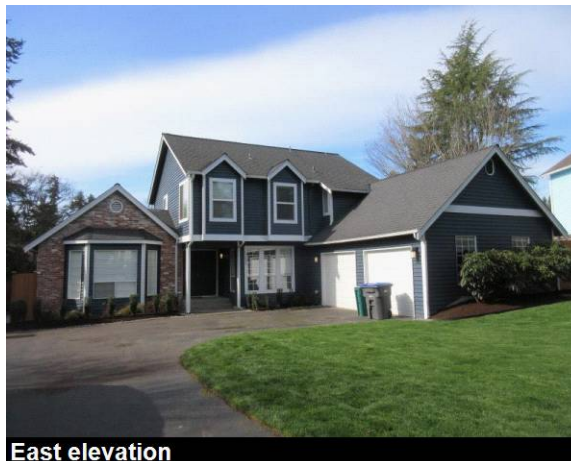
East elevation
